CONSTRUCTION PROGRESS REPORT NO. 1

SUMMER PLACE PHASE 1 CRESECENT CITY, CALIFORNIA

Date Issued: December 19, 2011

Project No. 1134

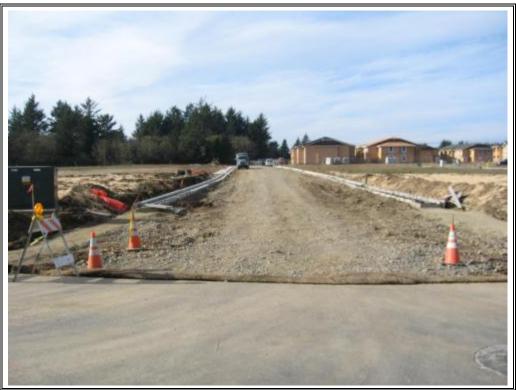
1. Main entrance off of Summer Lane.

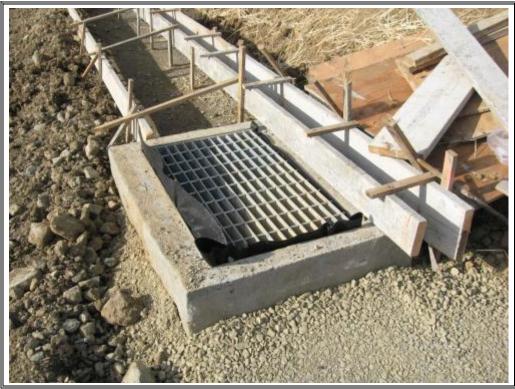
2. Storm drain inlet.

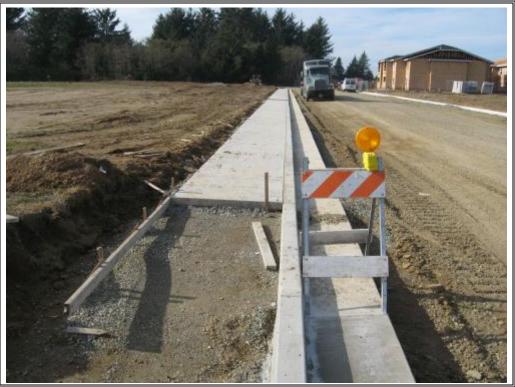
The main entrance road is graded with stone base in place. Curb and gutter is mostly complete with exception of approximate 50' sections that tie into Summer Lane. Sidewalk is poured at approximately 75% of the south side of the access road. Storm drain and drain inlets are installed. On site access roads and parking areas are rough graded. Curb and gutter forming and pouring is in progress on the north side of the property heading south. Grading around the buildings will require fine grading in preparation for hardscape and landscaping.

3. Curb, gutter and sidewalk at main entrance drive.

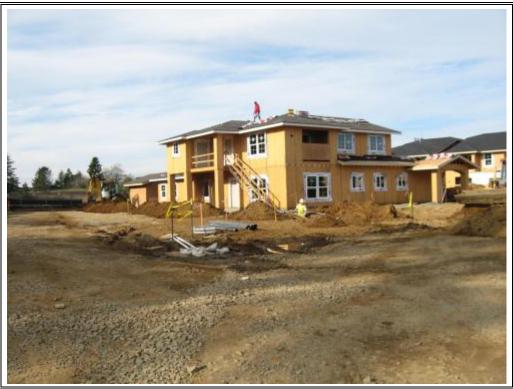
4. Building A (Community Center)

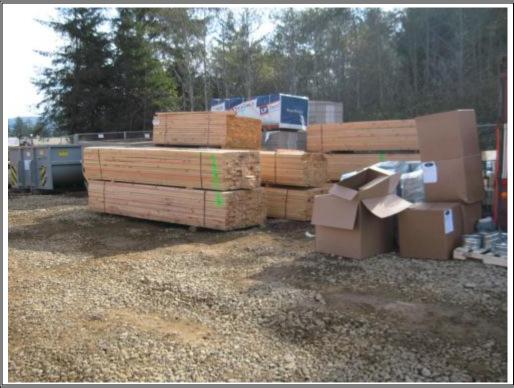
5. Stored lumber.

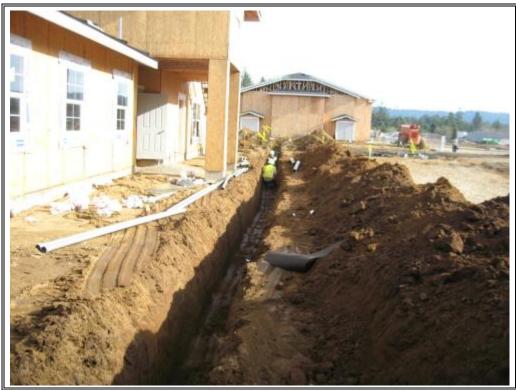
6. Underground electrical conduit installation.

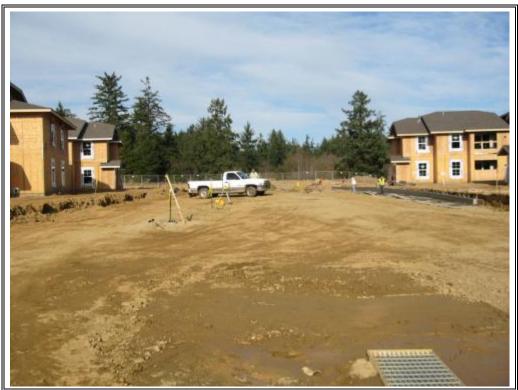
7. Access road and placeing between buildings.

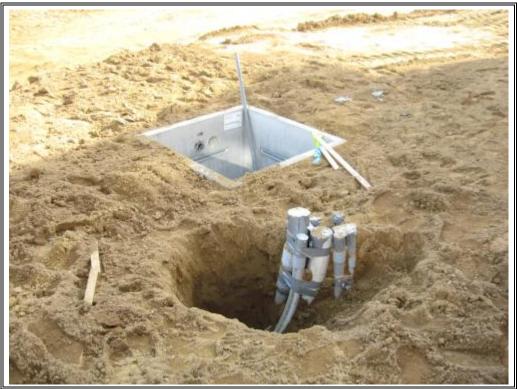
8. Electrical conduits and vault.

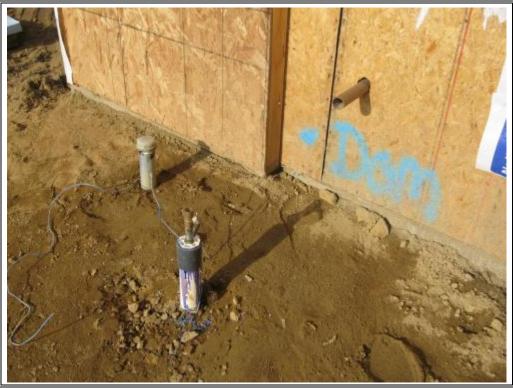
Underground sanitary and storm sewer lines were tied into the City with all building lateral ties complete. The water main is tied into the City, on site saddle valves, backflows and lateral feeds are stubbed to the buildings. The gas main is tied into the City and lateral stubs to each building complete. Electrical vaults are set and conduits are mostly installed and stubbed into each building. Wet utilities are signed off by the City and dry utilities will reportedly be signed off December 7.

9. Water and gas stub to building.

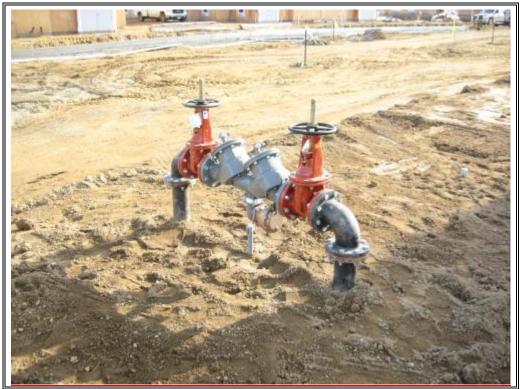
10. Water main valves and backflow.

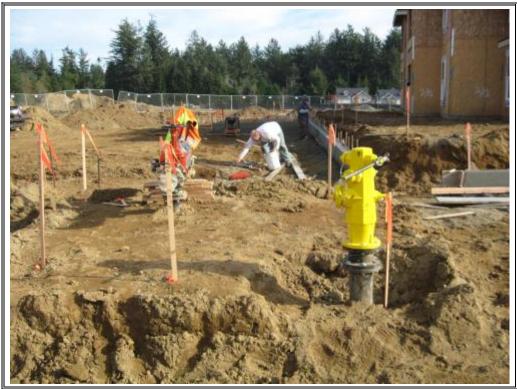
11. Fire hydrant and curb/gutter forms at Building E.

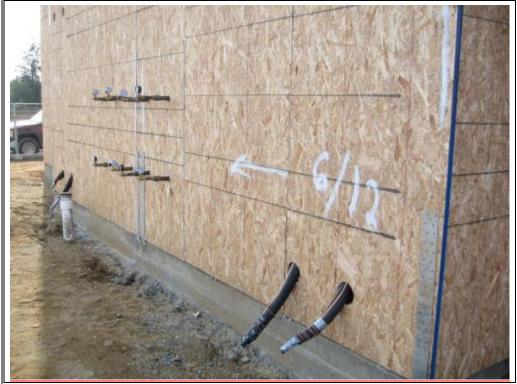
Vent line stub outs and condenser line sets are complete at all buildings.

12. HVAC condenser lines and gas meter stubs.

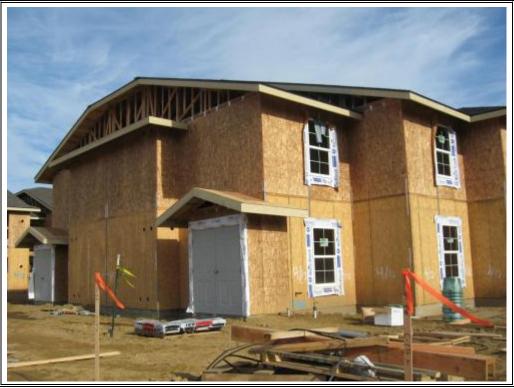
13. Building B

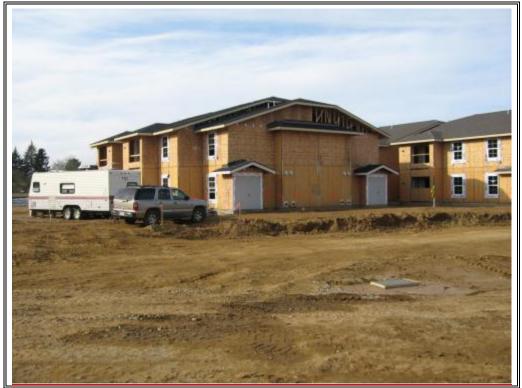
- a. The site is reportedly locked during non-working hours. A motorhome trailer is located on site and is being used by a day laborer for off-hours site security.
- **Permits:** There are eight building permits issued for the project—Buildings A, B, C, D, E, F, G and H. All are dated 6/02/2011. See copies in Appendix.

14. Building H and G, and security trailer.

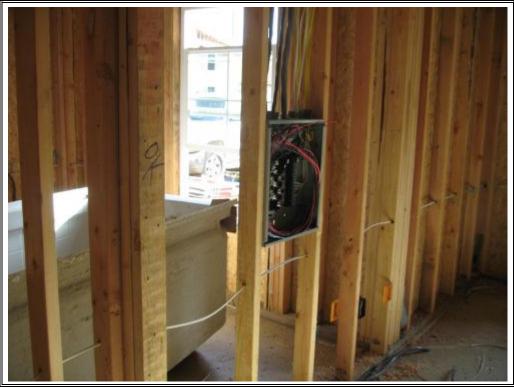
Rough electrical is in progress and in various stages of completion at Buildings A, B and C. Work includes box mounting, wiring, and service panel installation.

15. Interior unit electrical panel.

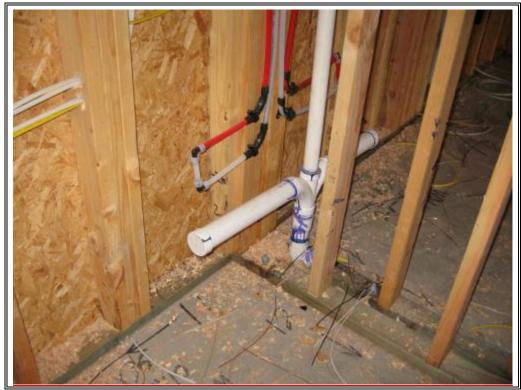
Plumbing waste and vent lines are mostly complete in all buildings. Water lines are complete on the first floor of all buildings and in progress on the second floors. Gas lines are mostly complete at all buildings. Tub enclosures are staged in all units and being set in Building H.

16. Interior lavatory waste and water lines.

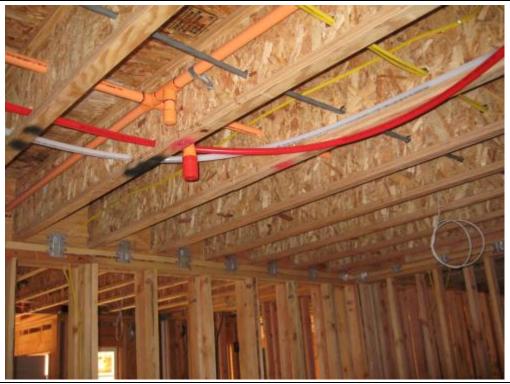
Fire sprinkler installation is complete at Buildings H and G, and in progress on the first floor of F.

17. Overhead water and sprinkler lines.

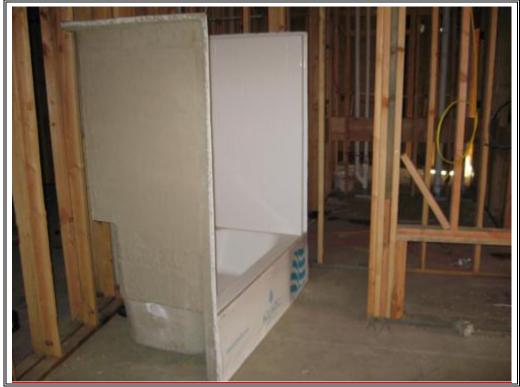
18. Tub enclosure.
