PROPERTY CONDITION ASSESSMENT REPORT RESORT

123 Main Street
City, State, Zip
NDDS Project #2311111

RE: Property Condition Report
Resort
123 Main Street
City, State, Zip
NDDS Project #2311111

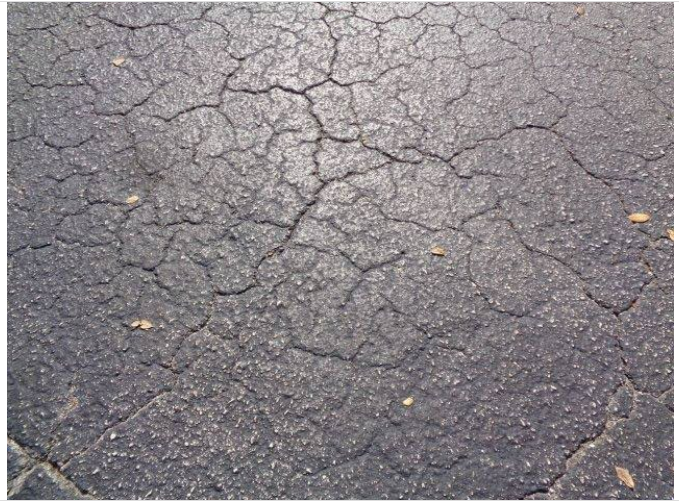
19. Typical asphalt pavement damage.

- 3) Portions of the parking lot and driveway areas is encumbered with isolated wide (1/4" or larger) that have previously been sealed, but have since reopened. Due to the age of the paving and the fact that the cracks are not widespread alligatoring type, a full overlay is not prudent at this time. These cracks will require individual attention so as to not allow stormwater infiltration into the sub-base. Repairs should include routing along the length of each crack and then sealing. Costs for repairs are included within the Physical Deficiencies/Deferred Maintenance Table 1.

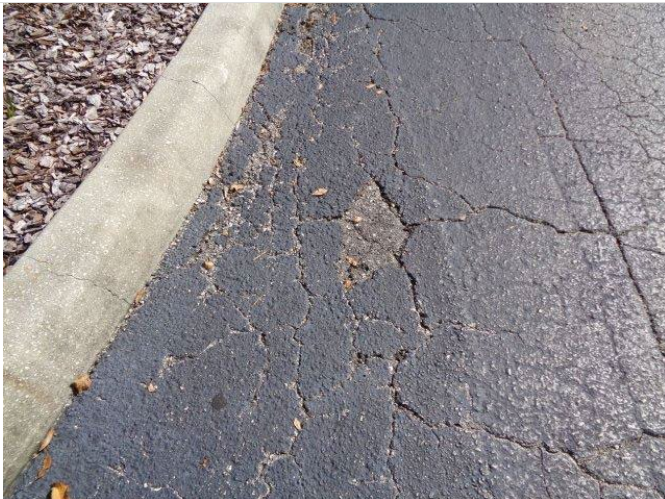
20. Typical asphalt pavement damage.

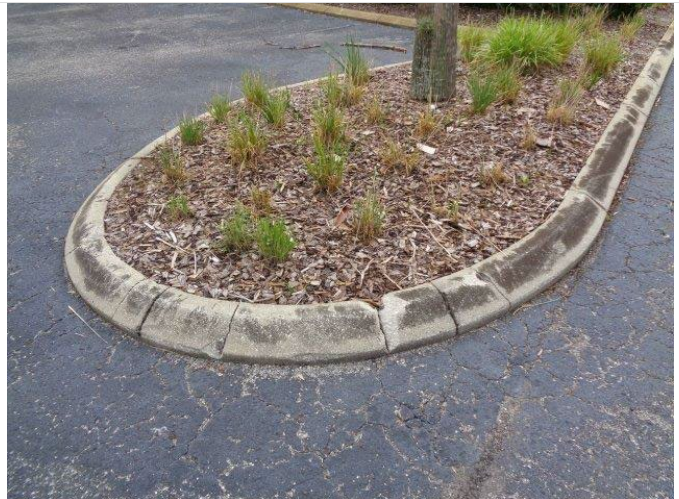
21. Typical asphalt pavement damage.

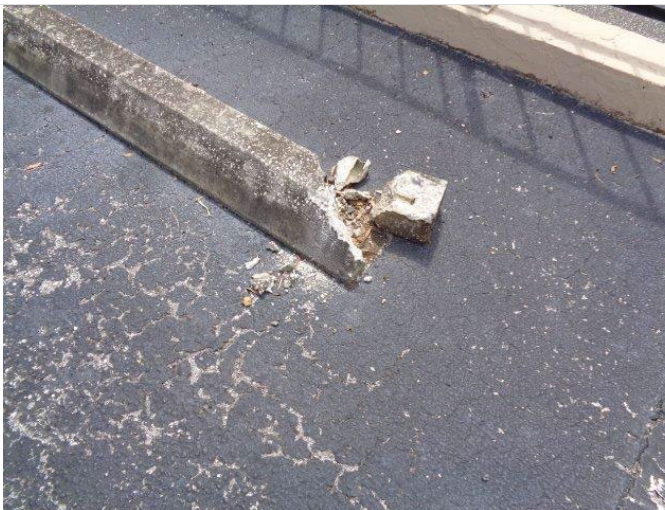
22. Typical cast-in-place concrete curb damage.

- 5) Cast-in-place concrete curbing was found to be in good-to-fair condition. Isolated sections of the concrete curbing were noted to be chipped, spalled and damaged throughout the parking lot and driveway areas (Photos X & X). Repair such sections with a concrete patching compound to match existing. Costs for repairs are included within the Physical Deficiencies/Deferred Maintenance Table 1.

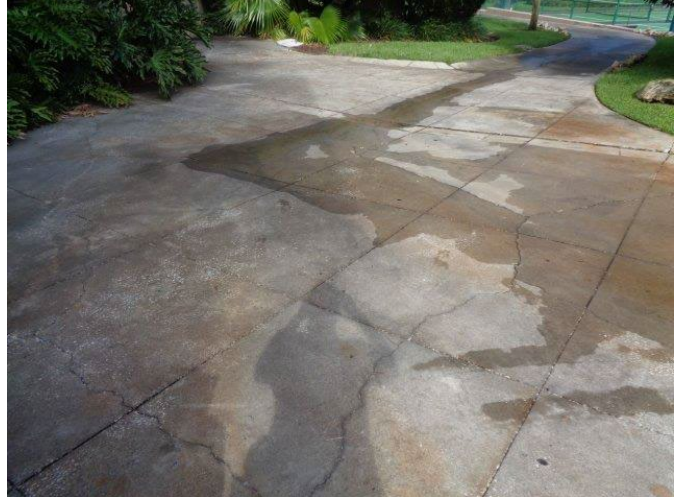
25. Typical cracks in the concrete sidewalk.

- 7) There were isolated cracked sections that were 1/4" or larger. Most of these cracks can be patched with a non-shrinking grout. Costs have been included to repair the sidewalk cracks in the Cost schedule; however, this work can be completed in-house or by an outside contractor at minimal cost.

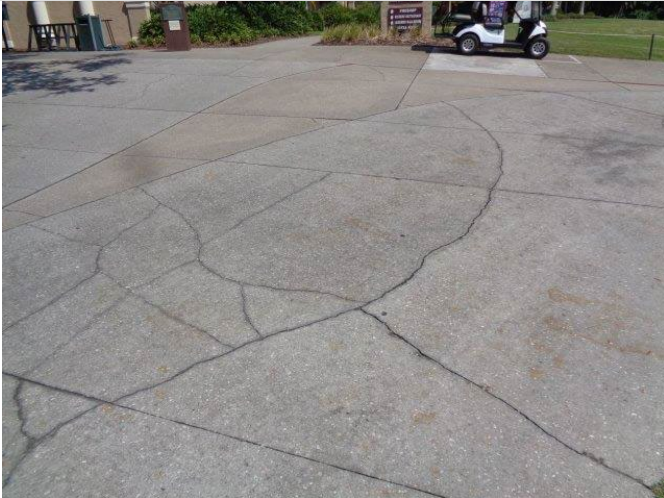
26. Patio area between the San Miguel and San Diego buildings. Note the cracks in the concrete sidewalk.

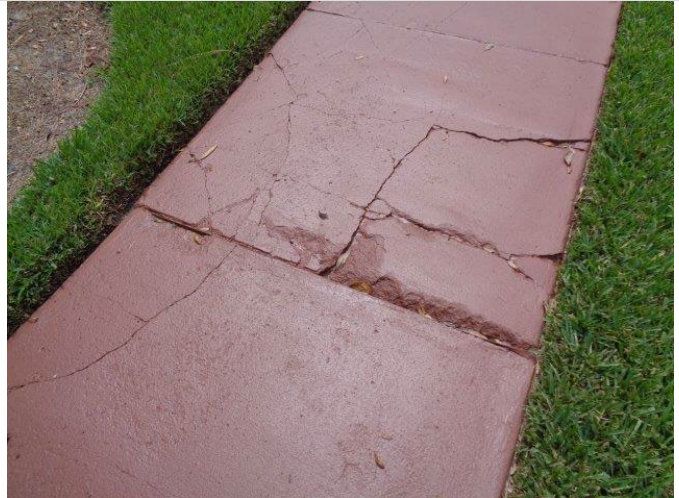
27. Patio area at the south end of the Golf Club. Note the cracks in the concrete sidewalk.

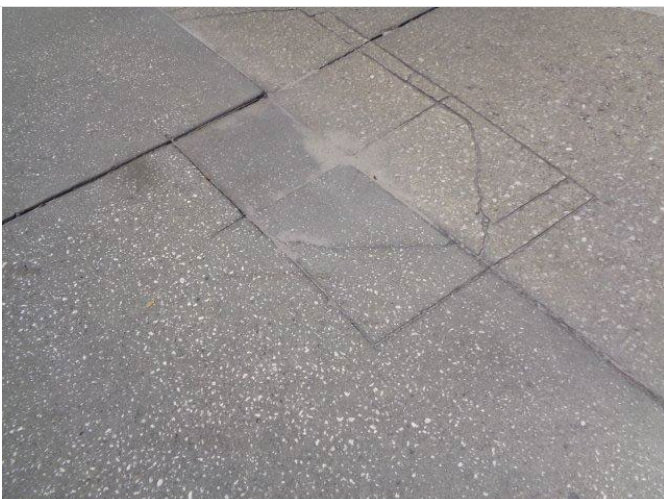
28. Sidewalk along the south of the San Miguel building. Note the tripping hazard.

- 8) Sidewalks exhibit various sections of heaving and/or settlement. Most of these cracks can be patched with a non-shrinking grout. Special attention is directed to the areas which could be a tripping hazard. These sections of sidewalk should be removed and replaced. Costs for repairs are included within the Physical Deficiencies/Deferred Maintenance Table 1.

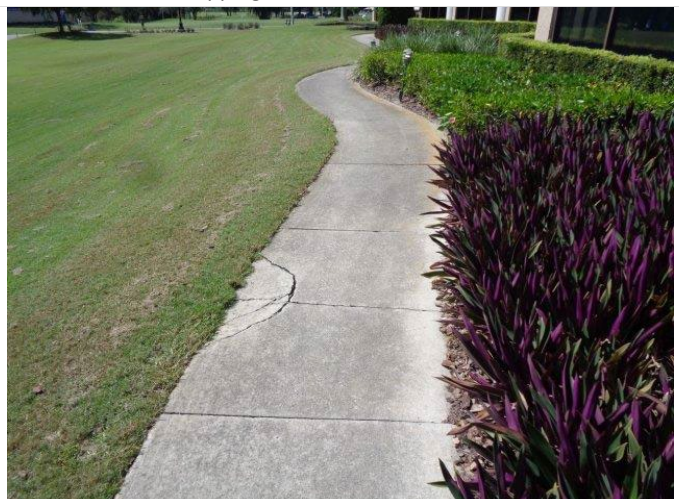
29. Flatwork at the south end of the Golf Club. Note the tripping hazard.

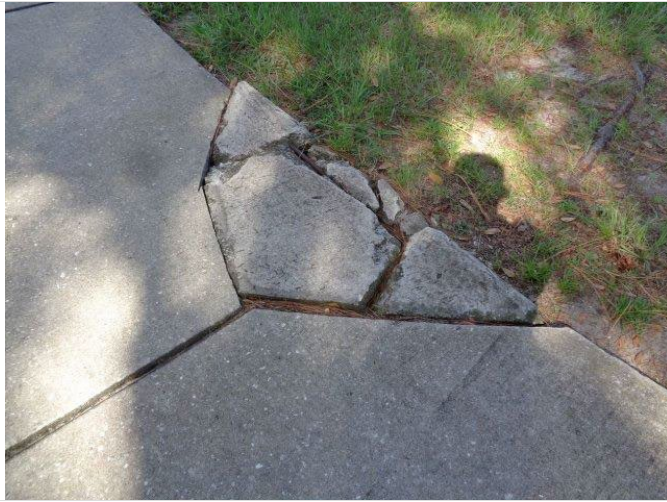
30. Sidewalk along the east end of the Golf Club. Note the tripping hazard.

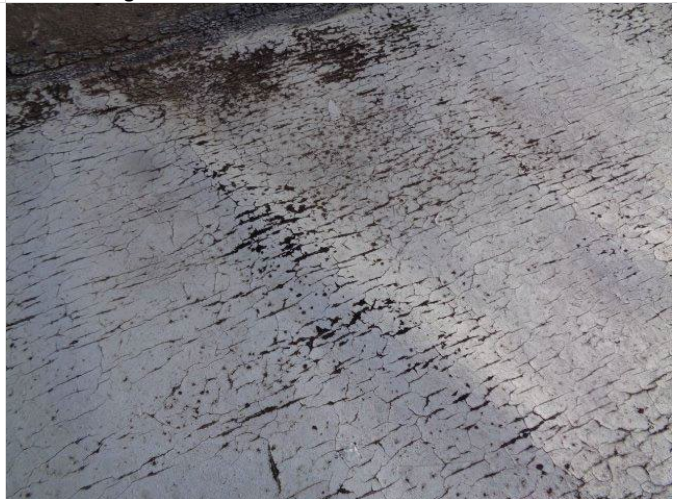
99. Typical BUR membrane damage.

| PROPERTY CONDITION ASSESSMENT SUMMARY | | | | |
|---|---|---|---|---|
| Assorted BUR Membrane Repairs (Repair Allowance) | | | | \$2,500 |

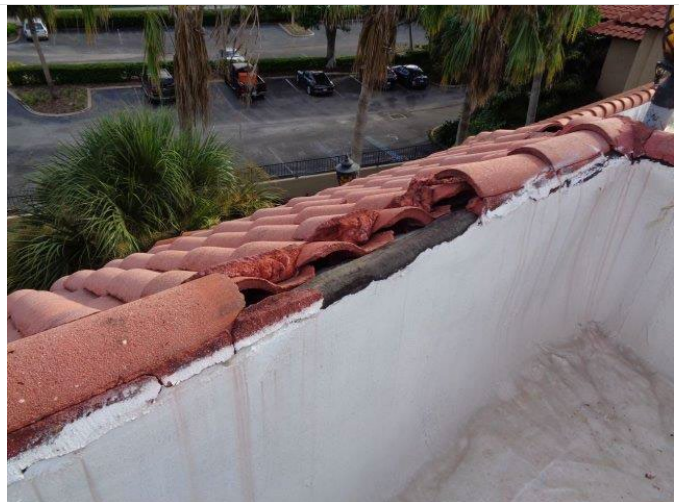
101. Damaged clay terracotta tile.

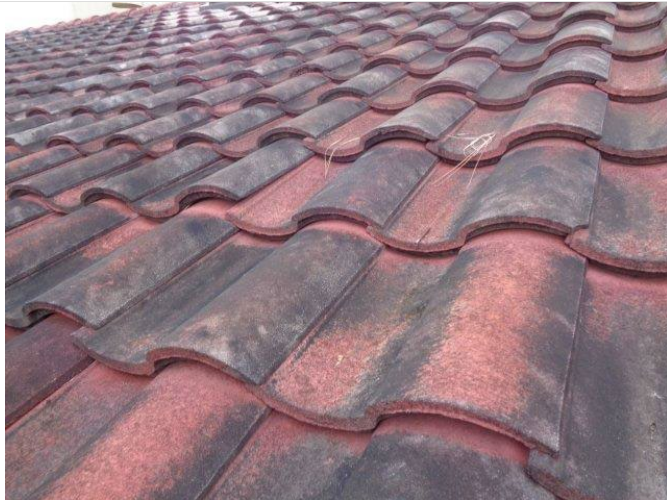
102. Damaged clay terracotta coping.

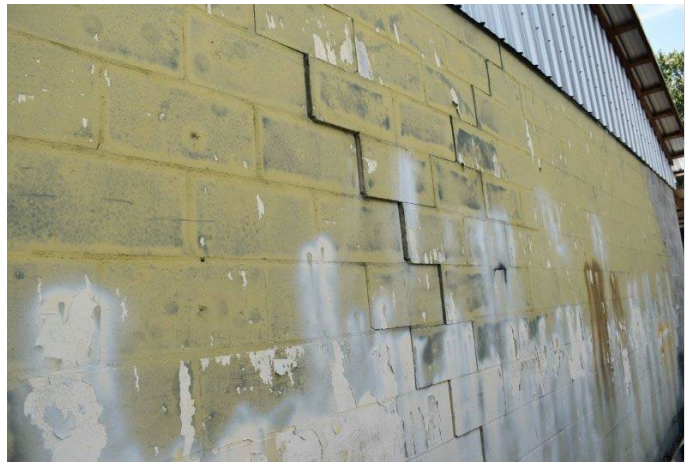
198. South side of one of the landscaping buildings. Note the step crack in the CMU wall.

| PROPERTY CONDITION ASSESSMENT SUMMARY | | | | |
|---|---|---|---|---|
| Re-Point/Repair CMU Wall Crack at the landscape facility | | | | \$1,200 |

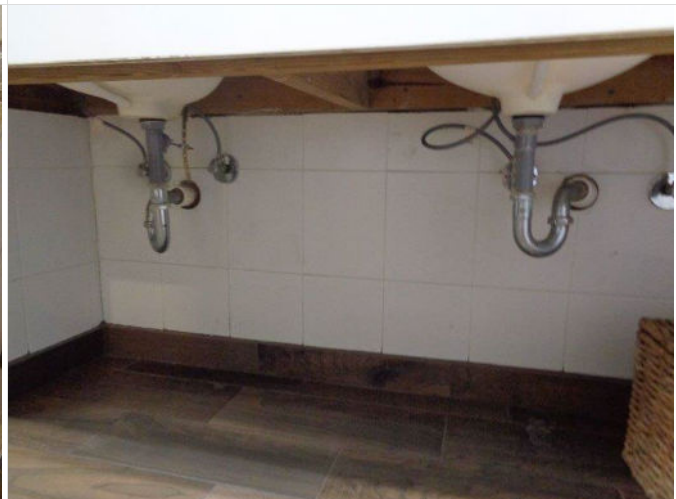
200. ADA designated stall does not meet maneuverability requirements of 60" diameter radius.

- 29) Some of the restrooms at the Subject Property have been brought into compliance with the ADA regulations. However, during our site survey, we noted that several of the restrooms provided limited handicapped accessibility. The law became effective for existing buildings classified as "Public Accommodations" on January 26, 1992. We recommend that an ADA survey be conducted to identify all barriers and any readily achievable improvements/modifications. Costs for the survey and an allowance for restroom upgrades are included within the Physical Deficiencies/Deferred Maintenance Table 1.
