PROPERTY CONDITION ASSESSMENT REPORT

COMMERCIAL BUILDING

123 Main Street

NDDS Project 2311111

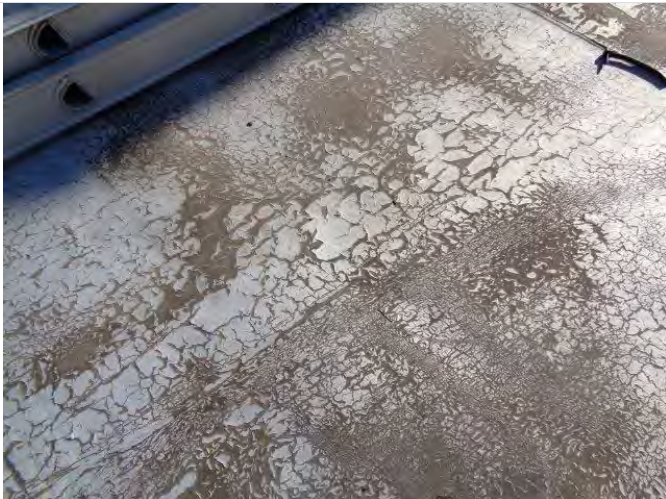
39. Typical condition of the BUR membrane.

- 5) The ages of the roofs are unknown, but they appear to have surpassed their EUL of 15 years. The roof systems are also in poor condition and have aged past the point where preventative maintenance repairs will produce a return on dollars invested; therefore, replacement is required early in the reserve term and costs for work to tear the roofs off down to the concrete roof deck and install similar built-up roof systems have been included in the Capital Replacement Reserve Schedule. Of note, based on the year of construction (1974 which is pre-1980), there is a potential that asbestos-containing materials (ACMs) are present. Additional costs may be associated with the abatement and disposal of any asbestos containing roofing materials during the replacement of the roof. *Refer to detailed roof assessment prepared by Aslan Group and published under separate cover.*

- 6) At this time, prior to the replacement of the roof, we recommend the use of “stop gap” measures to ensure water tightness and to perform emergency leak repairs only until the roofs are replaced. A budget for “stop gap” leak repairs during the first year are included within the Physical Deficiencies/Deferred Maintenance Table 1. *Refer to detailed roof assessment prepared by Aslan Group and published under separate cover.*

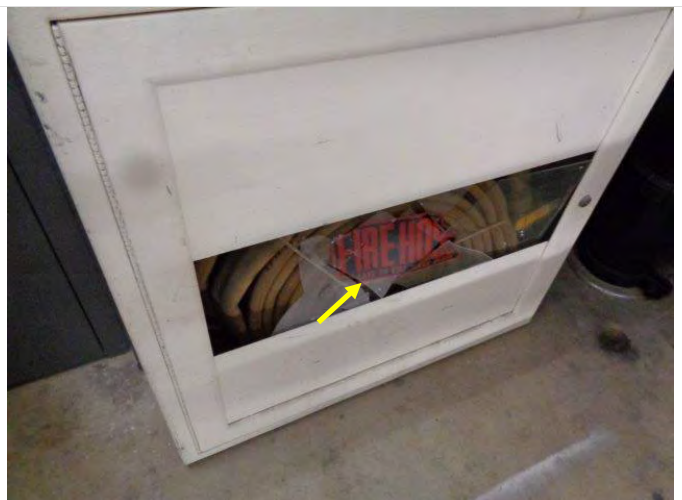
90. Typical fire hose encasement. Note that the glass panel within the 5th floor, west common stairwell was damaged.

| PROPERTY CONDITION ASSESSMENT SUMMARY | | | | |
|---|---|---|---|---|
| Repair/Replace Damaged Glass at Fire Hose Panel Encasement | \$100 | \$0 | | |

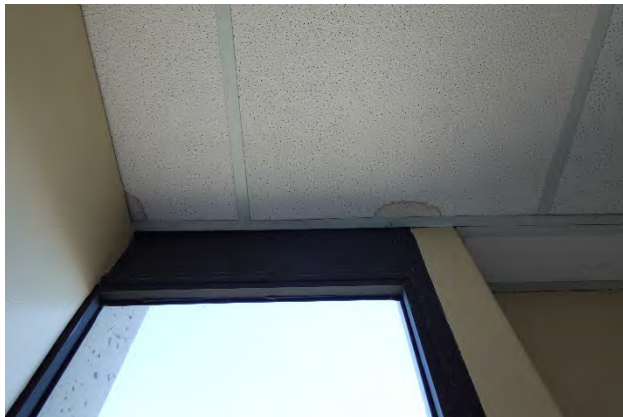
9 Water stains in the ceiling tile beneath where the urethane and silicone seals come in contact

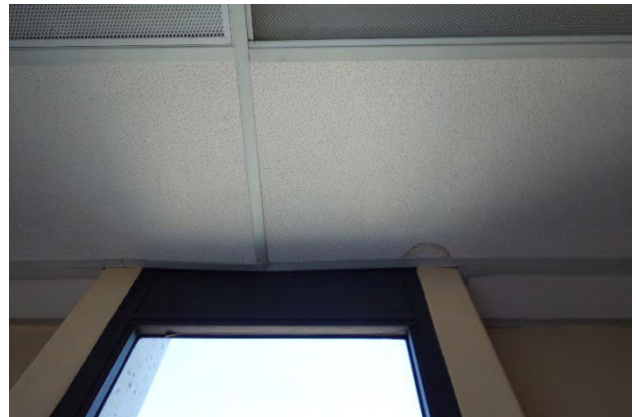
10 Water stains in the ceiling tile

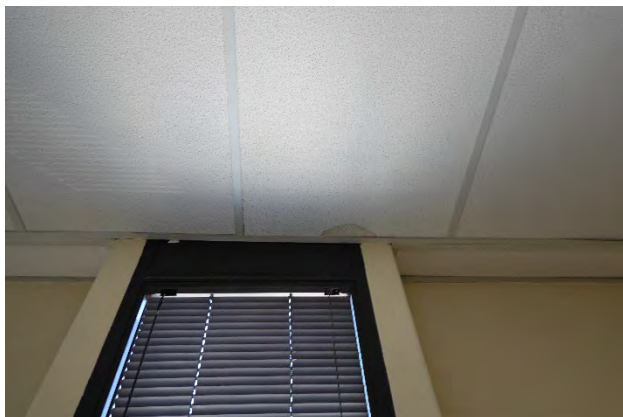
11 Water stains in the ceiling tile

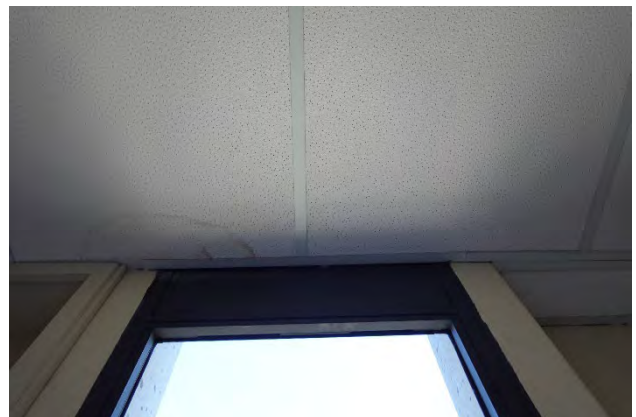
12 Water stains in the ceiling tile

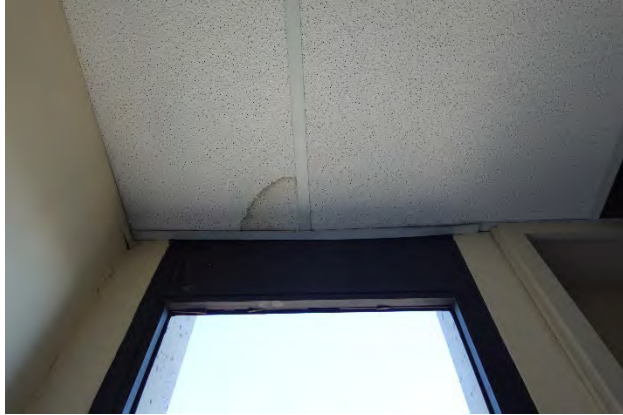
13 Water stain in the ceiling tile

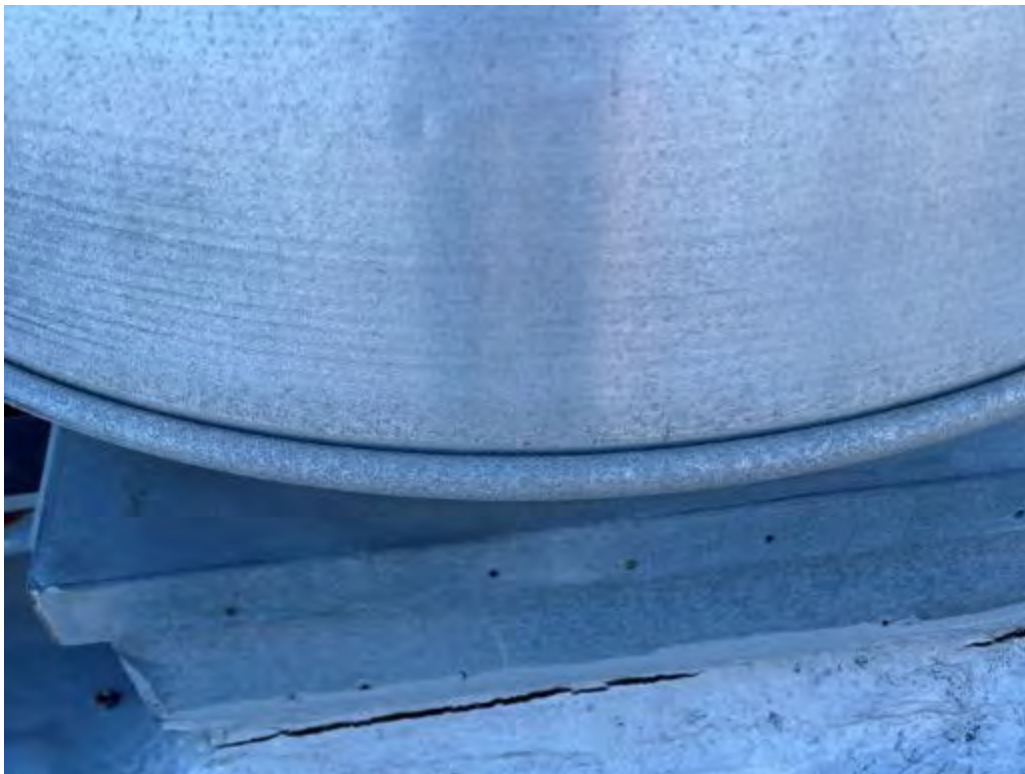
Split in curb flashing

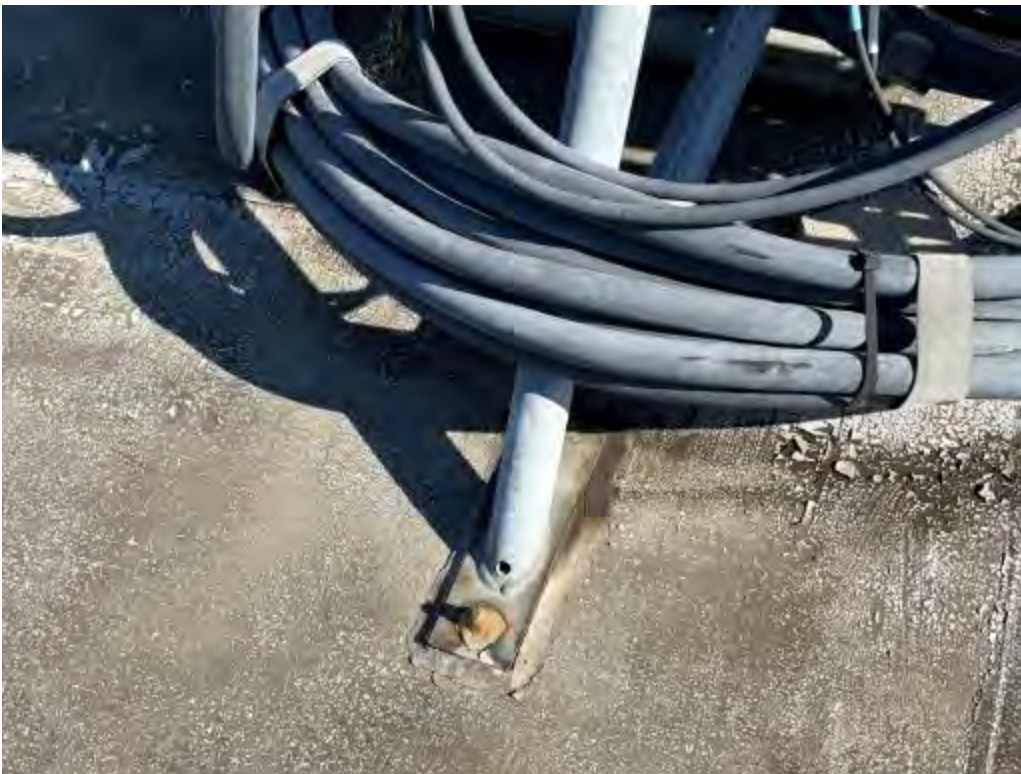
Antenna support rail improperly bolted through membrane

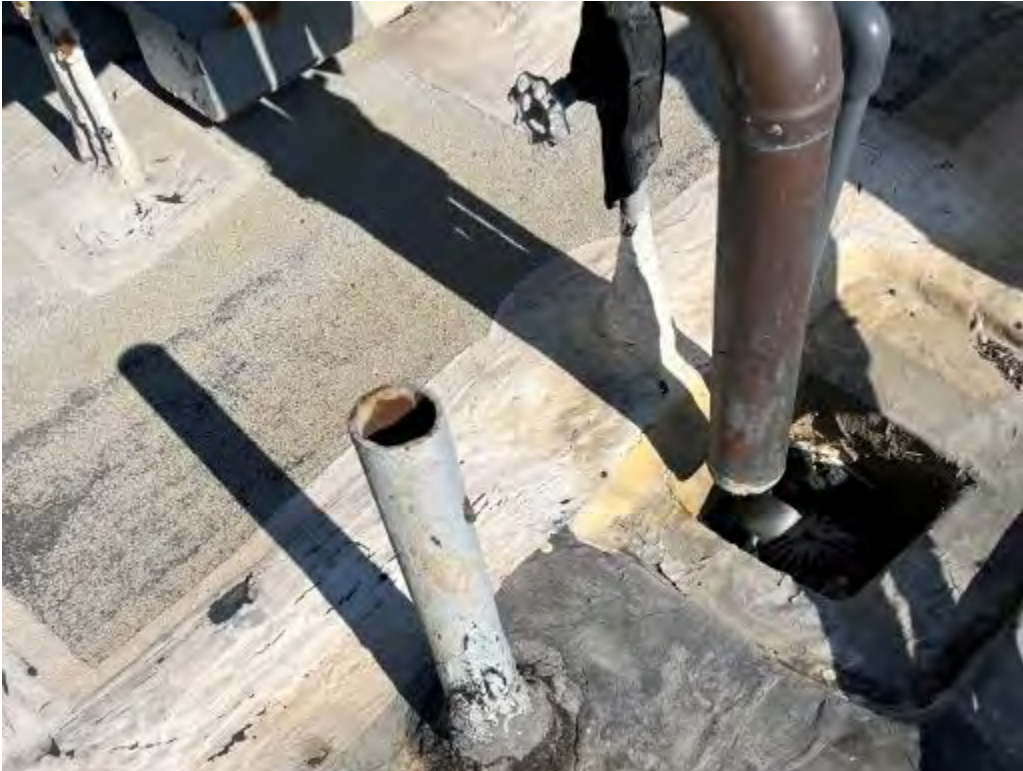
Improper plumbing vent flashing

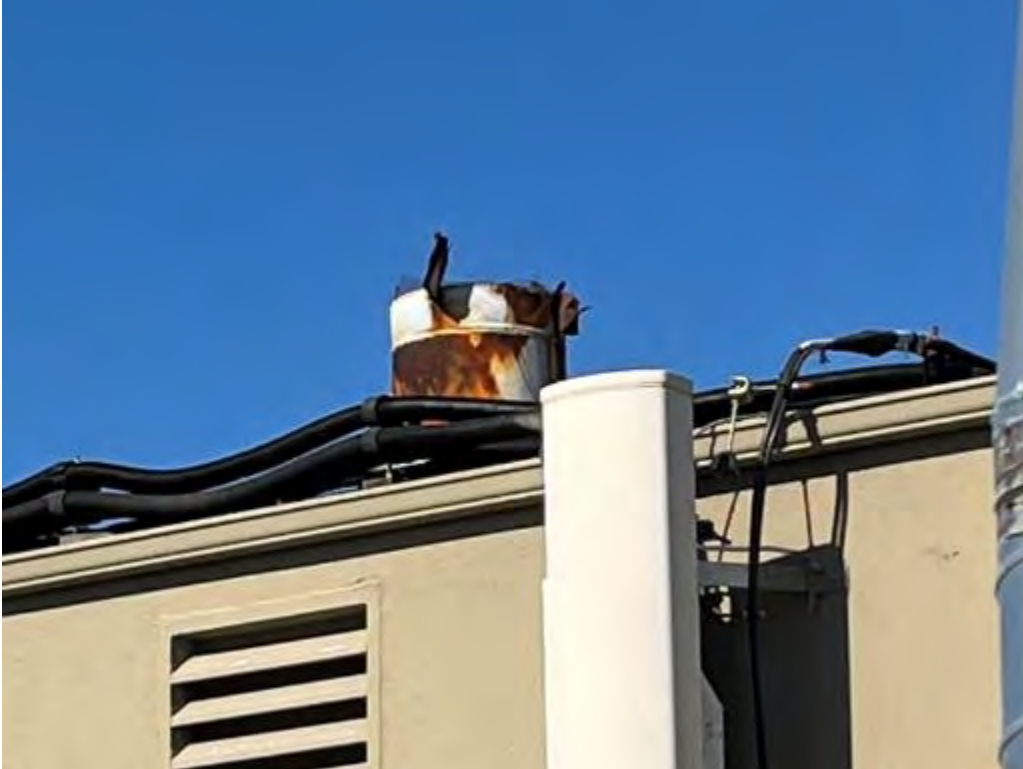
Missing flue cap on penthouse roof

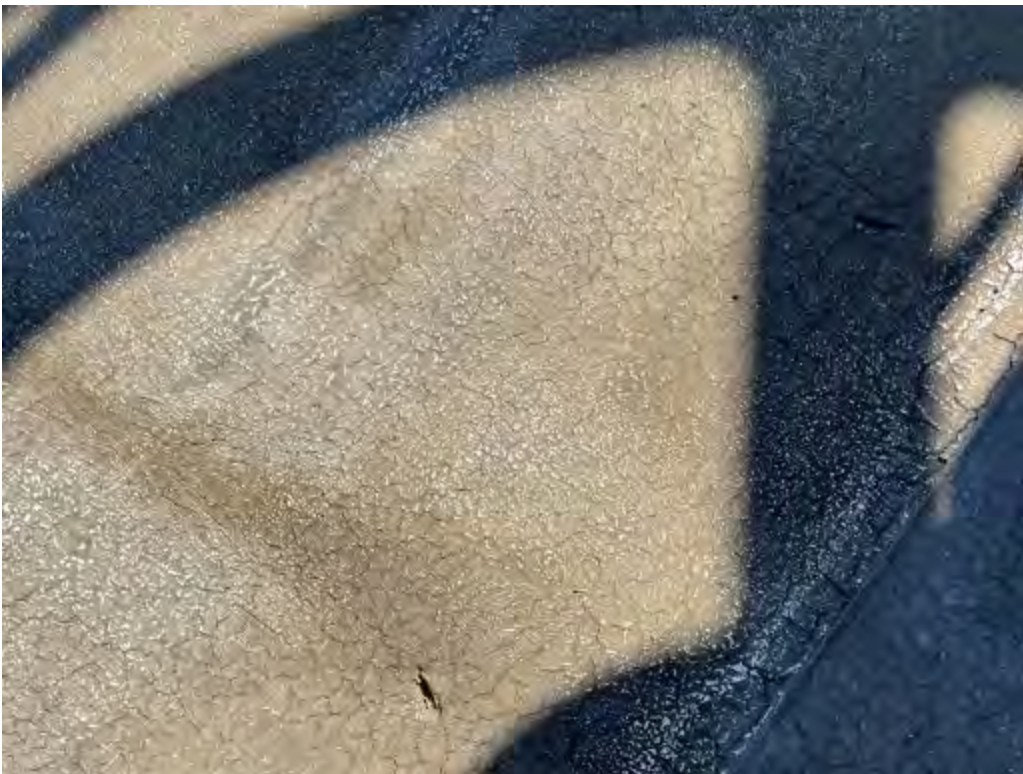
Puncture in membrane

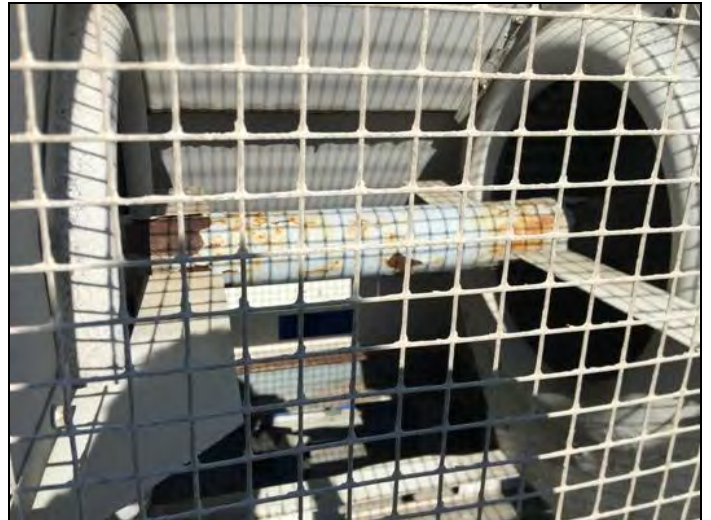
4. Note rusted drive shaft on evaporative condenser

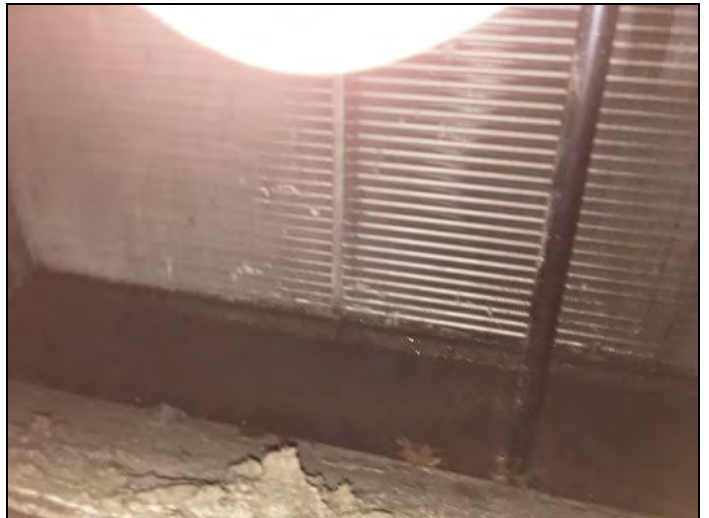
12. Cold deck DX cooling coils, corrosion and rusting of steel frames and condensate collection pan

- 10) The original 1970s DX cooling coils will reach their EUL early within the reserve period. In lieu of costly wholesale replacement, we believe that coil life may be extended to last beyond 10 years by performing the following O&M measures: Replace old steel epoxy coated condensate drain pans with stainless steel, properly slope for good drainage, and wire brush and epoxy coat rusted steel coil frames, as well as steel coil tube-sheet ends. The original 1970s hot water coils will also reach their EUL early within reserve period. In lieu of costly wholesale replacement, we believe that coil life may be extended to last beyond 10 years by performing the following O&M measures: Open, clean and inspect unit, wire brush and coat any corroded areas, and clean hot water coils. Costs for these repair measures are included within the Capital Replacement Reserve Schedule. *Refer to detailed assessment prepared by MEP and published under separate cover.*

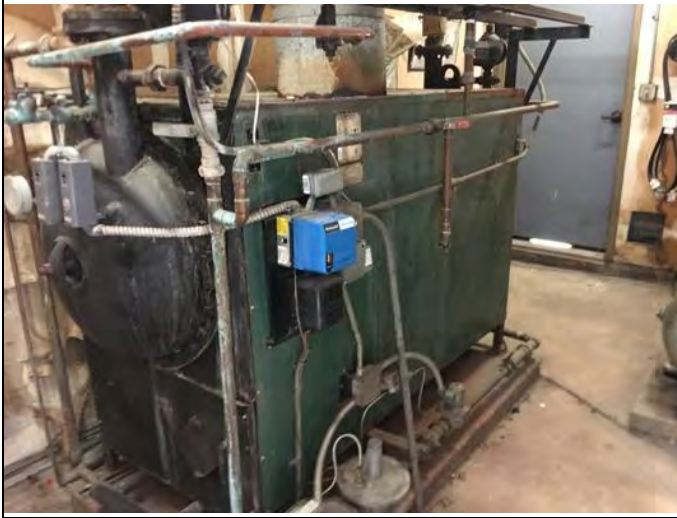
13. Gas-fired space heating hot water hydronic boiler (2012) poor condition

water for the heating system cannot be provided in case of boiler failure, boiler repair, or maintenance/service times. As an alternate, we suggest that when the boiler is replaced, two (2) ea. 1000-kBtuh input boilers (Raypak model MVB modulating vertical boiler, model H7-753A, 750-kBtuh input, minimum 86% efficiency) be installed instead of a single unit, as well as adding a second circulation pump. Costs for the replacement of the current boiler and the addition of a second boiler is included in the Capital Replacement Reserve Schedule. *Refer to detailed assessment prepared by MEP and published under separate cover.*

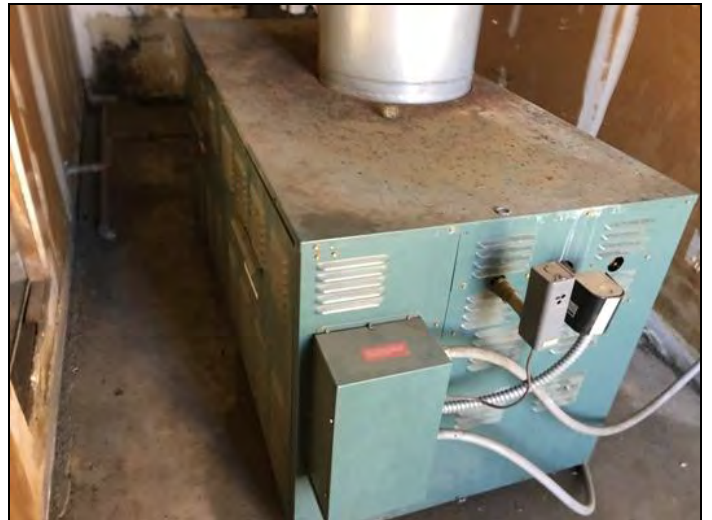
16. Gas fired domestic hot water boiler, 2004, rusted exterior case
