PHASE I ENVIRONMENTAL SITE ASSESSMENT REPORT

Resort

123 Main Street
City, State, Zip
NDDS Project #2311111
Date Issued: January 1, 2023

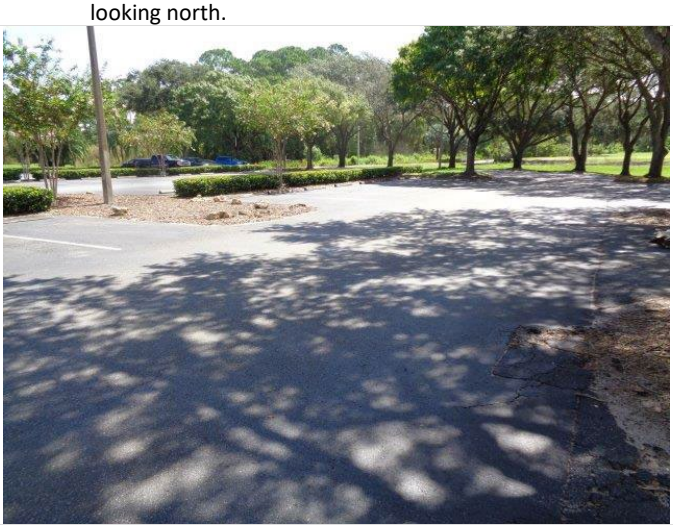
17. Asphalt paved parking lot at the south end of the Golf Club Facility.

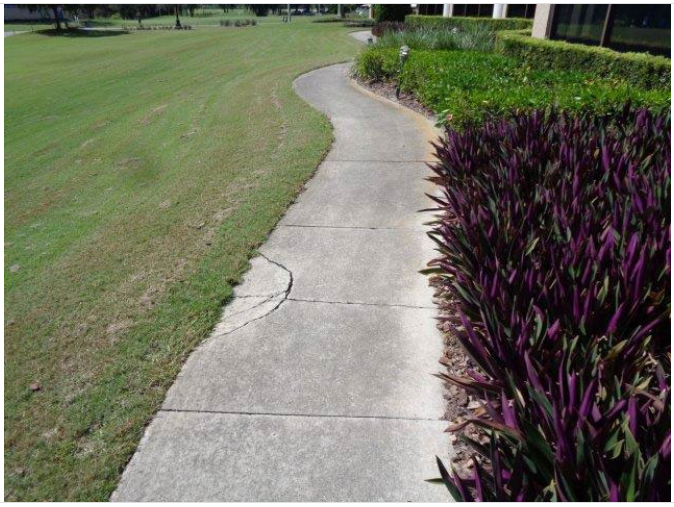
28. Sidewalk along the south of the San Miguel building. Note the tripping hazard.

29. Flatwork at the south end of the Golf Club. Note the tripping hazard.

30. Sidewalk along the east end of the Golf Club. Note the tripping hazard.

31. Sidewalk to the tennis courts west of the Golf Club. Note the tripping hazard.
