Seismic Risk Assessment

Office Building

1234 Due Diligence Lane Any City, Any State 12345 NDDS Project No.: 13-0456 Date Issued: August 1, 2013

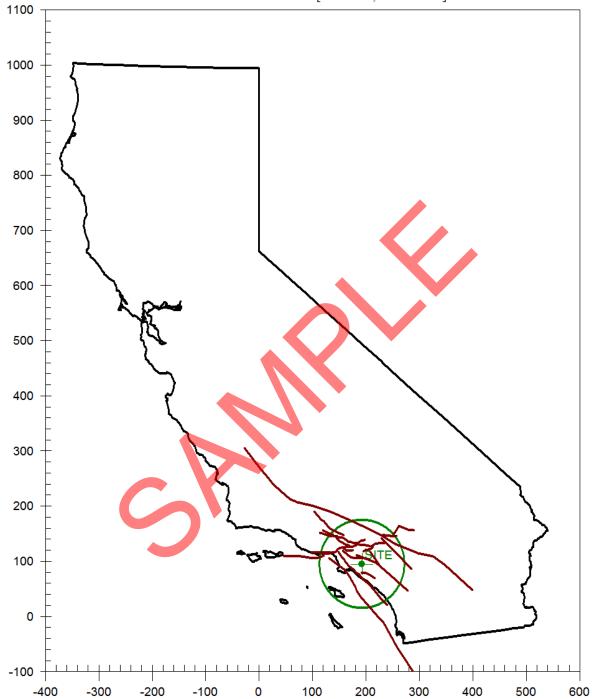
CALIFORNIA FAULT MAP

200 W Center St Promenade [N33.834, W117.916]

Low (The Chino-Central Ave (Elsinore) Fault is closest known active fault Fault Rupture Potential:

to the site and is located 1.2 miles from the site.

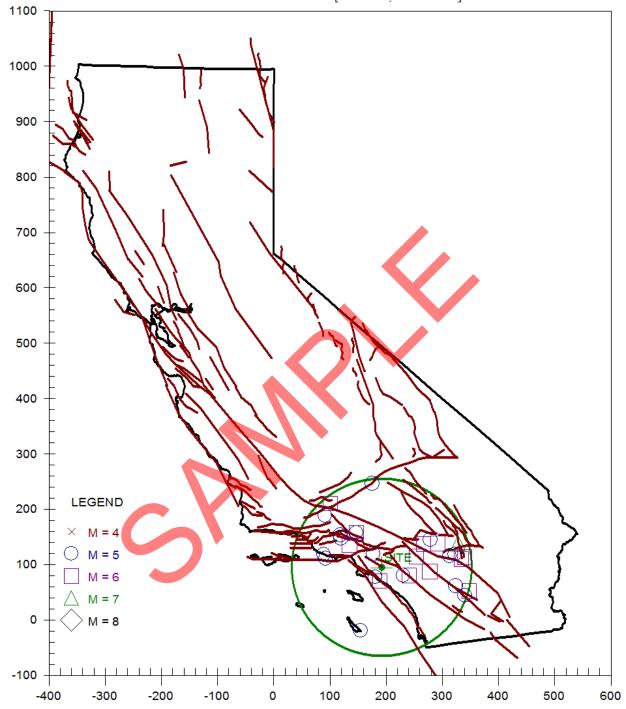
EARTHQUAKE EPICENTER MAP

200 W Center St Promenade [N33.834, W117.916]

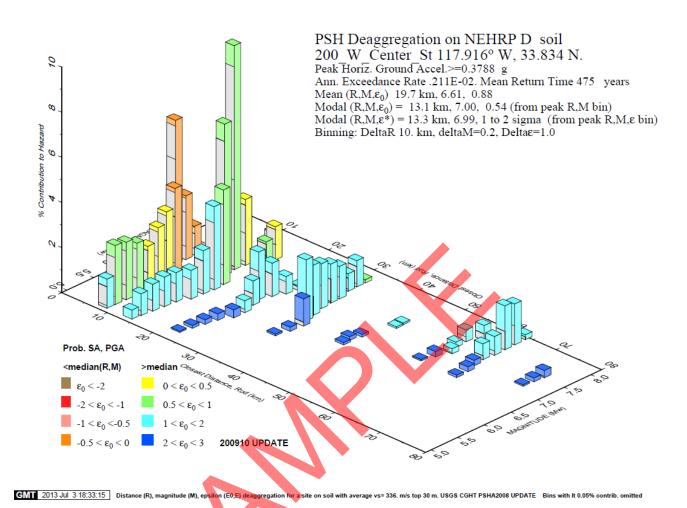
Ground Motion	Firm Rock	Soft Rock	Alluvium
Pga	0.343	0.356	0.389
Sa 0.2 sec	0.825	0.862	0.942
Sa 1 O sec	0.312	0.389	0.476

NEHRP Soil Corrections were used to calculate Soft Rock and Alluvium.

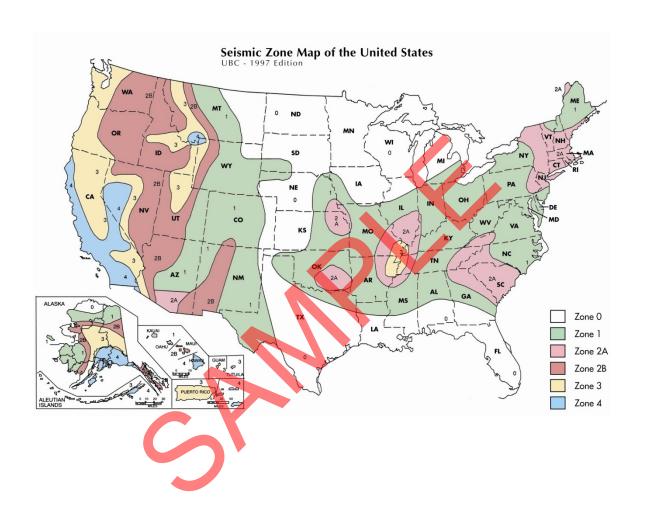
SEISMIC ZONE MAP OF THE UNITED STATES

UNIFORM BUILDING CODE 1997 VOLUME 2 TABLE 16.2

PML (SEL)	9%
Seismic Zone (UBC 1997)	Zone 4
Alquist Priolo Special Study Zone	No
Nearest Fault:	Chino-Central Ave (Elsinore)
Return Period:	475
Magnitude (Richter):	6.7
Distance to Site:	1.2 miles
Local Intensity (MMI ¹):	X
Peak Ground Acceleration (pga):	Average "a": 0.39 (g)
Damage Ratio:	d = 0.554 (b ms)a ^{0.630}
Scenario Expected Loss (PML50)	9%
b = 0.24; ms = 1.25
