PROPERTY CONDITION ASSESSMENT REPORT RESORT

123 Main Street
City, State, Zip
NDDS Project #2311111

RE: Property Condition Report
Resort
123 Main Street
City, State, Zip
NDDS Project #2311111

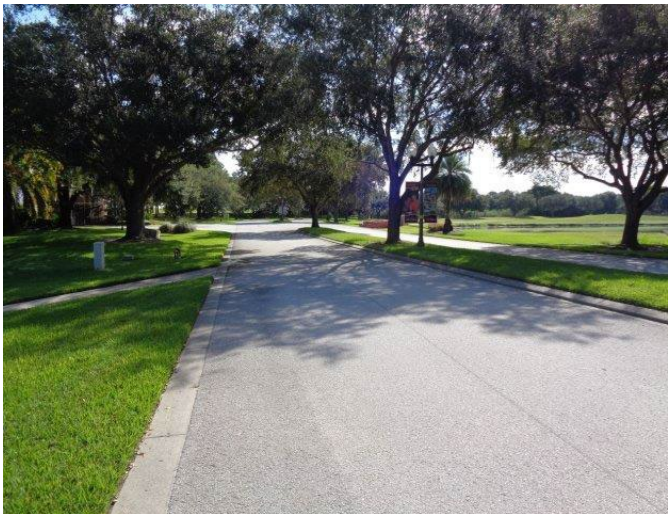
3. Typical asphalt paved driveway between the Resort Hotel and Golf Club Facility.

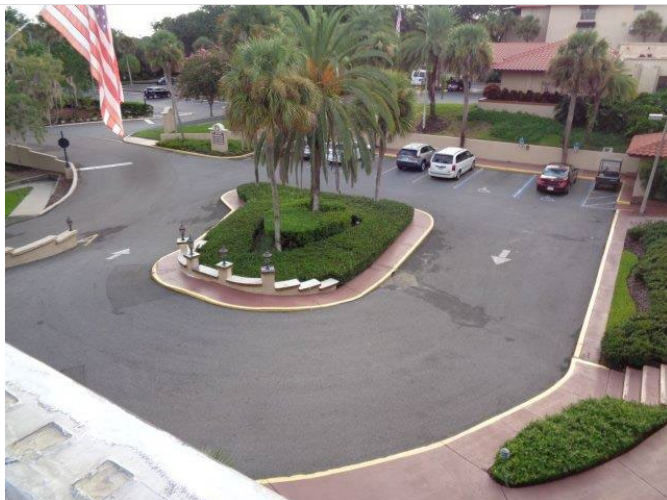
11. Typical asphalt paved driveway at the Resort Hotel.

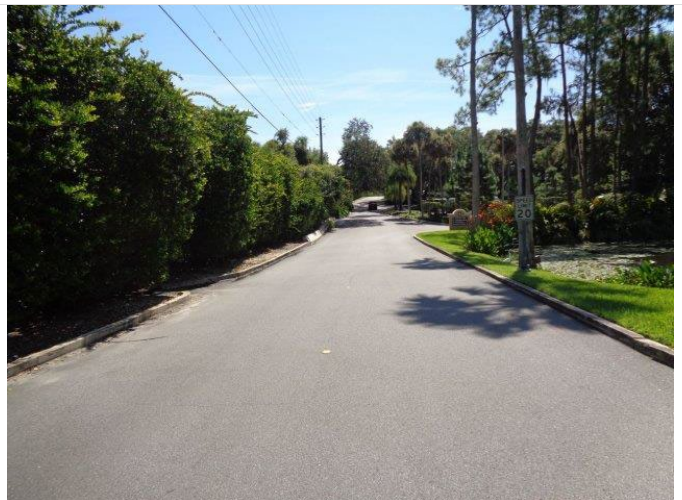
12. Typical asphalt paved driveway at the Resort Hotel.

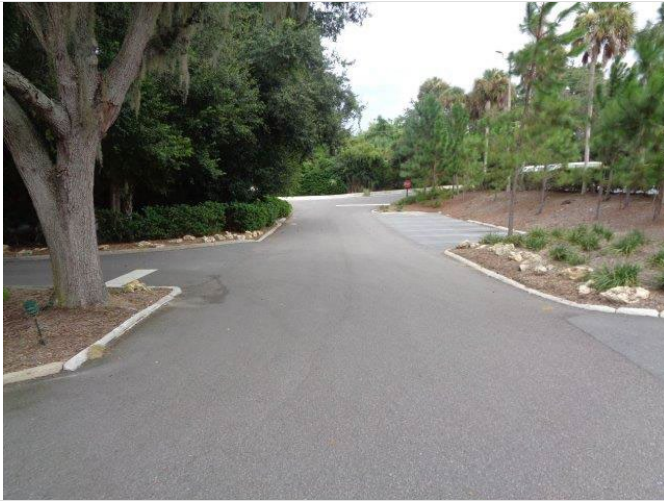
13. Typical asphalt paved driveway at the Resort Hotel.

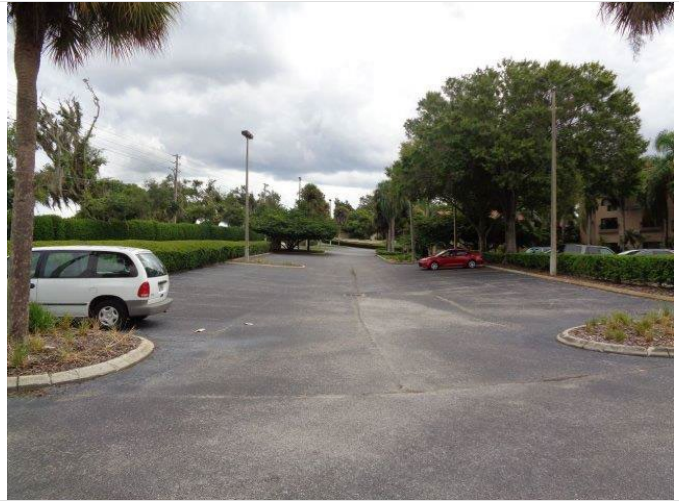
14. Asphalt paved driveway and parking lot along the north side of the San Diego building, looking east.

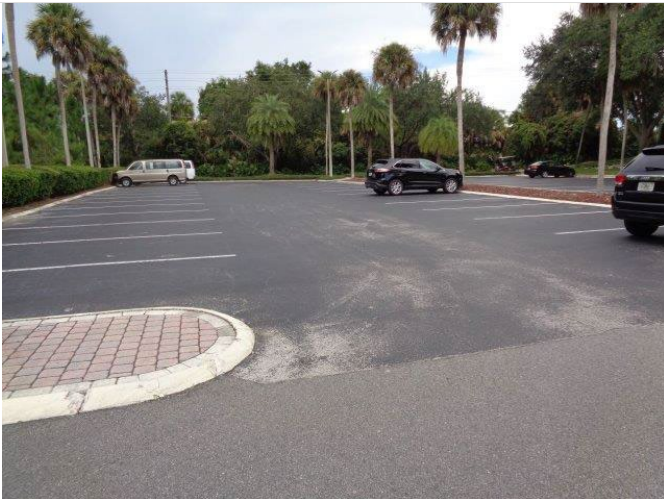
15. Asphalt paved parking lot near the main lobby entrance, looking north.

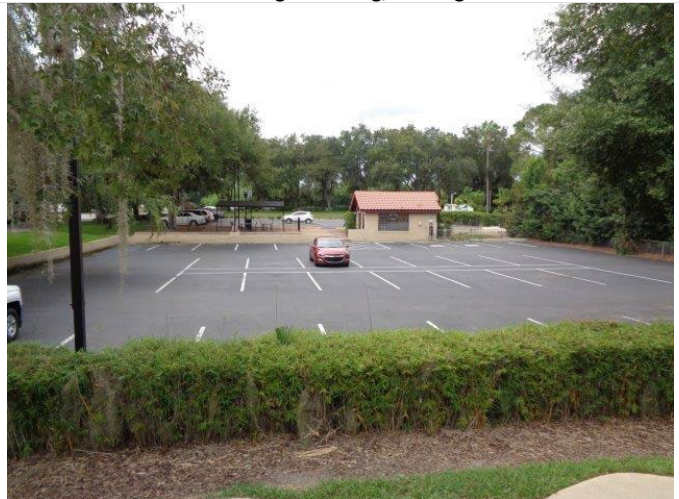
16. Asphalt paved parking lot near the main lobby entrance, looking west.

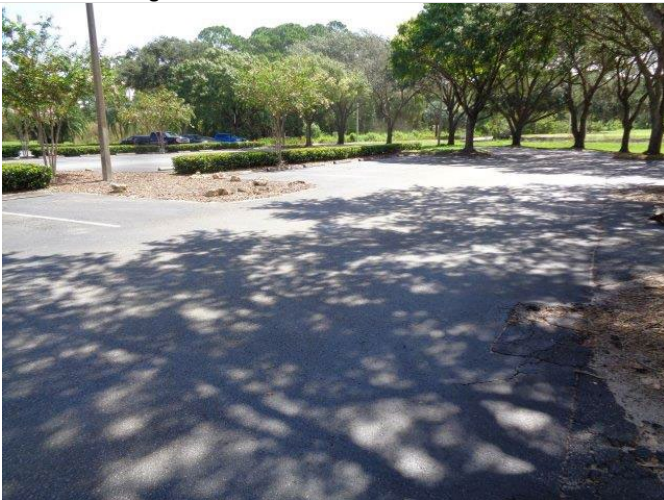
17. Asphalt paved parking lot at the south end of the Golf Club Facility.

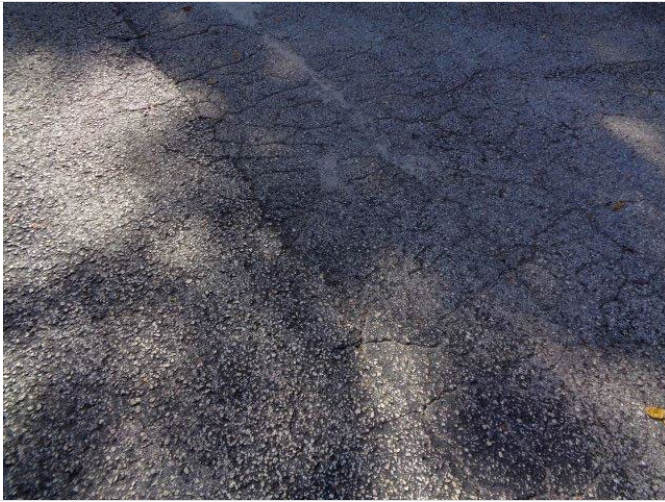
- 3) Portions of the parking lot and driveway areas is encumbered with isolated wide (1/4" or larger) that have previously been sealed, but have since reopened. Due to the age of the paving and the fact that the cracks are not widespread alligatoring type, a full overlay is not prudent at this time. These cracks will require individual attention so as to not allow stormwater infiltration into the sub-base. Repairs should include routing along the length of each crack and then sealing. Costs for repairs are included within the Physical Deficiencies/Deferred Maintenance Table 1.

19. Typical asphalt pavement damage.

| PROPERTY CONDITION ASSESSMENT SUMMARY | | | | |
|---|---|---|---|---|
| Asphalt Pavement Crack Routing and Sealing (Resort and Golf Club) | | | | \$4,750 |

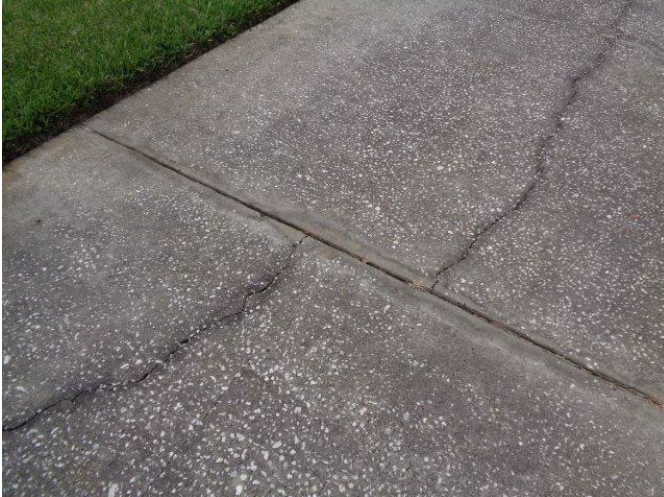
25. Typical cracks in the concrete sidewalk.

| PROPERTY CONDITION ASSESSMENT SUMMARY | | | | |
|---|---|---|---|---|
| Sidewalk Trip Hazard Repair (Resort and Golf Club) | | | \$3,600 | |

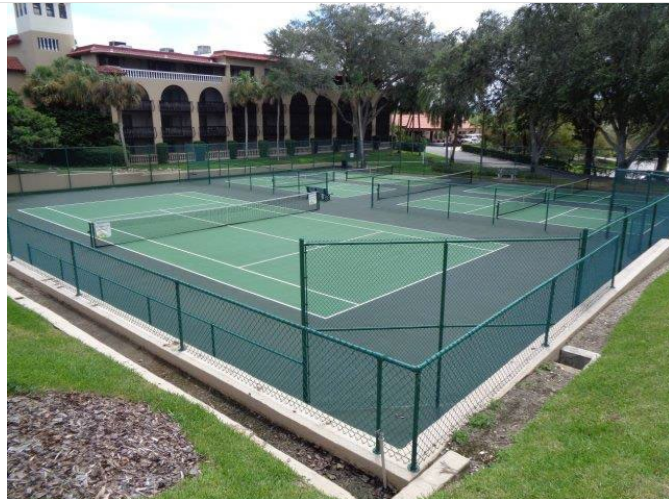
45. Tennis and pickle ball courts at the north of the San Miguel building, looking southwest.

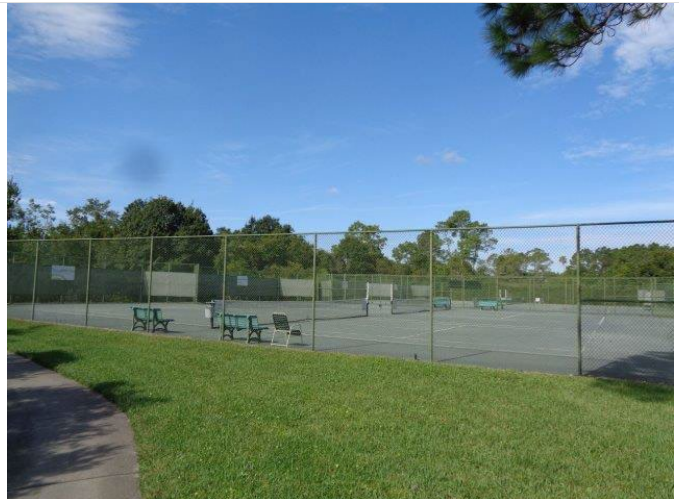
46. Tennis courts to the west of the Golf Club, looking west.

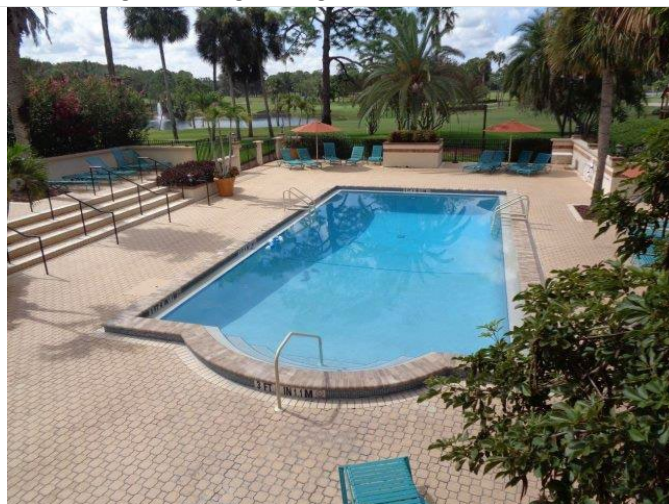
47. Swimming pool and patio at the south end of the main lobby, looking south.

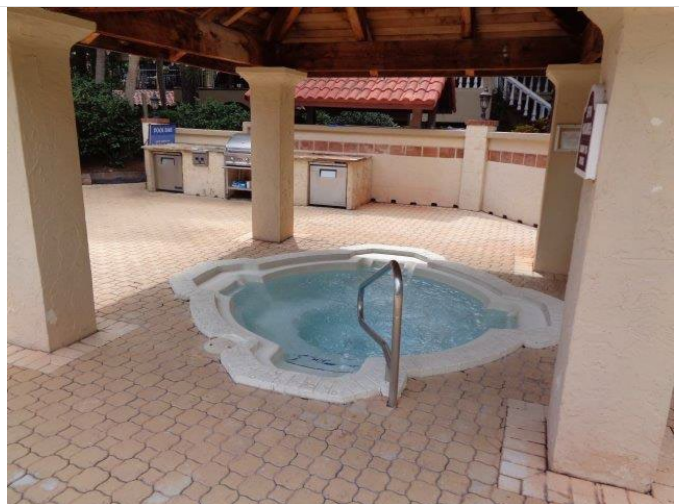
48. Spa adjacent to the swimming pool referenced in Photo 47.

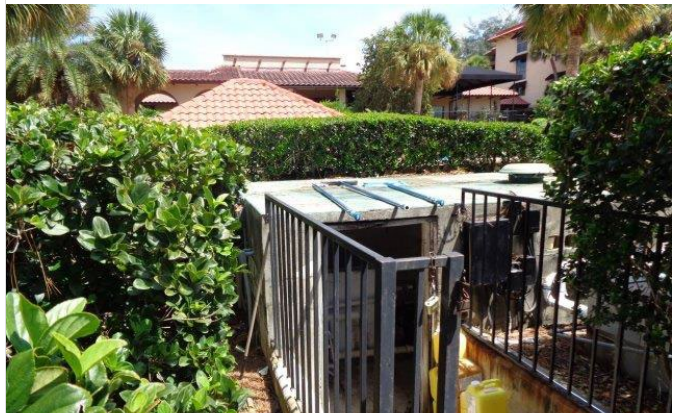
58. Concrete shed at the southwest corner of the inground pool equipment.

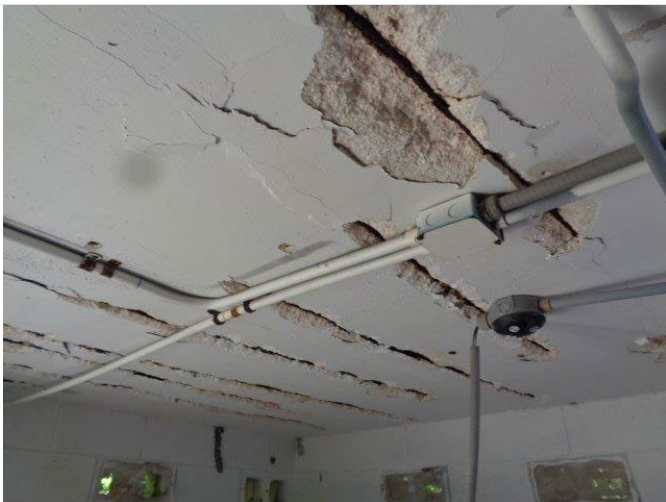
59. Spalled concrete and corroded rebar in the concrete shed referenced in Photo 58.

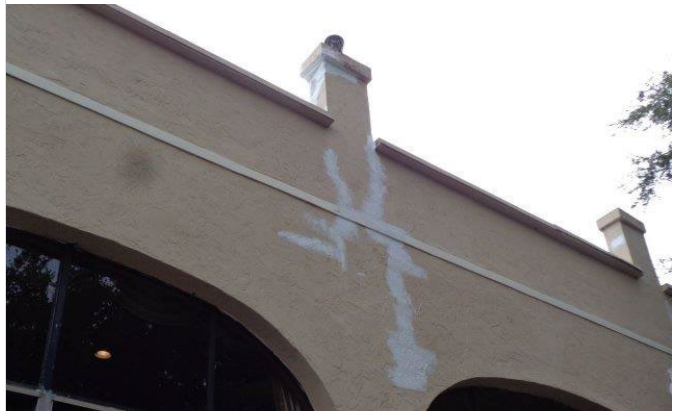
Various patches to the stucco finishes along the inside and outside faces of the parapet walls were made, specifically atop the Convention Center building. (Photos 75 & 76).

75. Partial view of the north façade of the Conference Center building, looking southwest. Note the stucco repairs.

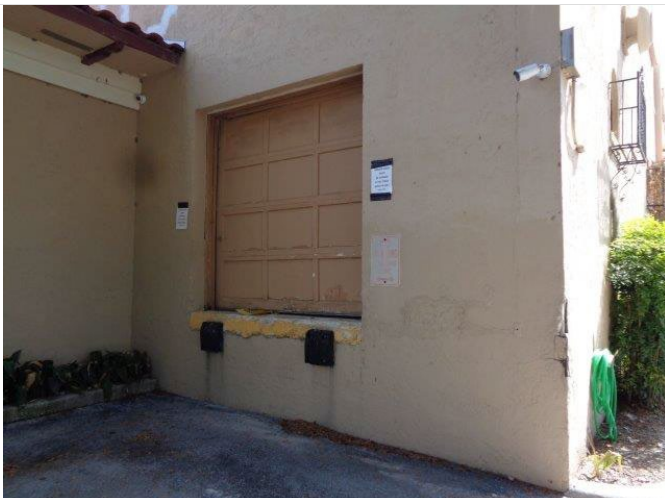
76. Closer up of the north façade referenced in Photo 75. Note the stucco repairs.

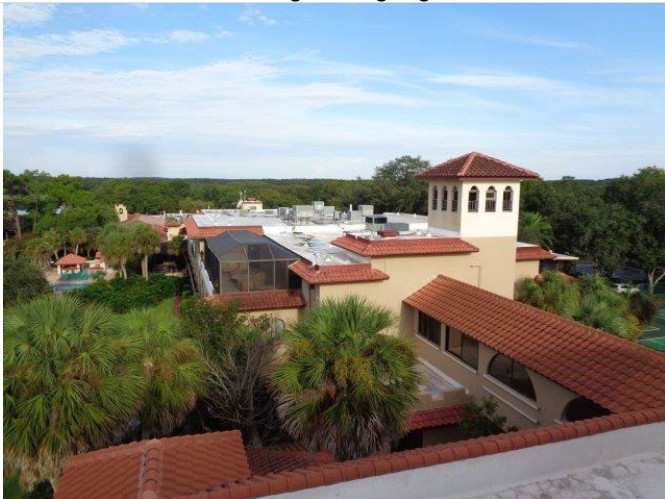
86. Partial view of the roof atop the San Diego building, looking east. Note the BUR membrane.

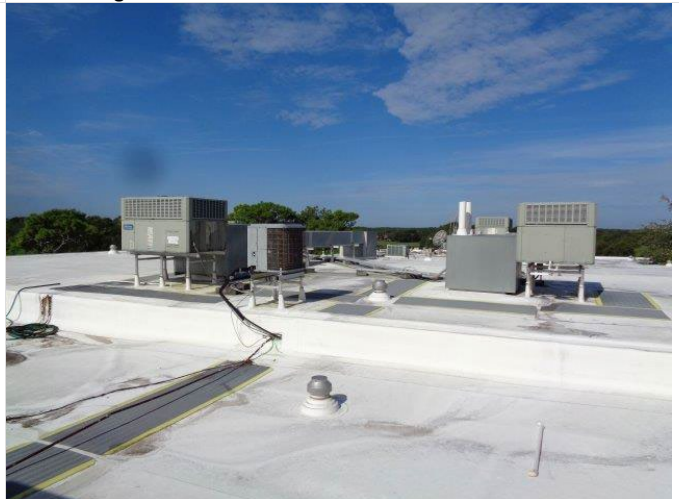
87. View of the roof of the San Miguel building, looking west.

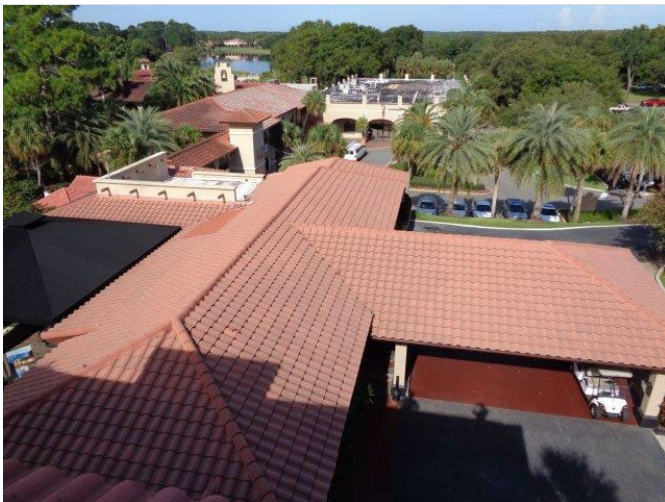
88. Partial view of the roof of the San Miguel building. Note the TPO membrane and various RTU's and a/c condensers.

| ITEM | QUANTITY | UNIT | UNIT COST | IMMEDIATE COSTS | SHORT TERM COSTS | COMMENTS |
|--|---|---|---|---|---|--|
| Investigate TPO roof warranty(s) ** | 1 | LS | \$1,500.00 | \$0 | \$0 | Should the warranty(s) of the TPO roof membrane be located, a roof warranty transfer inspection by the roofing manufacturer would be recommended. |

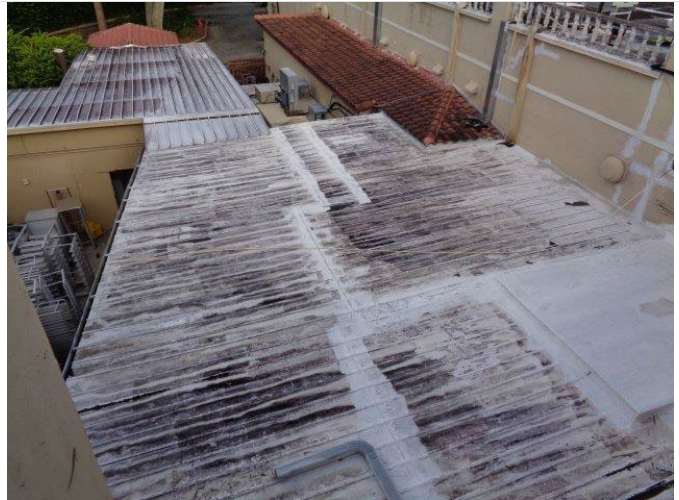
91. Partial view of the roof atop the Conference Center building, looking west. Note the BUR membrane.

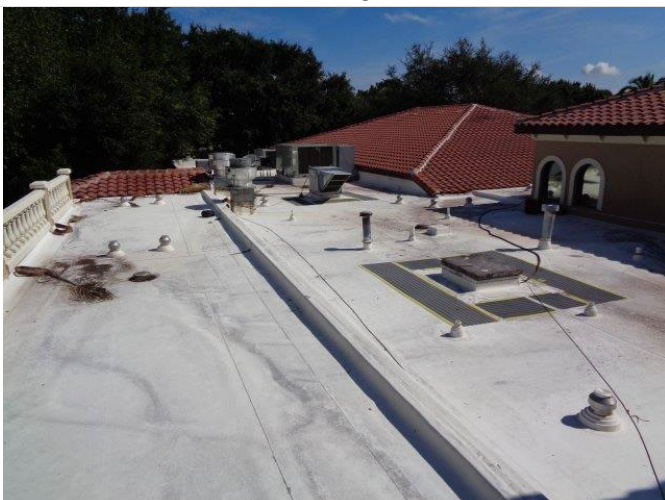
94. Partial view of the roof atop the Billiards room, looking east.

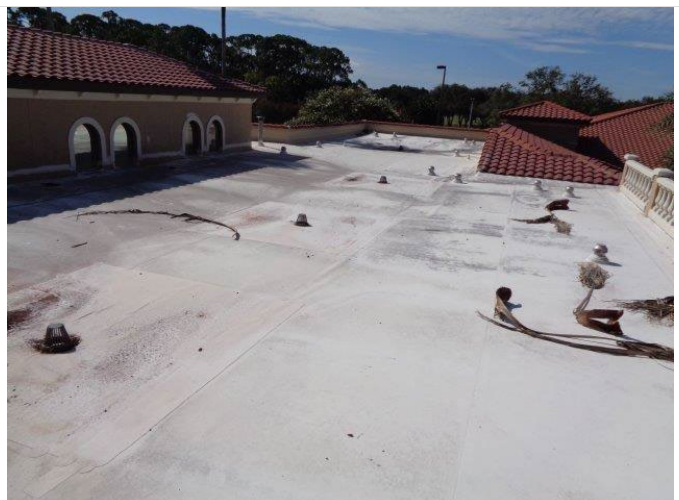
95. Partial view of the roof atop the Golf Club, looking north. Note the TPO membrane.

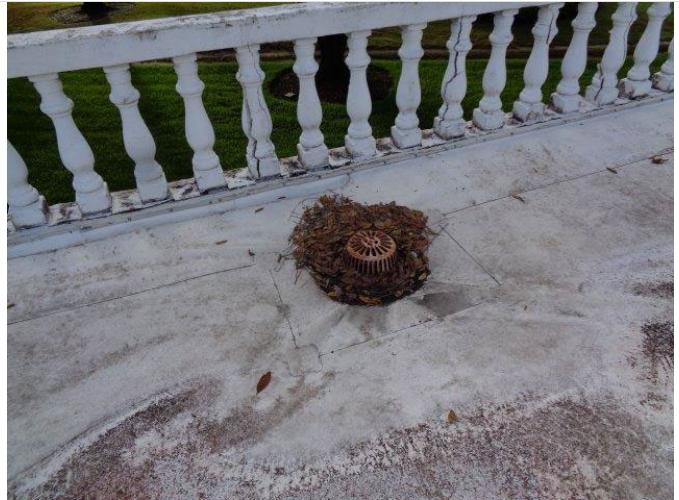
97. Typical parapet wall atop the roof.

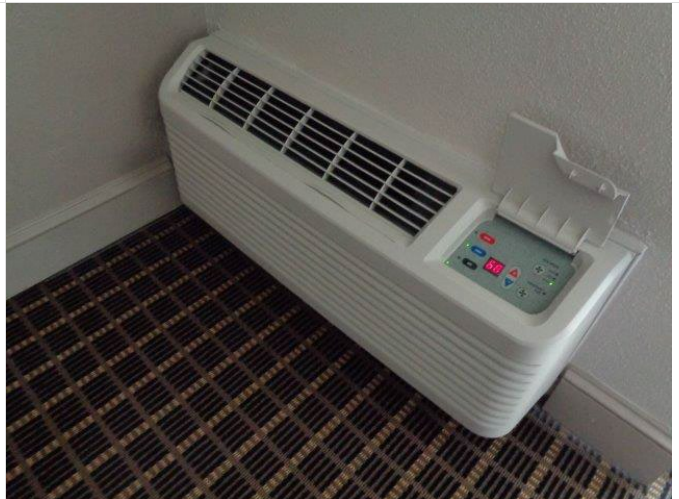
105. Typical PTAC unit for the guestrooms.

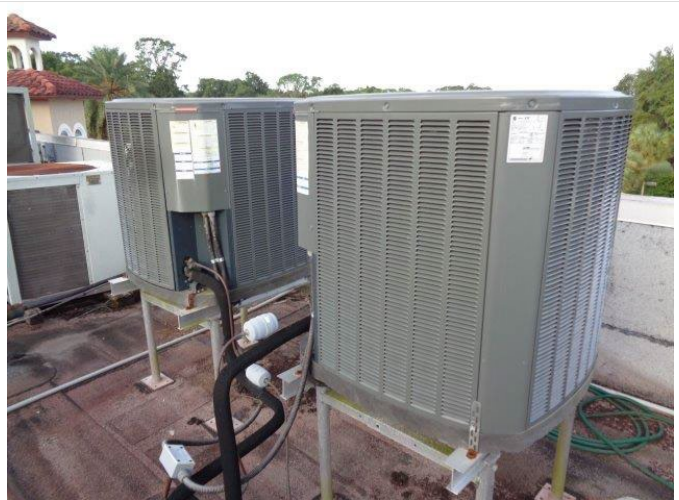
108. Typical packaged RTU's and a/c condensers atop the roof.

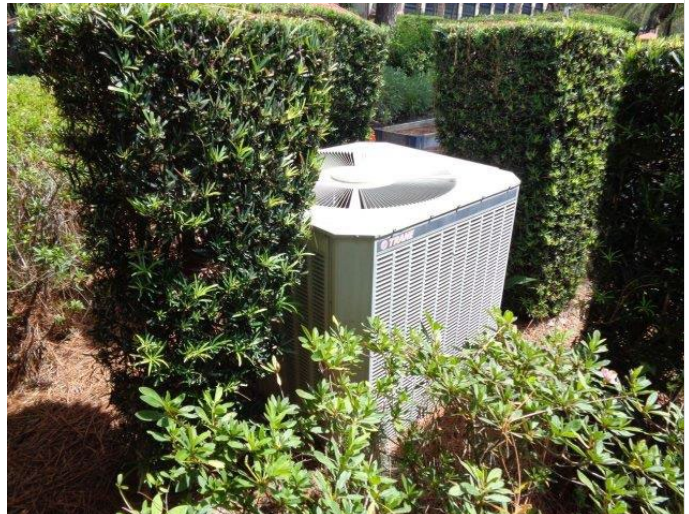
110. Typical split system a/c condenser at grade.

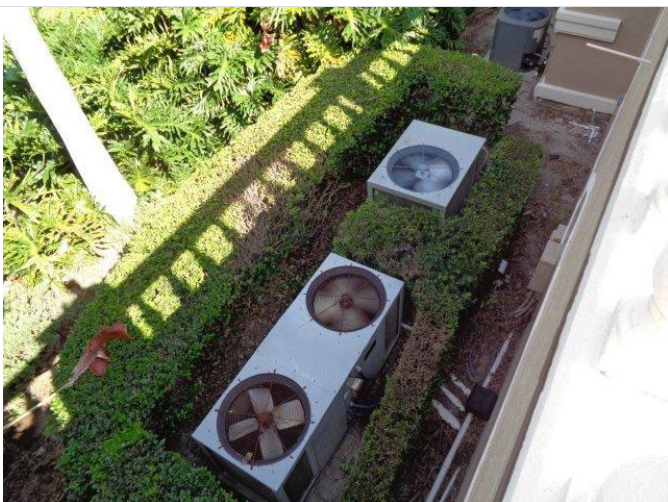
111. Typical split system a/c condenser at grade.

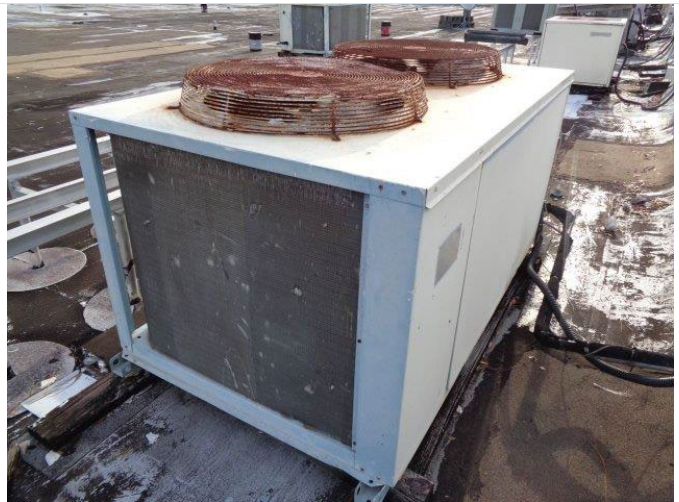
114. Typical packaged RTU.

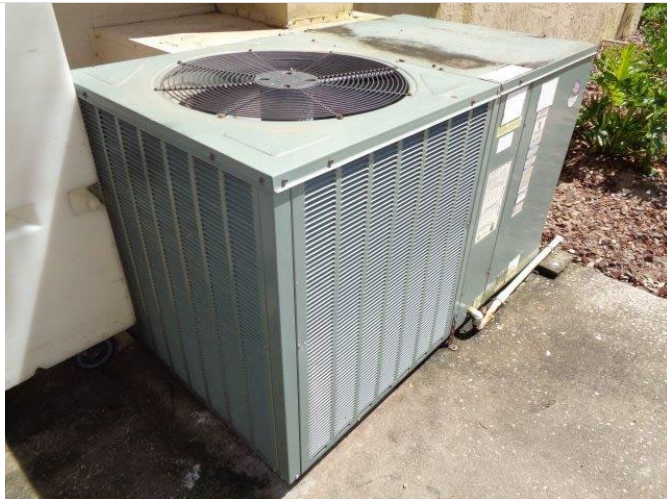
115. Older packaged RTU.

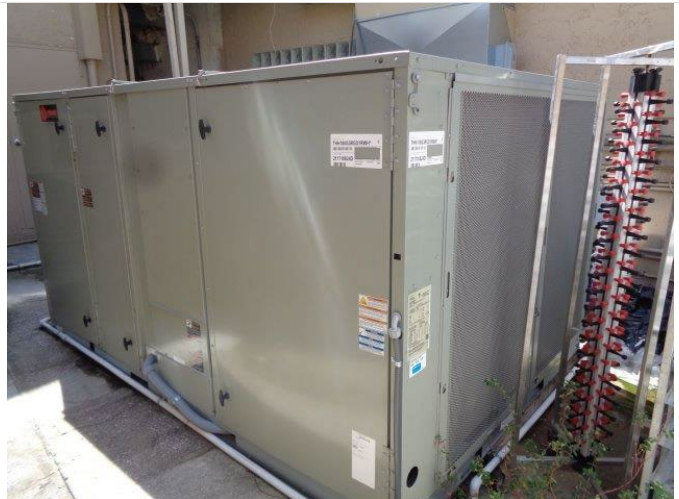
116. Typical packaged unit at grade.

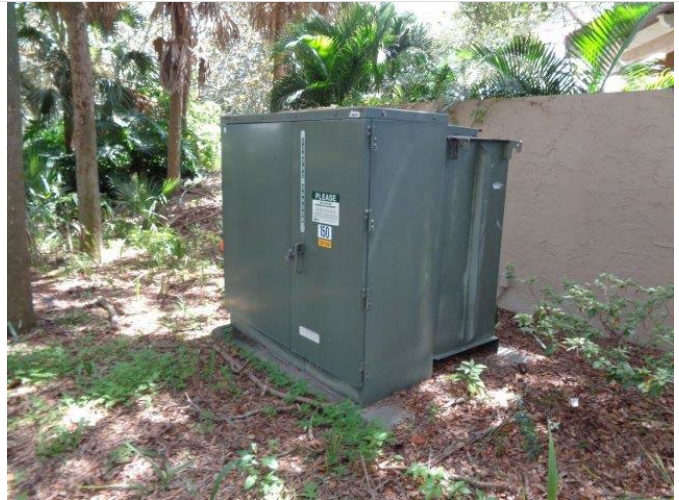
120. Pad mounted electrical transformer at the Resort Hotel.

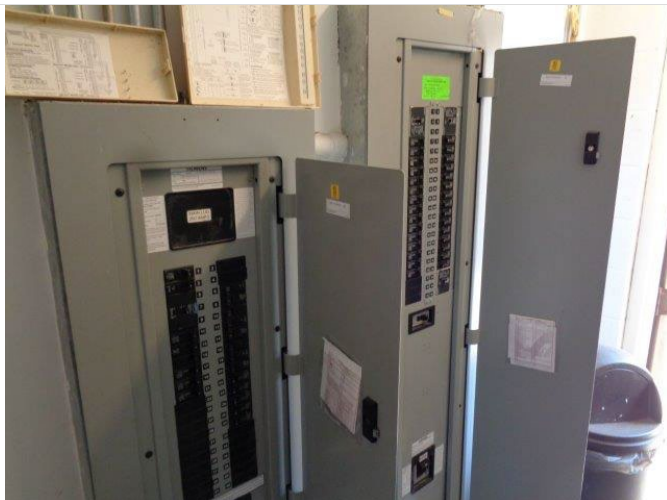
123. Typical main electric panel and distribution panels.

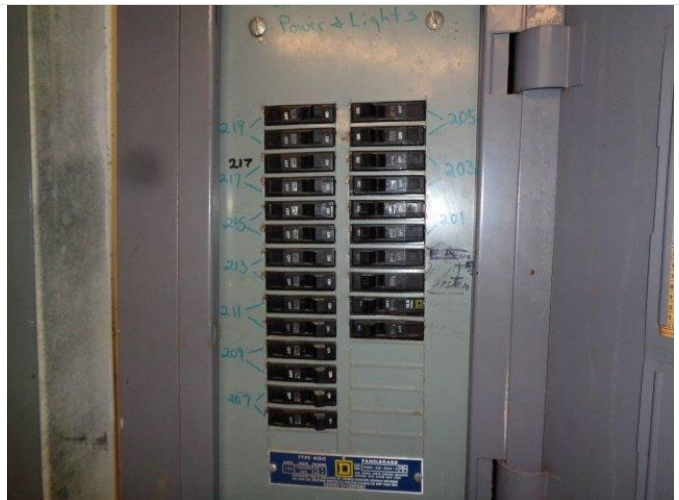
124. Typical distribution panels.

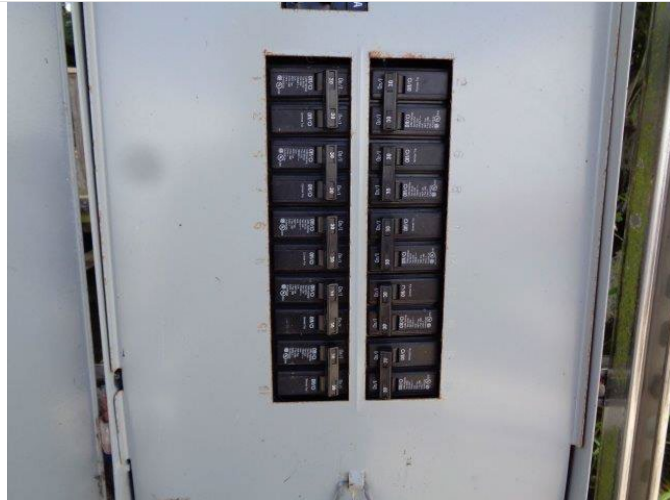
125. Typical distribution panel for the individual guestrooms.

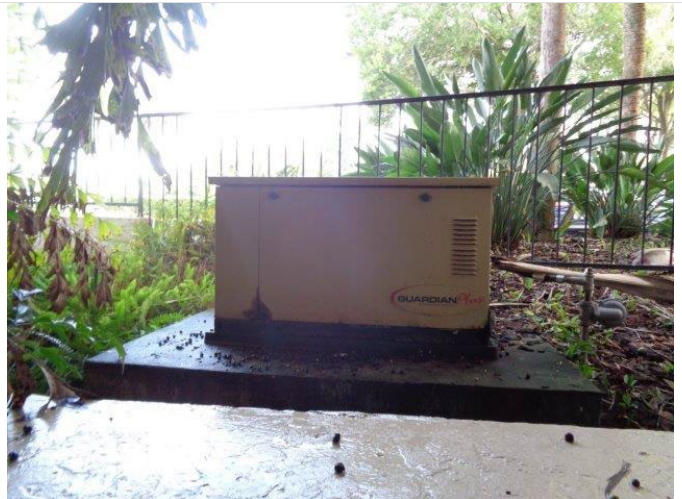
128. One of two natural gas emergency electrical back-up generators at the Resort Hotel.

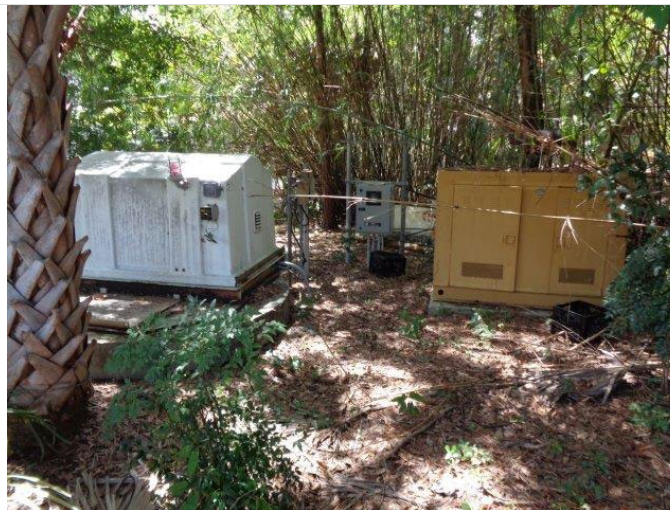
129. One of two natural gas emergency electrical back-up generators at the Resort Hotel.

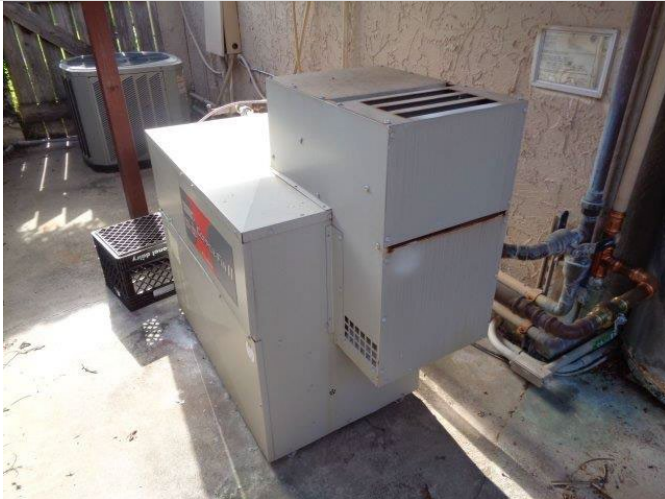
131. Typical gas-fired hot water boiler for the Resort Hotel.

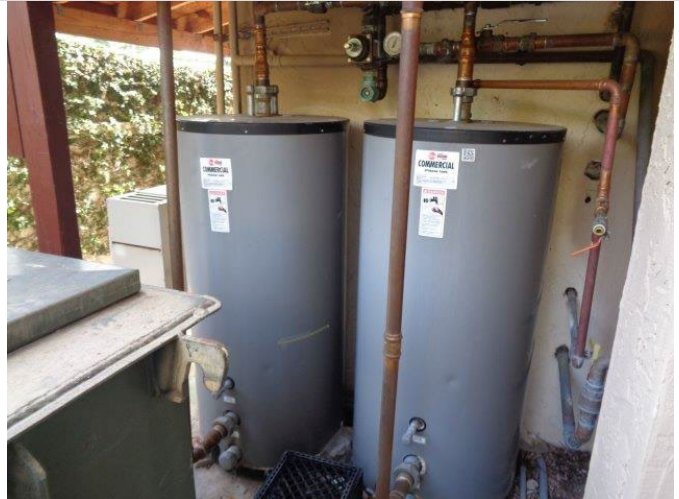
133. Typical hot water storage tanks for the Resort Hotel.

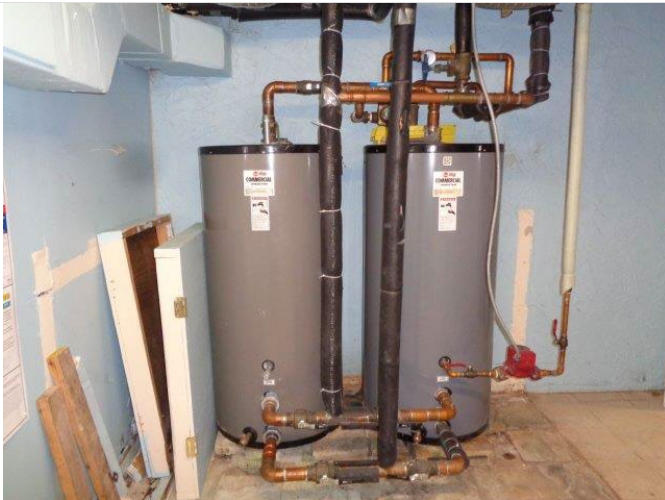
134. Typical hot water storage tanks for the Resort Hotel.

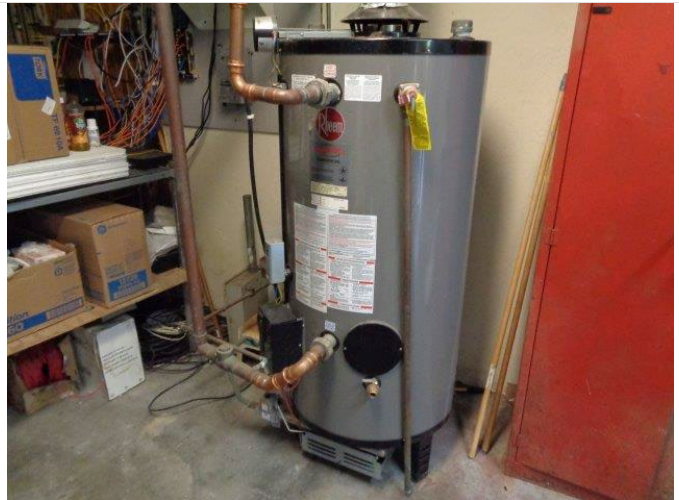
135. Typical individual domestic hot water heater.

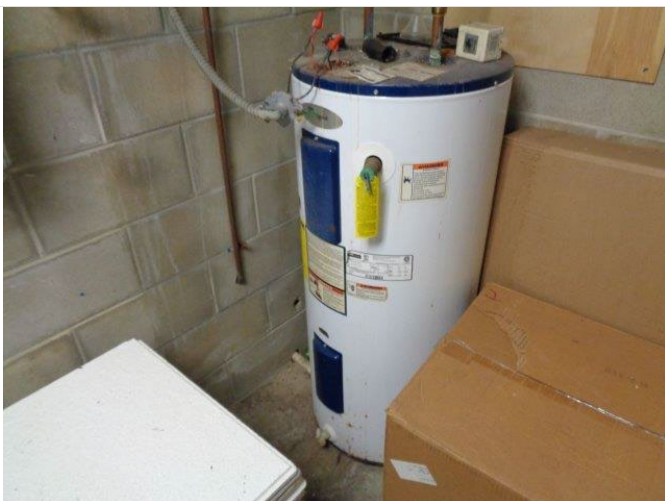
136. Typical individual domestic hot water heater.

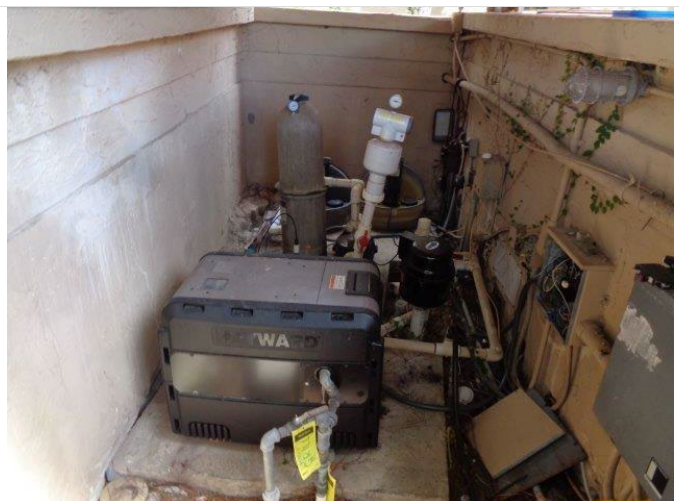
137. Inground pool heater.

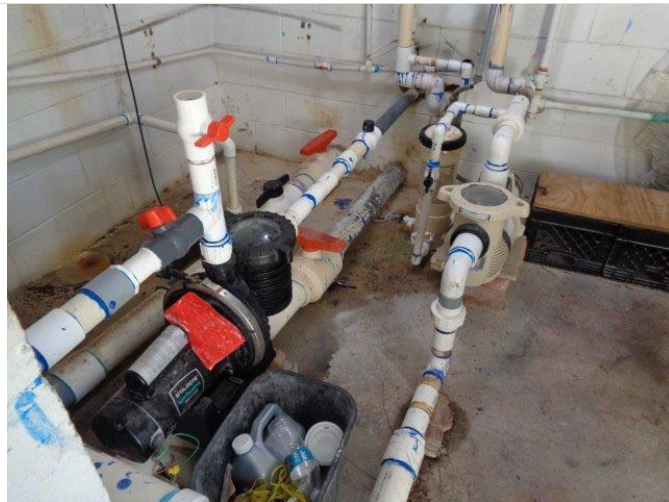
138. Inground pool pumps and filter.

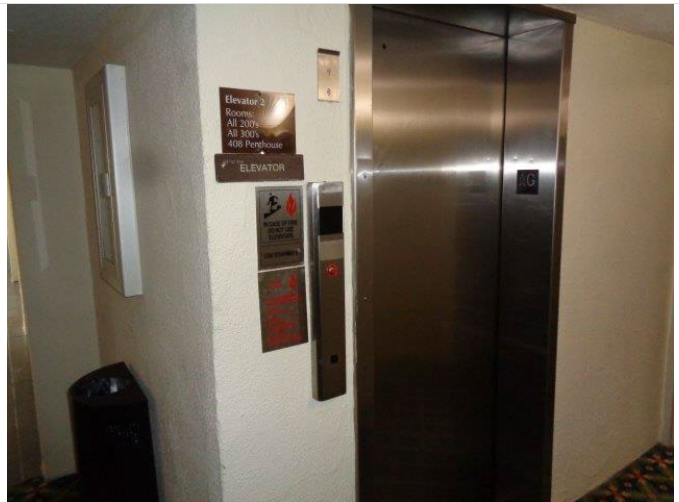
139. Typical passenger elevator in the Resort Hotel buildings.

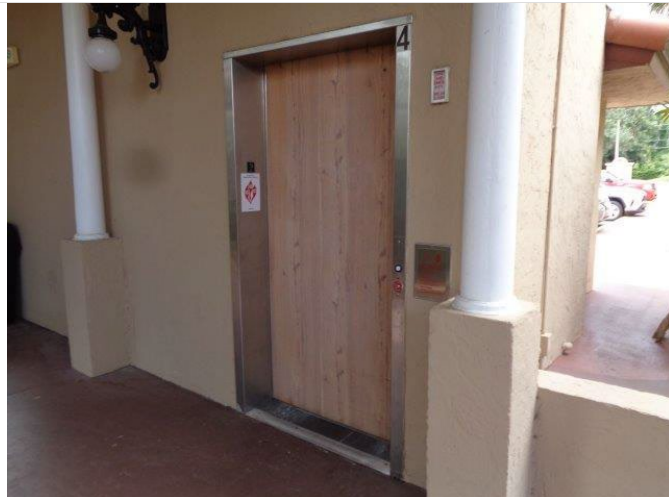
140. Passenger elevator in for the breezeway of the Resort Hotel.

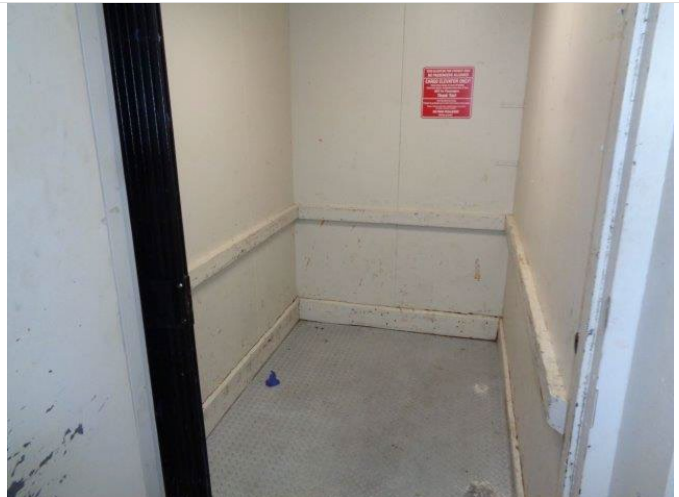
141. Service elevator for the kitchens in the Restaurant Complex.

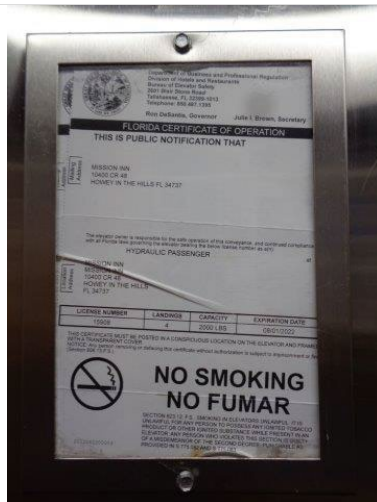
142. One of three out-of-date inspection tags in the passenger elevators of the Resort Hotel buildings.

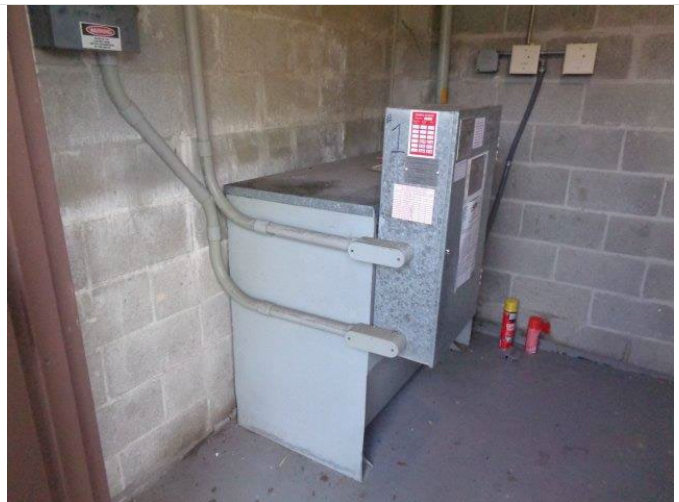
143. Typical hydraulic elevator equipment.

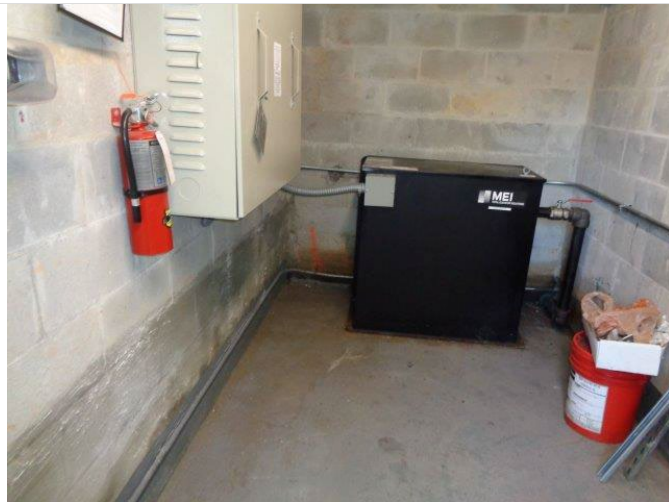
144. Typical hydraulic elevator equipment.

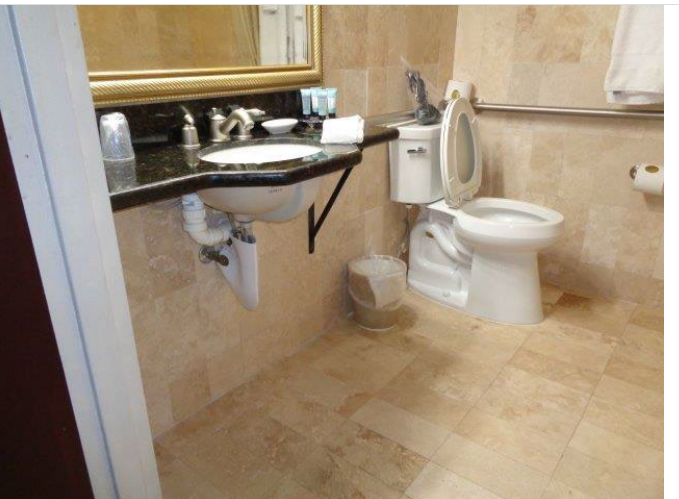
160. One of two ADA handicap guestrooms. Note the "roll-in" shower.

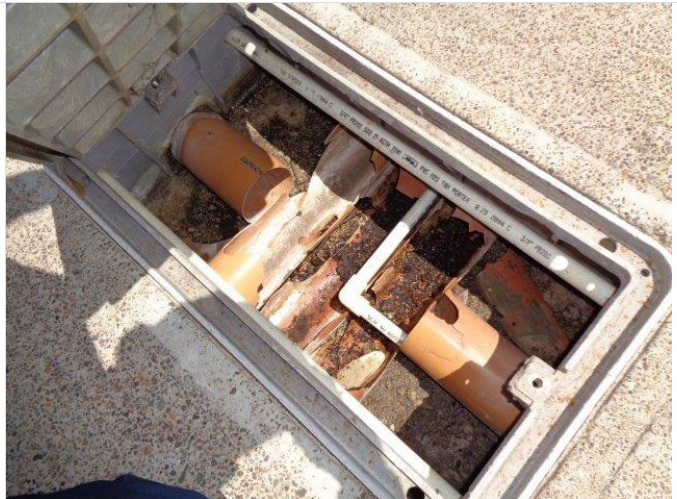
189. Typical access panel for the boat slips. Note the damaged/deteriorated electrical passthrough tubes.

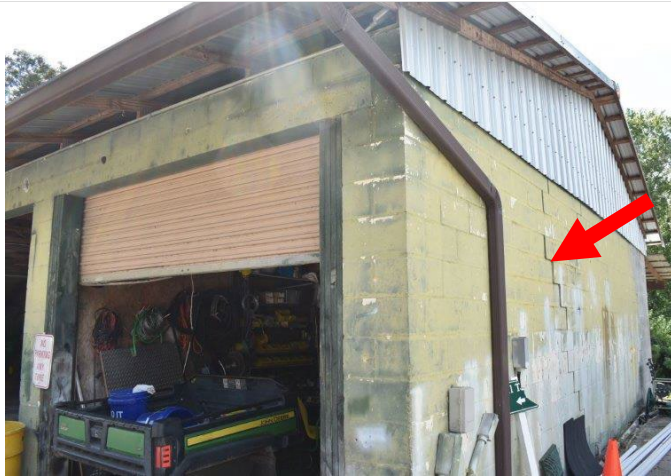
198. South side of one of the landscaping buildings. Note the step crack in the CMU wall.
