PROPERTY CONDITION ASSESSMENT REPORT

COMMERCIAL BUILDING

123 Main Street

NDDS Project 2311111

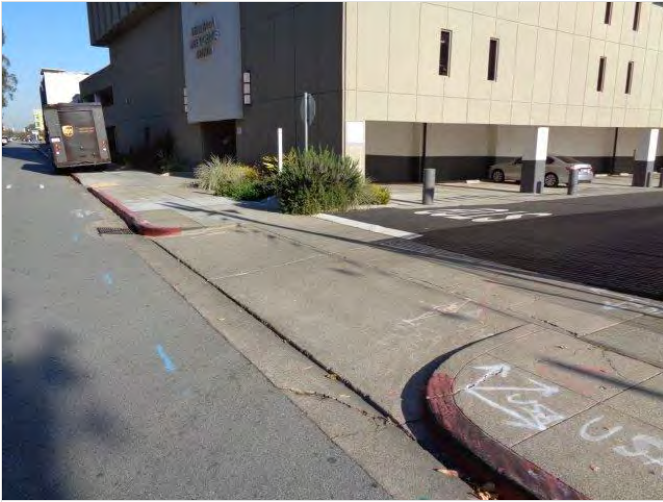
1. Southernmost entrance to the Subject Property looking north.

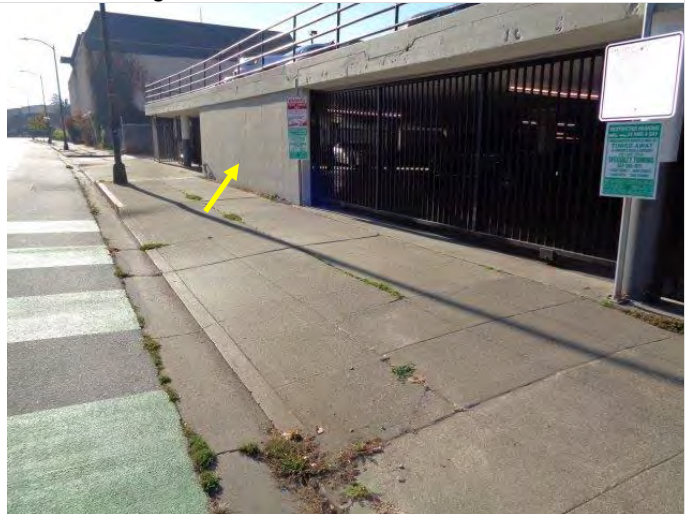
4. Northernmost entrance to the Subject Property looking south. Note the exterior parking Garage.

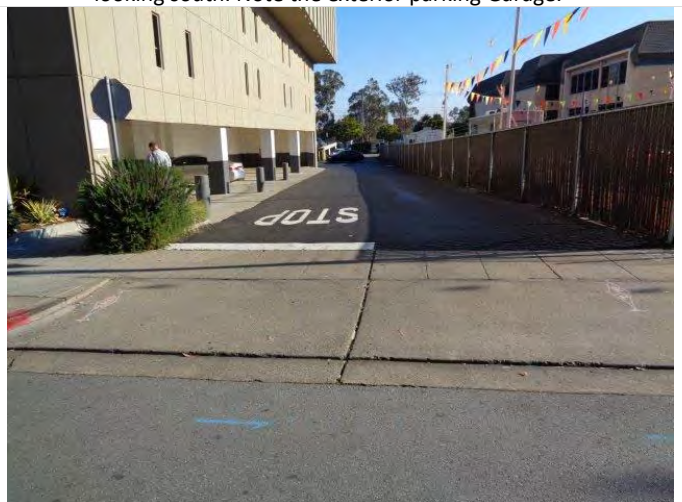
6. Asphalt paved driveway along the south end of the Subject, looking east.

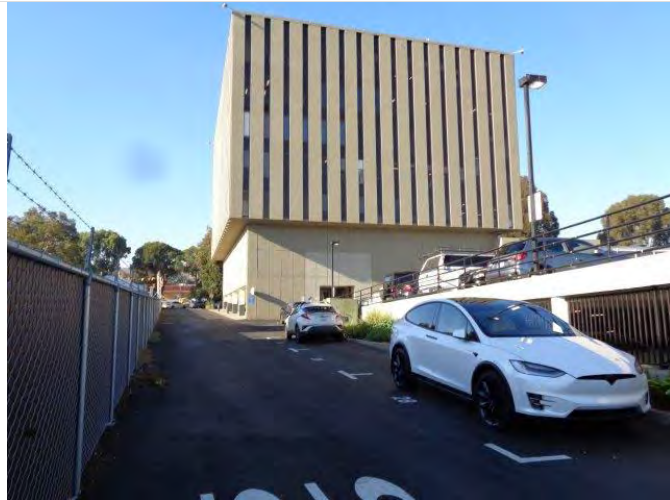
7. Asphalt paved driveway along the south end of the Subject, looking west.

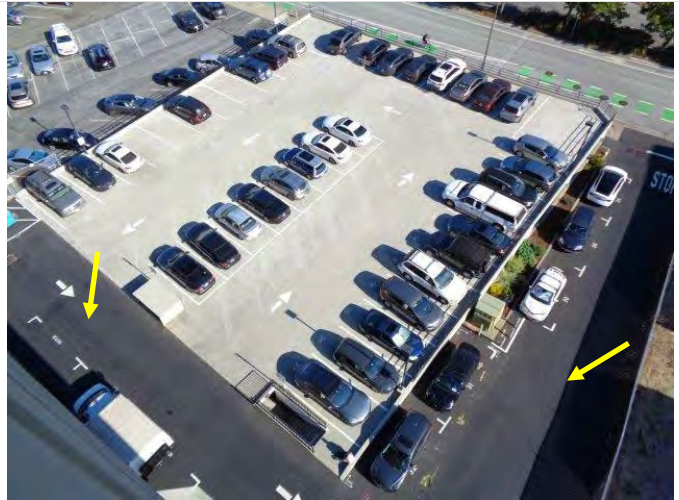
8. Top level of the exterior concrete paved parking garage, looking east. Also note the two asphalt paved driveways.

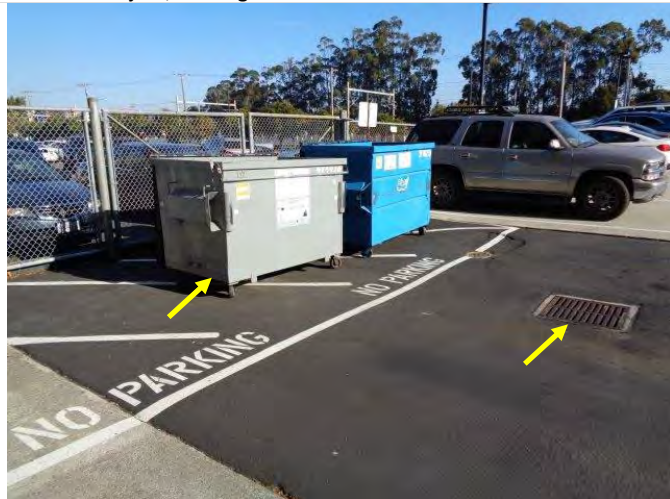
9. North end of the asphalt paved driveway. Note the refuse containers and the typical catch basin.

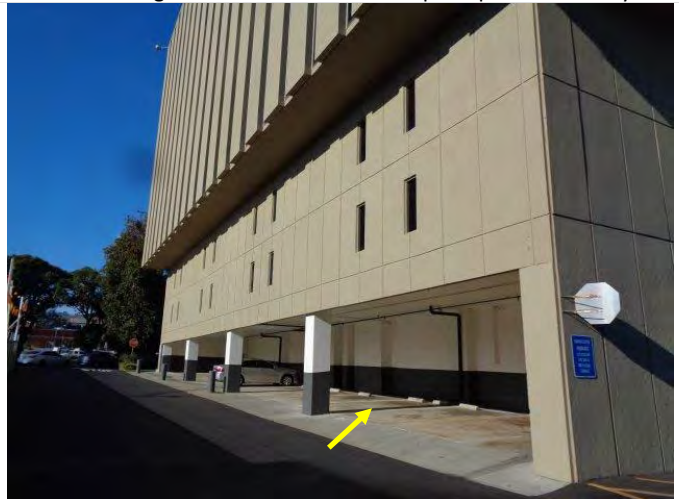
10. Underbuilding parking along the south end of the building, looking west.

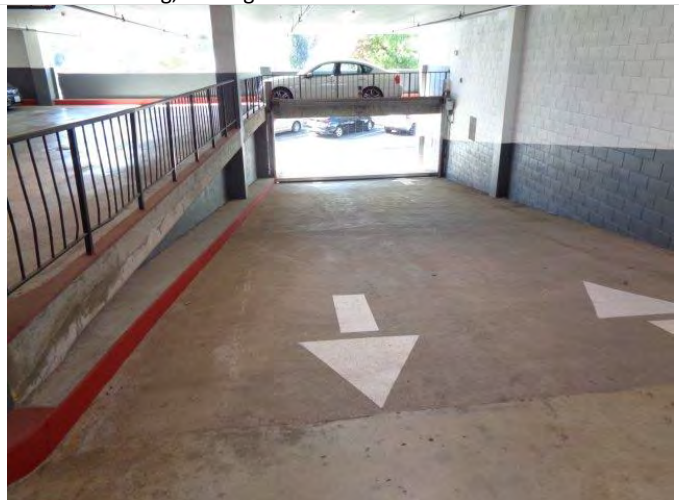
12. Entrance ramp to the second level parking garage looking west.

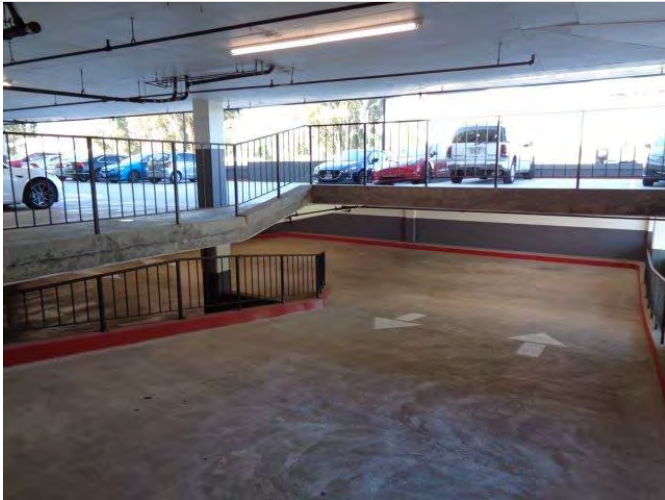
13. Ramp to the third level parking garage.

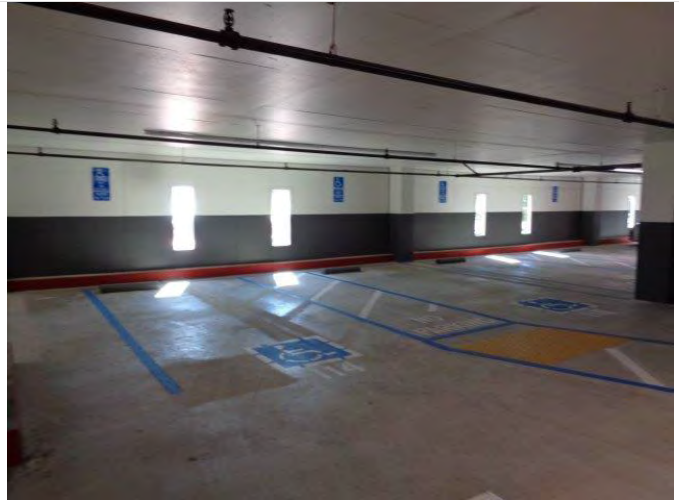
14. ADA parking stalls near the elevator bank on the second floor level underbuilding parking garage.

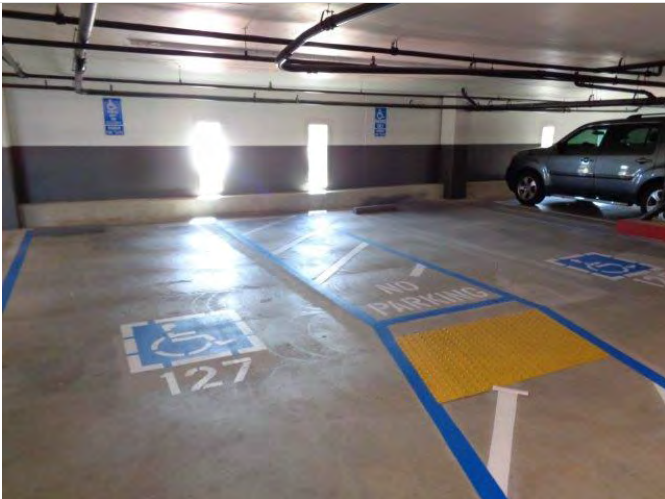
15. ADA parking stalls near the elevator bank on third floor level underbuilding parking garage.

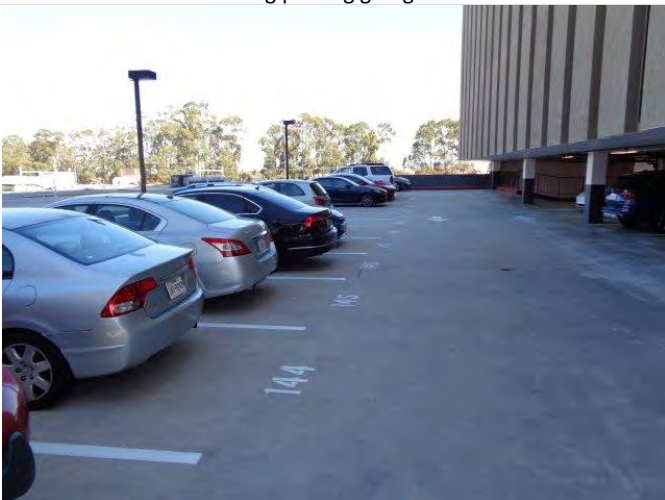
17. Third floor (top) level of the underbuilding parking garage extension. Looking east.

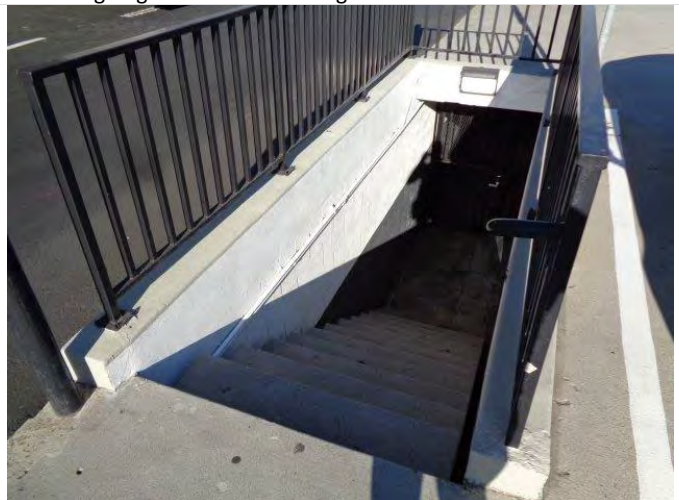
18. Stairs leading to the lower level of the exterior parking garage.

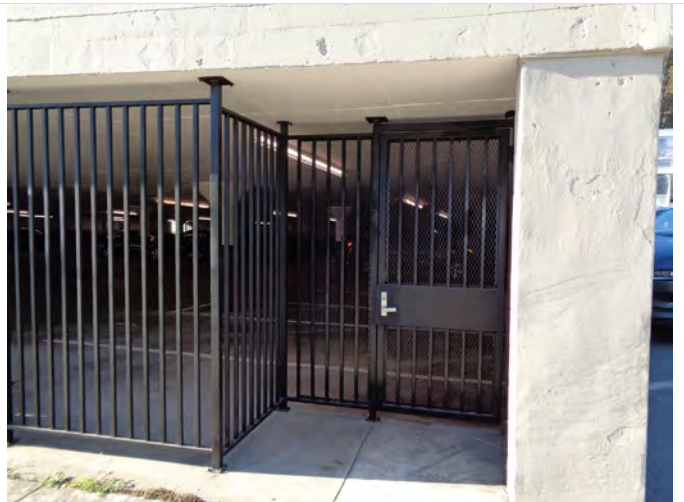
20. Northernmost mandoor to the lower level of the exterior parking garage

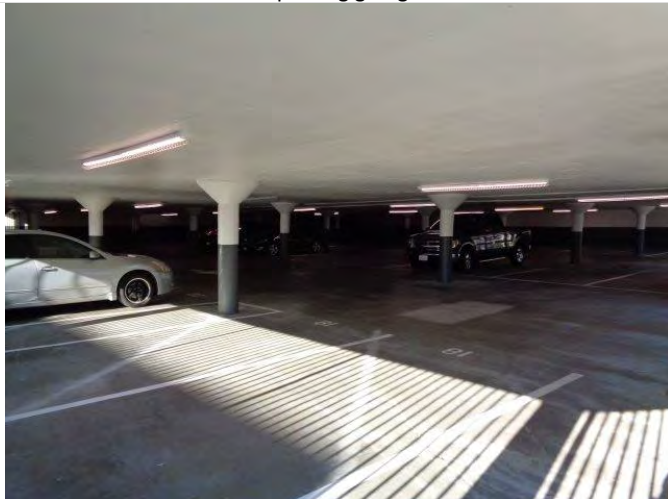
21. Lower level of the exterior parking garage.

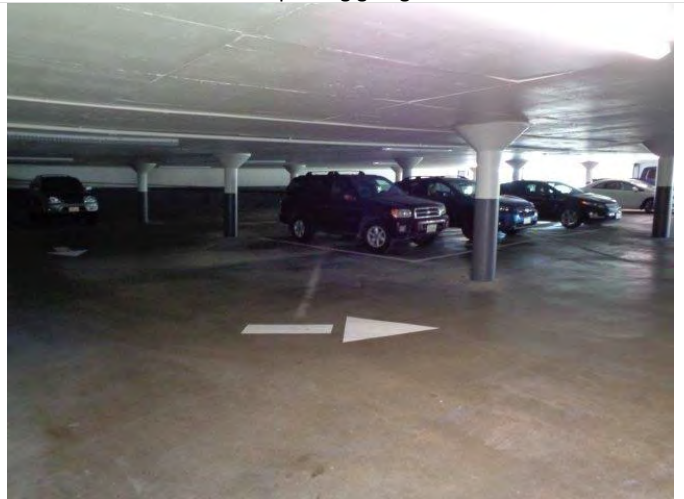
22. Lower level of the exterior parking garage.

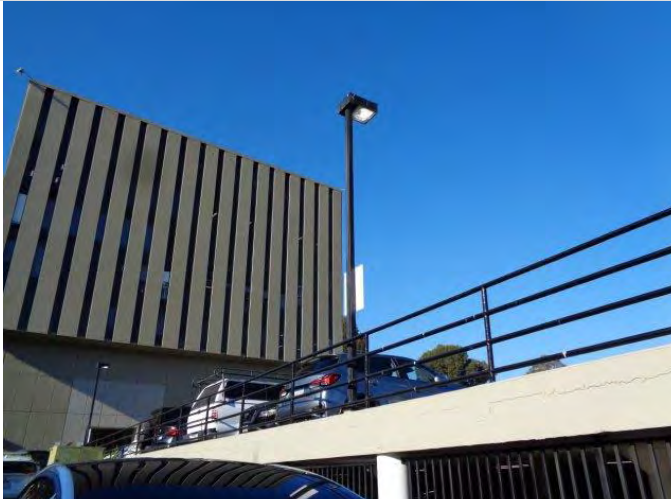
25. Typical pole mounted lighting fixture.

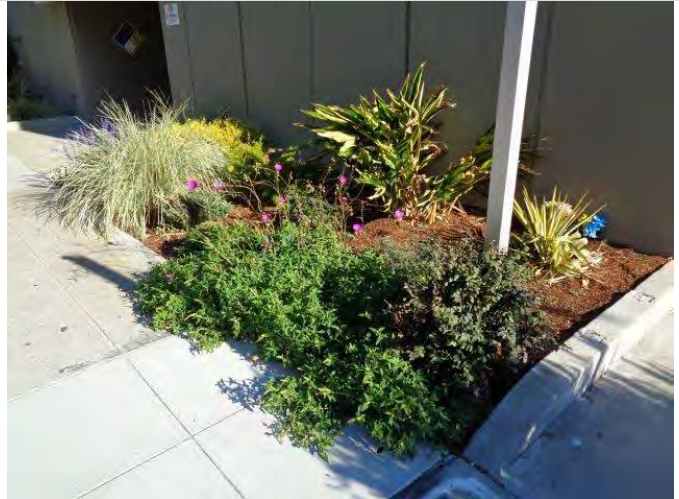
26. Typical landscaping at the west end of the building.

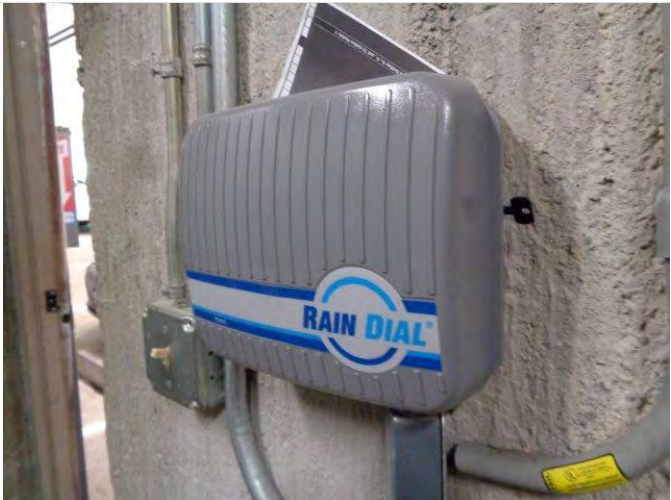
27. Landscaping irrigation controls.

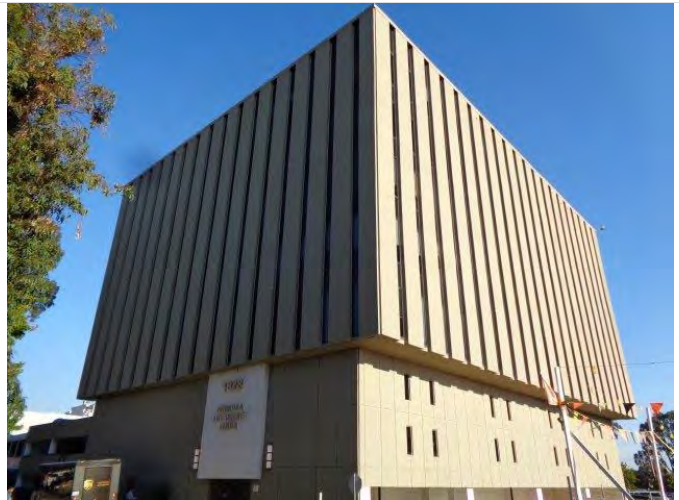
28. View of the west (front) and south facades of the building, looking northeast.

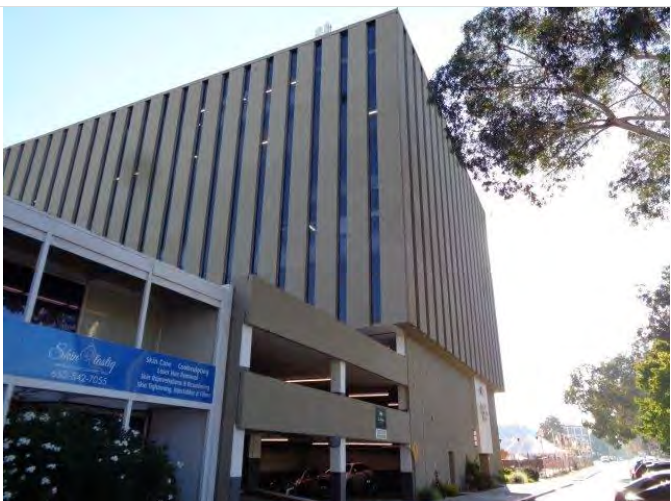
29. View of the west (front) and north facades of the building, looking southeast.

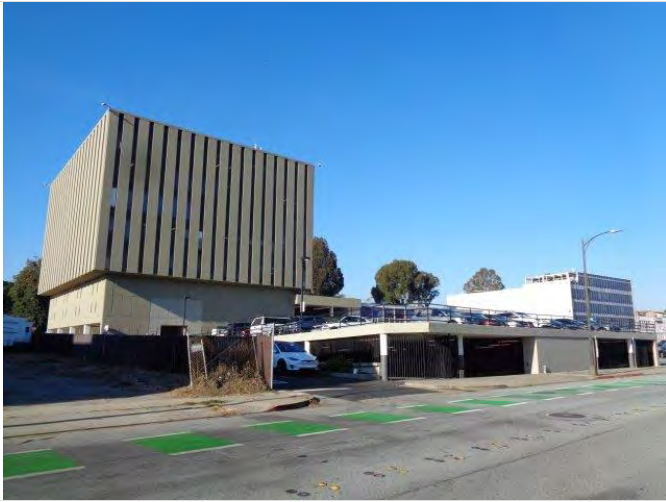
31. View of the east (rear) and south facades of the building, looking northeast.

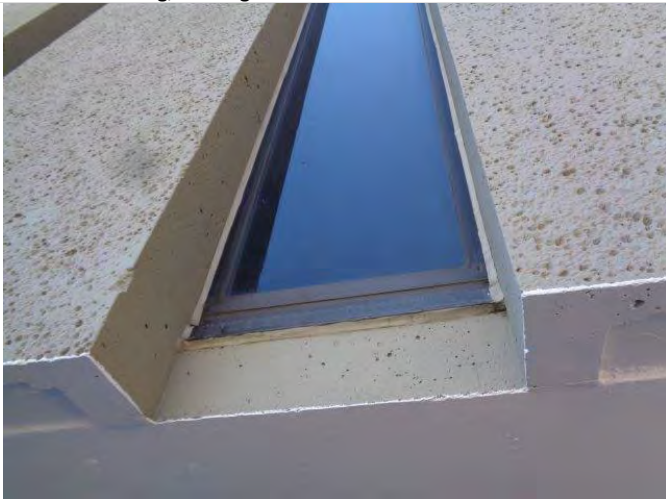
33. Close up of the typical building façade.

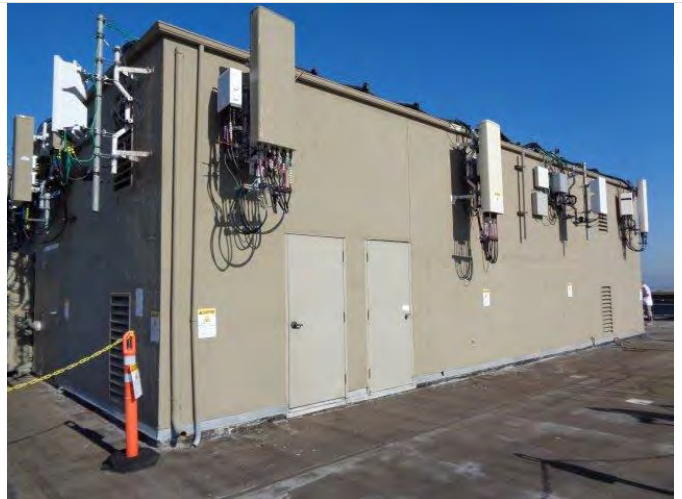
34. Penthouse atop the roof.

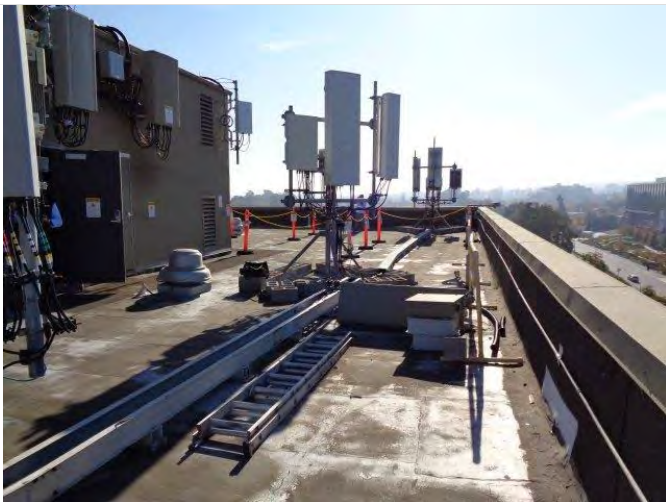
35. West end of the roof, looking south.

| ITEM | QUANTITY | UNIT | UNIT COST | IMMEDIATE COSTS | SHORT TERM COSTS | COMMENTS |
|---|---|---|---|---|---|---|
| "Stop-Gap" Repairs to Roofs | 1 | LS | \$5,000 | \$5,000 | | We recommend the use of "stop gap" measures to ensure water tightness and to perform emergency leak repairs only until the roofs are replaced. |

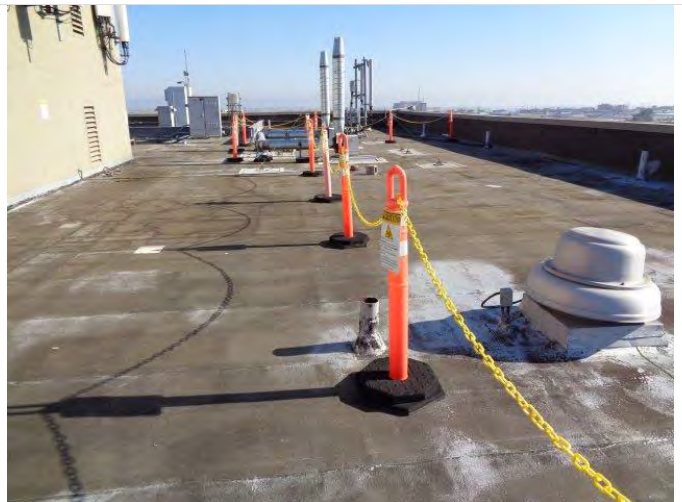
36. South end of the roof, looking east.

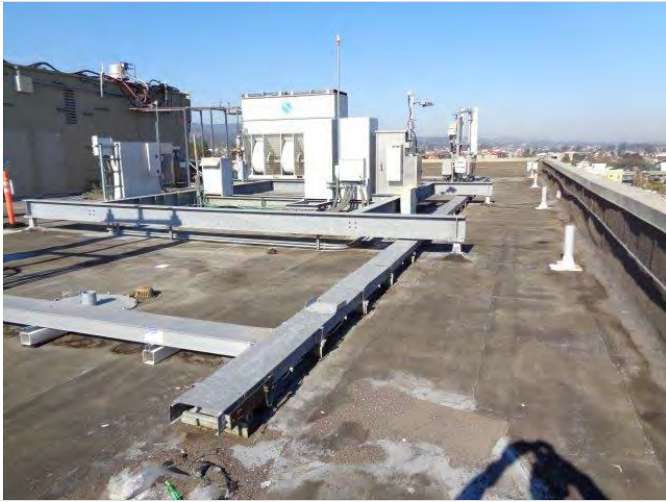
37. East end of the roof, looking north.

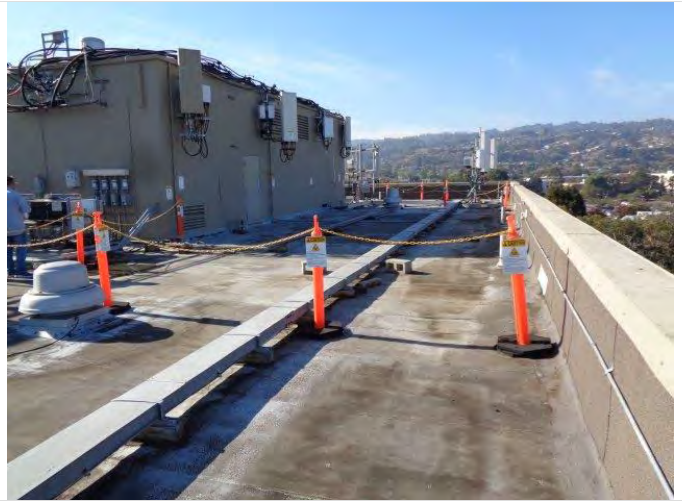
38. North end of the roof, looking west.

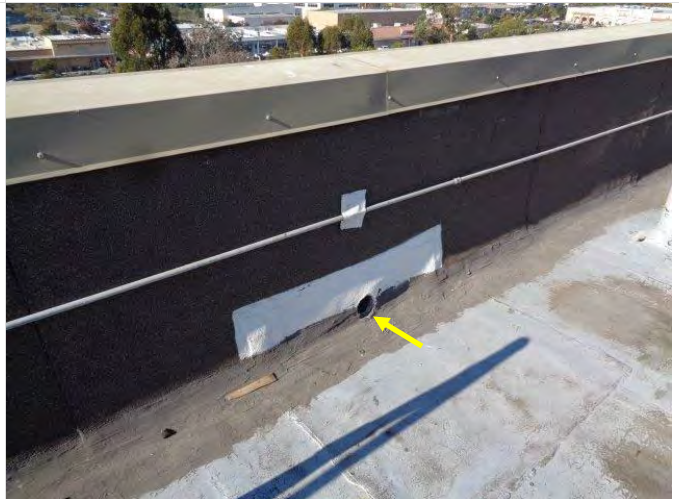
40. Typical parapet and through wall overflow scupper.

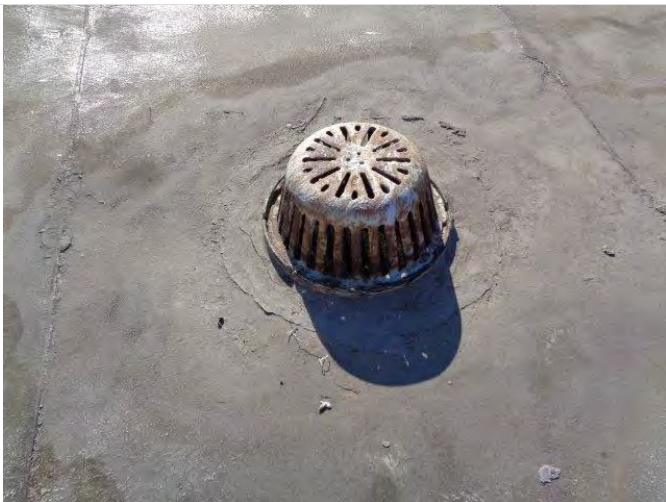
41. Typical interior roof drain.

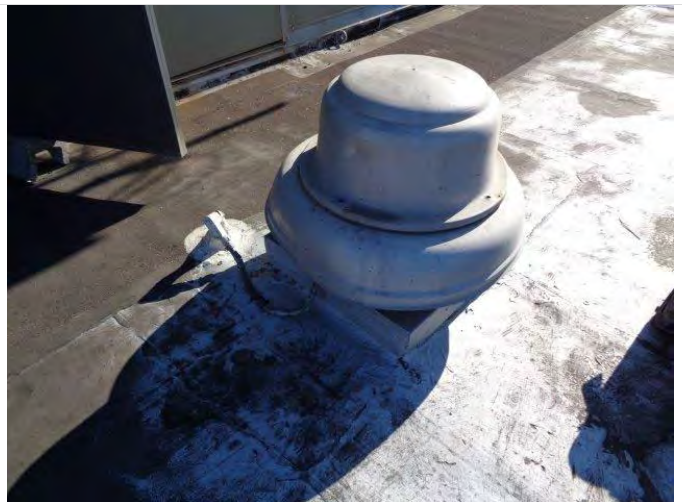
42. Typical exhaust vent atop the roof.

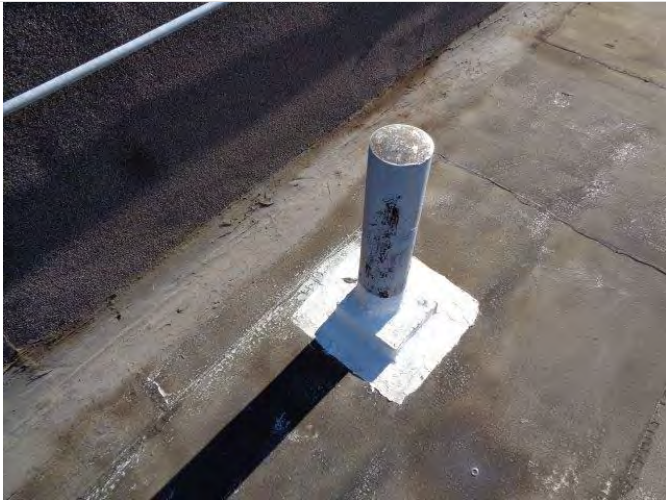
43. Typical window washing equipment support anchor atop the roof.

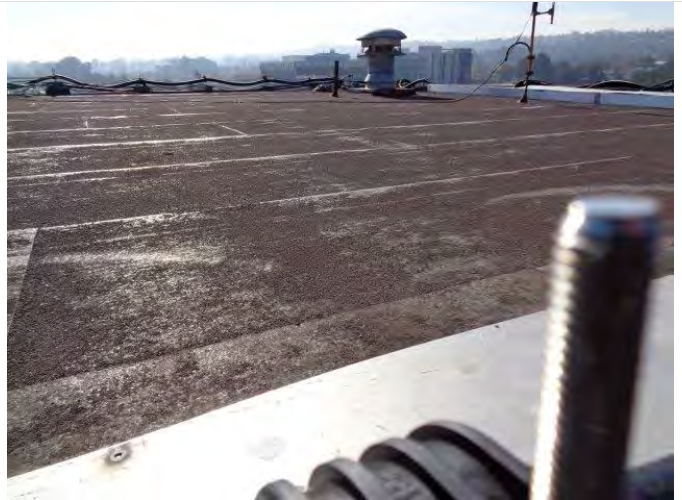
44. West half of the penthouse roof, looking southwest.

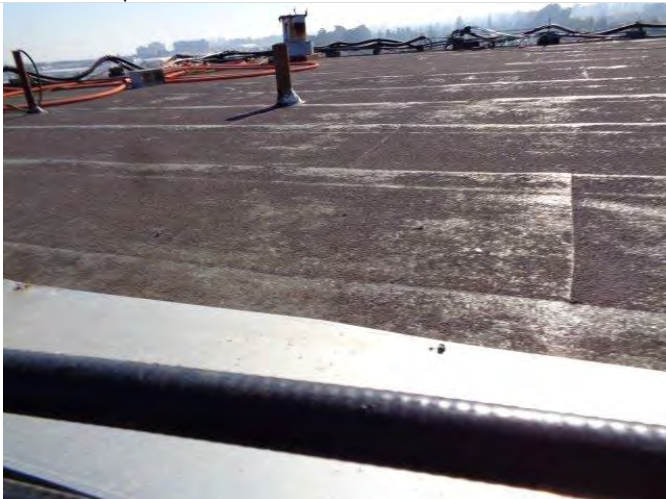
45. East half of the penthouse roof, looking southeast.

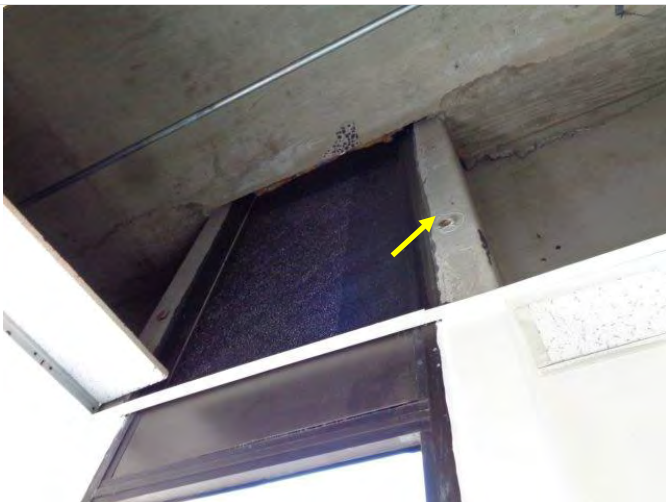
47. Typical precast concrete wall panel.

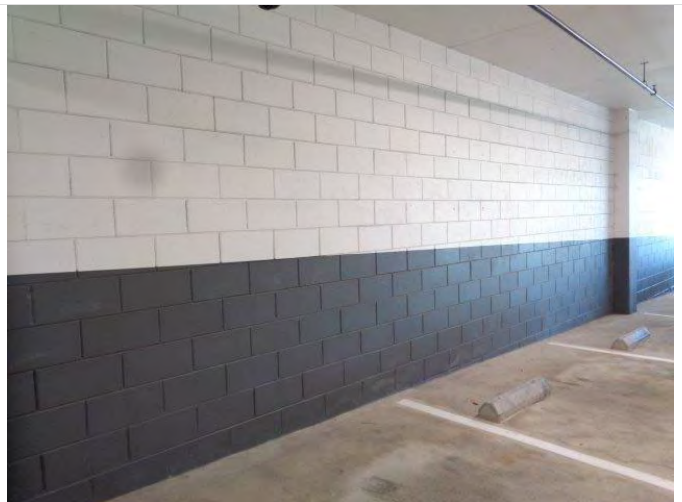
48. Typical CMU wall.

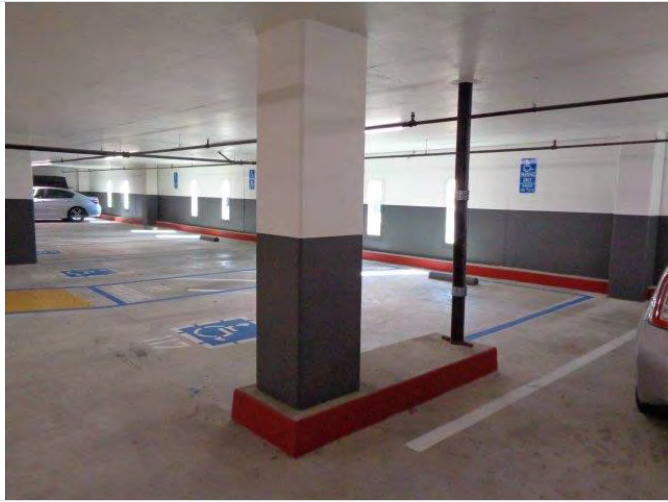
49. Typical concrete column.

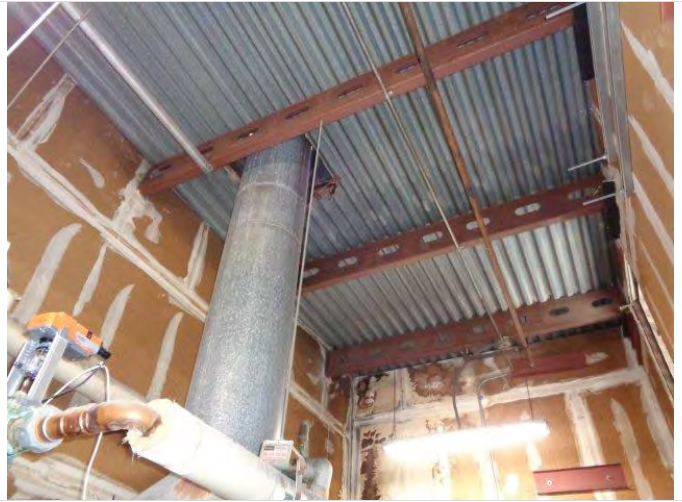
50. Partial view of the penthouse roof framing.

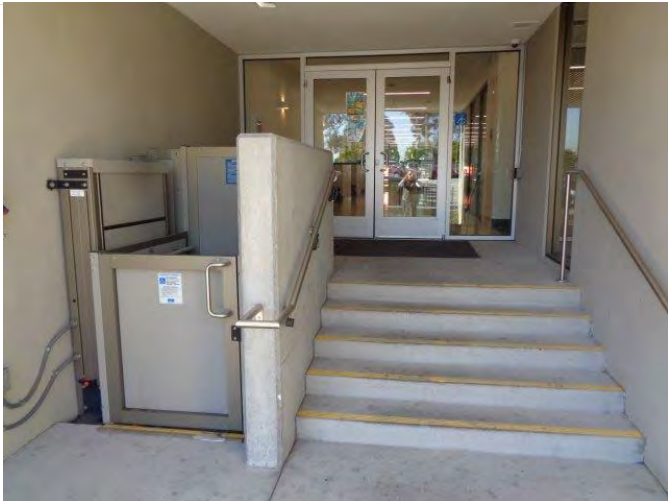
51. Main (west) entrance to the building

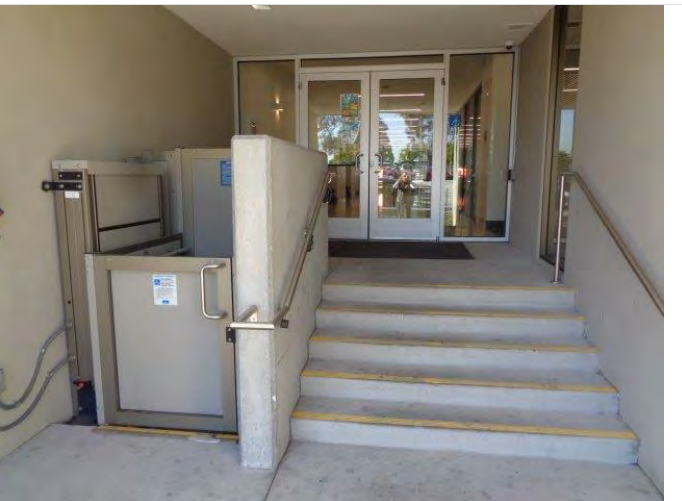
52. Rear (east) entrance to the building.

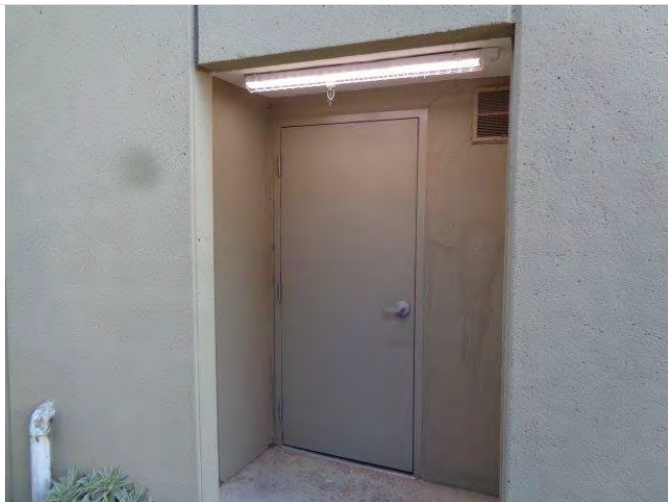
53. Typical service door.

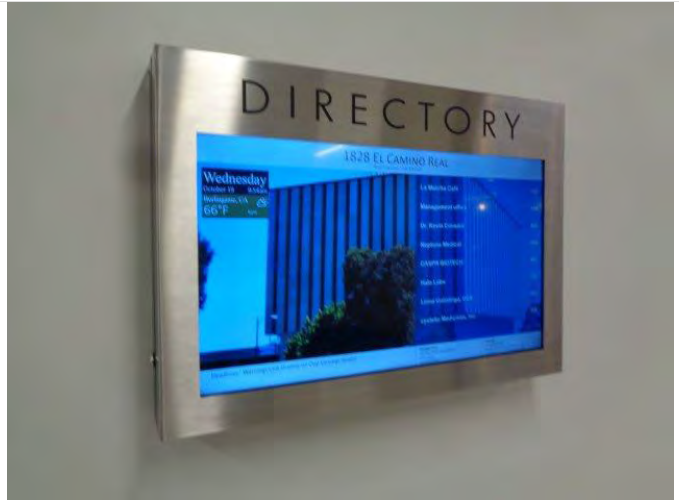
56. Digital directory in the first floor lobby.

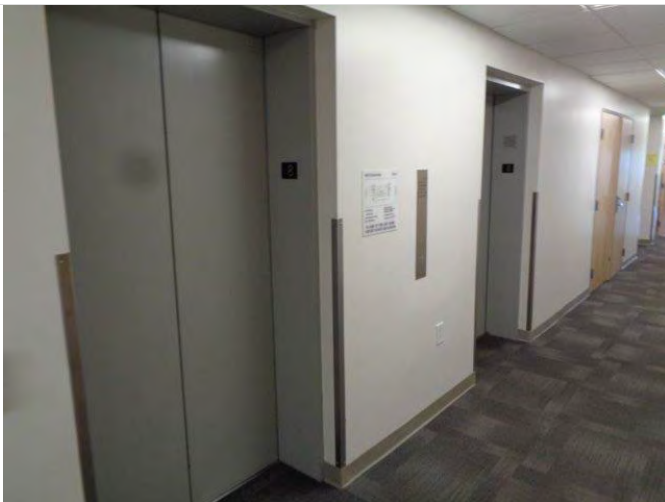
59. Typical elevator bank in the tenant floor main corridors.

The elevators at the Subject appeared to be in general compliance with the ADA guidelines; however, the elevators were without “white on black” car operating and/or entrance panels in Braille and were without handrails. Costs for installation are included in the Physical Deficiencies / Deferred Maintenance Table 1.

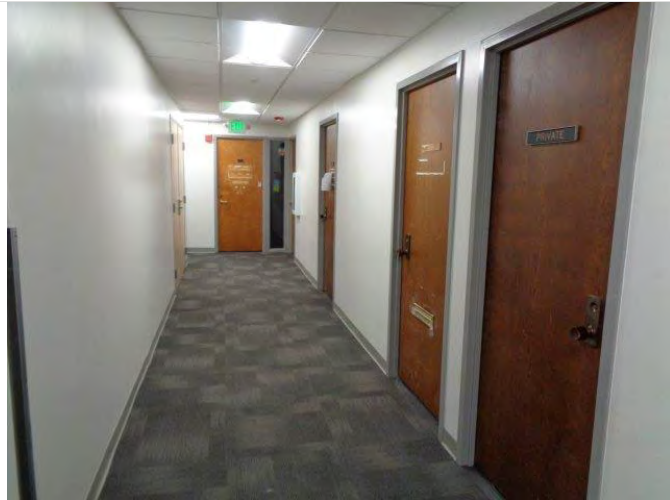
61. Typical tenant floor corridor.

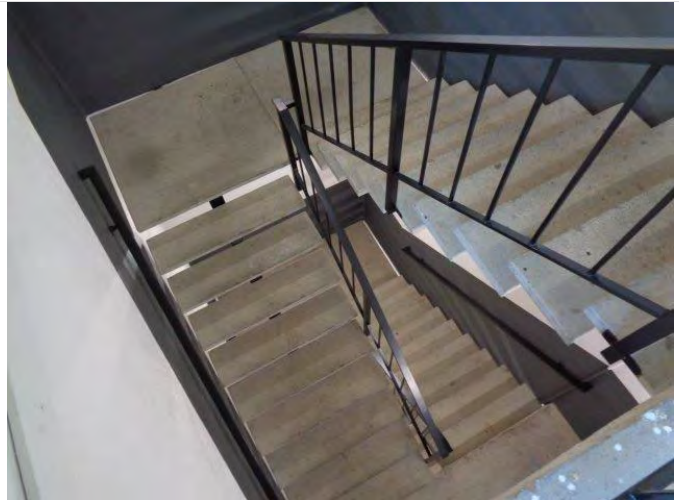
62. One of two typical interior stairways.

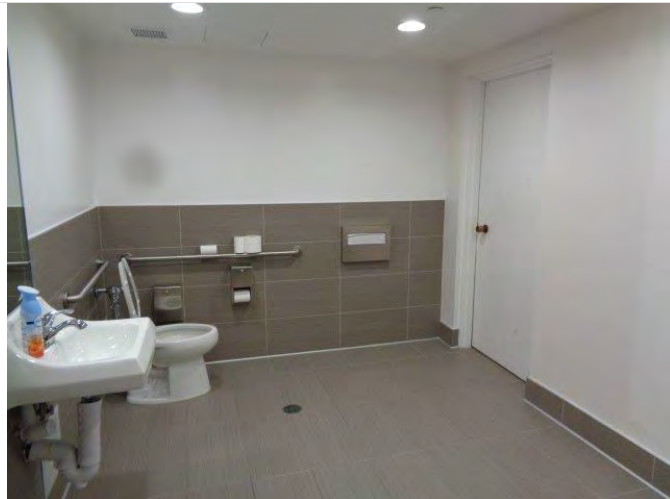
63. Typical "All Gender Restroom".

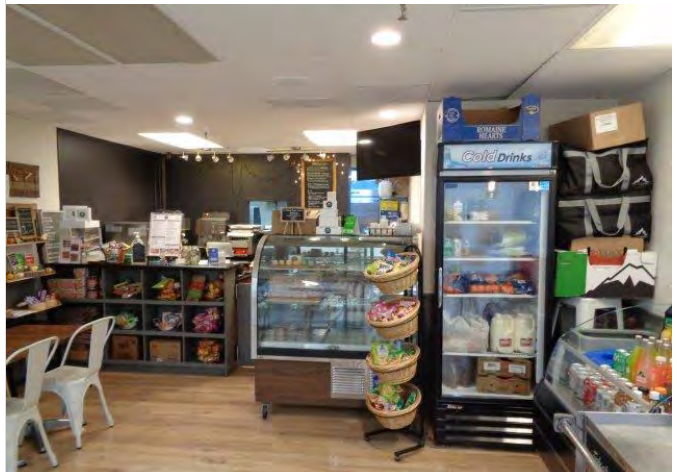
64. La Mocha Café tenant finishes.

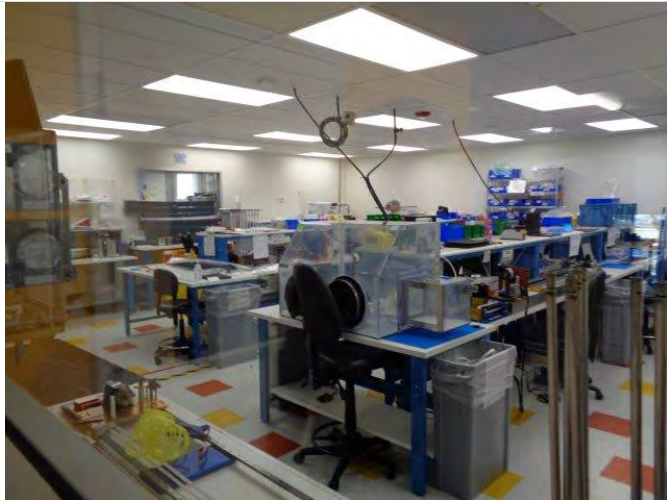
67. Typical tenant finishes.

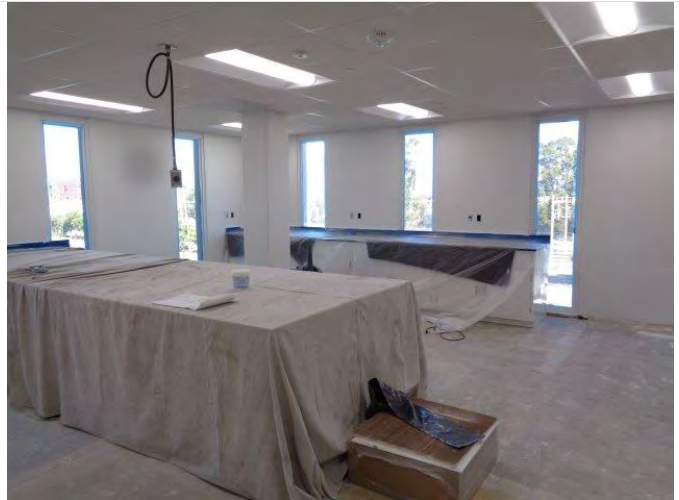
68. Typical tenant finishes. Note that this tenant space was being renovated.

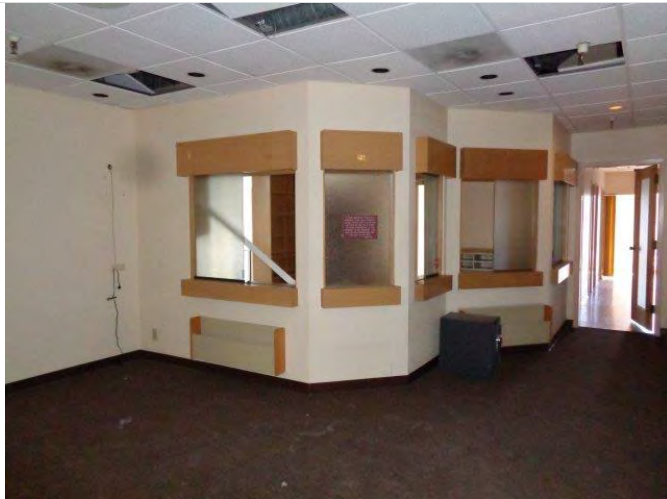
69. Typical tenant finishes. Note that this tenant space was vacant.

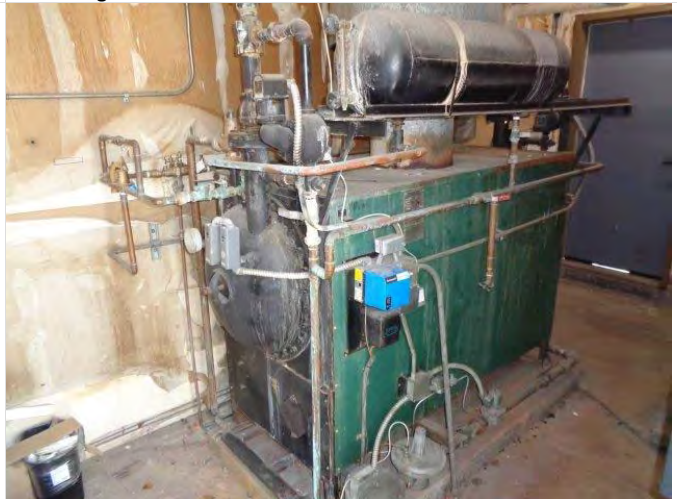
70. Gas-fired hot water boiler for the heating system.

| ITEM | EUL | EFF AGE | RUL | QUANTITY | UNIT | UNIT COST | SECTION NO. | CAPITAL REPLACEMENT RESERVES SCHEDULE - COST PER YEAR | | | | | | | | | | | | SUMMARY |
|---|---|---|---|---|---|---|---|---|---|---|---|---|---|---|---|---|---|---|---|---|
| Replace Space Heating Hot Water Boiler | 20 | 20 | 0 | 1,500 | kBtuh | \$65 | 7.1 | \$97,500 | - | - | - | - | - | - | - | - | - | - | - | \$97,500 |

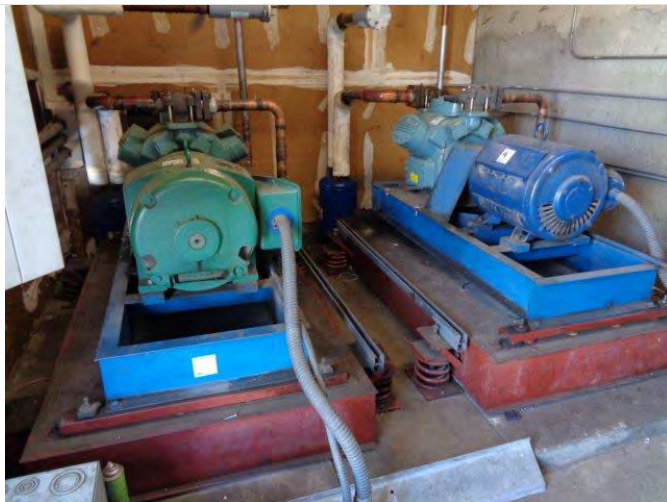
71. Refrigeration compressors for the air conditioning system.

| ITEM | EUL | EFF AGE | RUL | QUANTITY | UNIT | UNIT COST | SECTION NO. | CAPITAL REPLACEMENT RESERVES SCHEDULE - COST PER YEAR | | | | | | | | | | | | SUMMARY |
|---|---|---|---|---|---|---|---|---|---|---|---|---|---|---|---|---|---|---|---|---|
| Replace Refrigeration Compressors | 50 | 48 | 2 | 2 | Comp | \$95,000 | 7.1 | - | \$190,000 | - | - | - | - | - | - | - | - | - | - | \$190,000 |

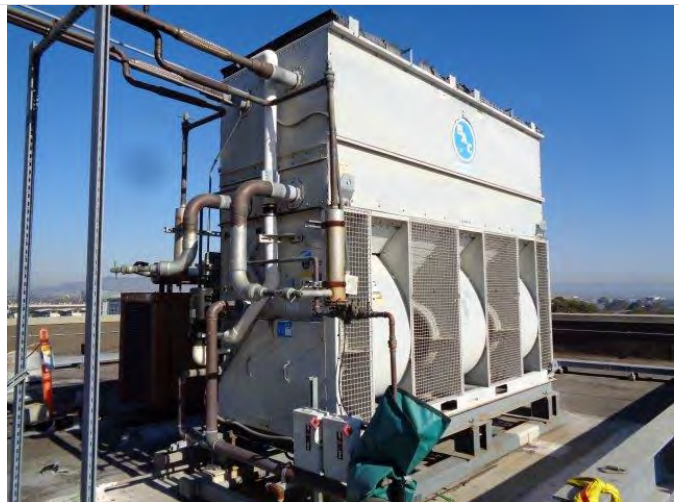
72. BAC cooling tower atop the roof.

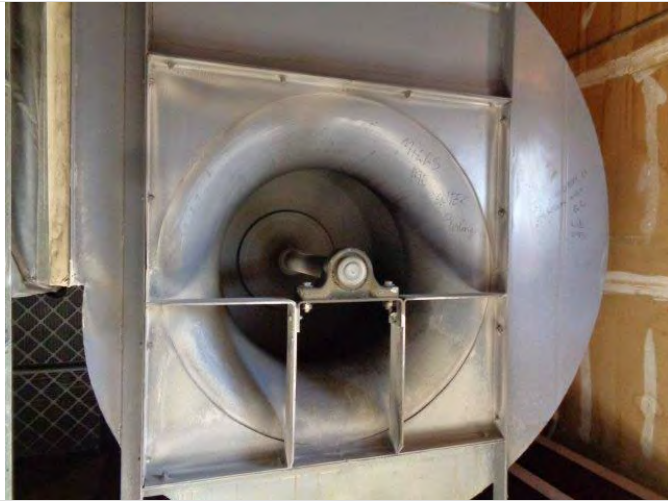
73. Centrifugal supply air fan.

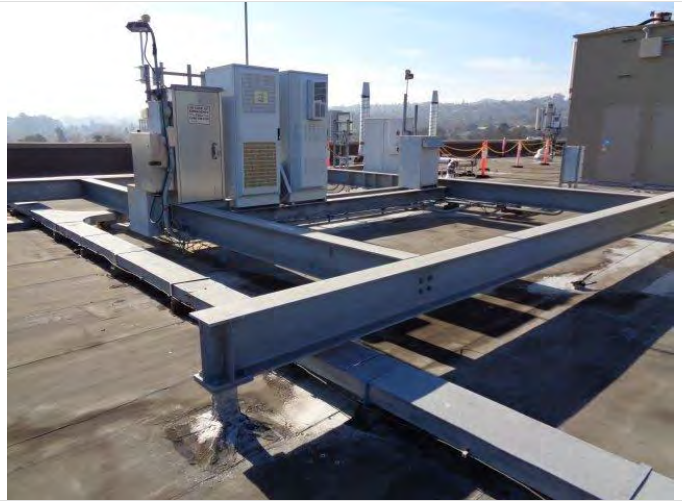
74. Dunnage for tenant equipment.

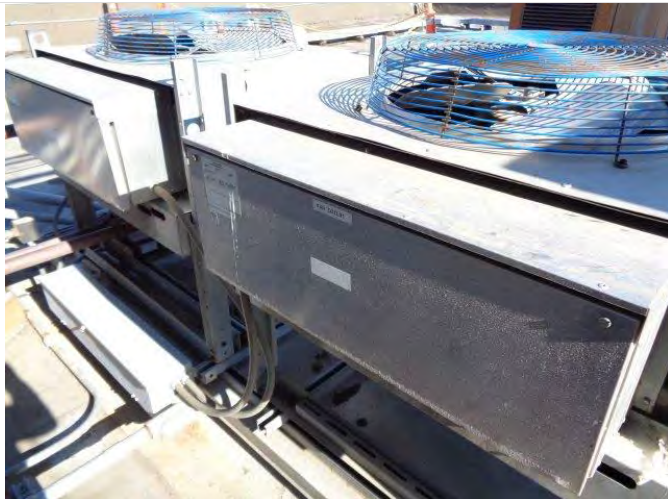
75. Tenant HVAC equipment.

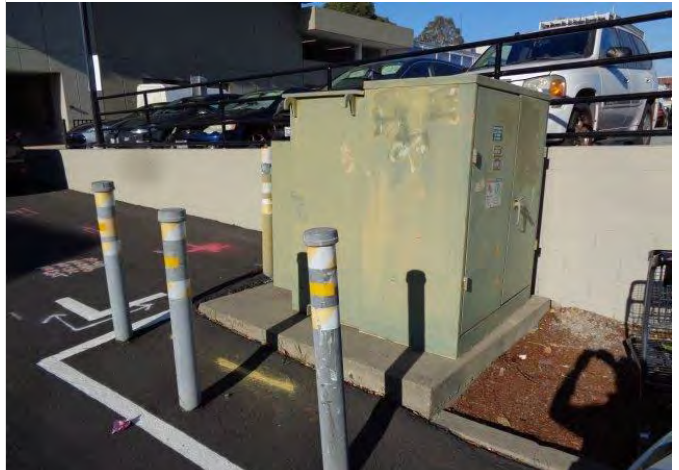
76. Main electrical transformer for the building.

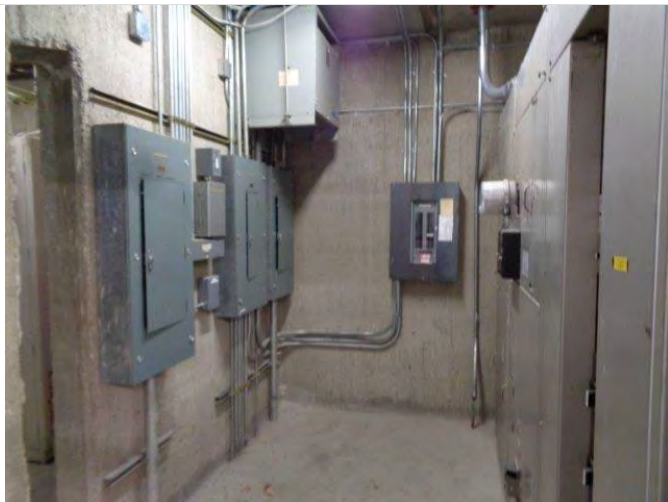
77. Main electrical panel and distribution panels.

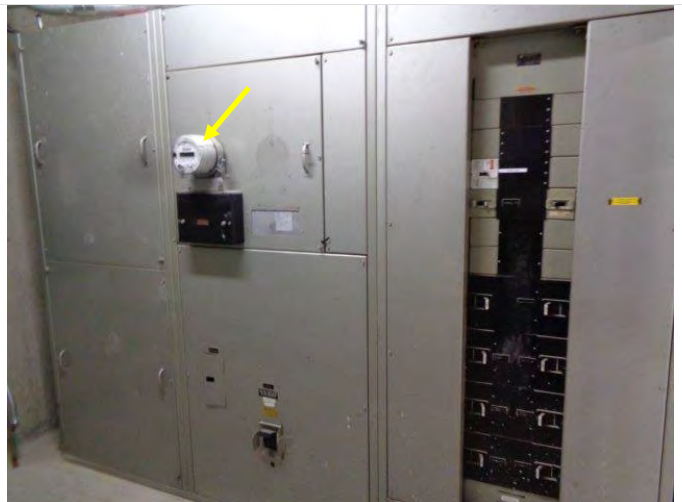
78. Main electrical panel and switch gear. Also note the building electric meter.

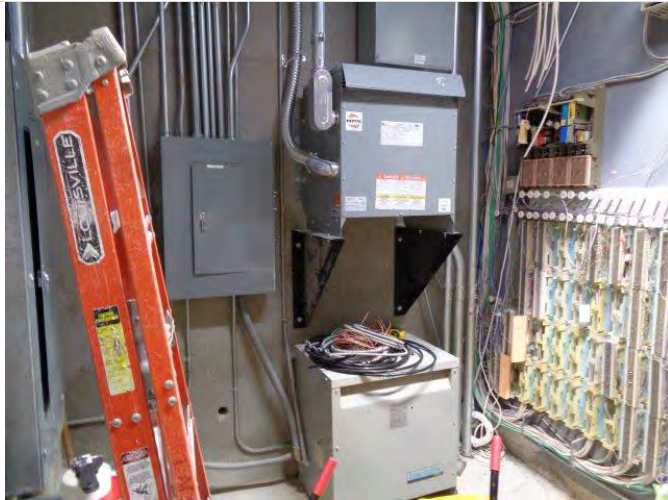
79. Typical step-down transformer on each of the tenant floor levels.

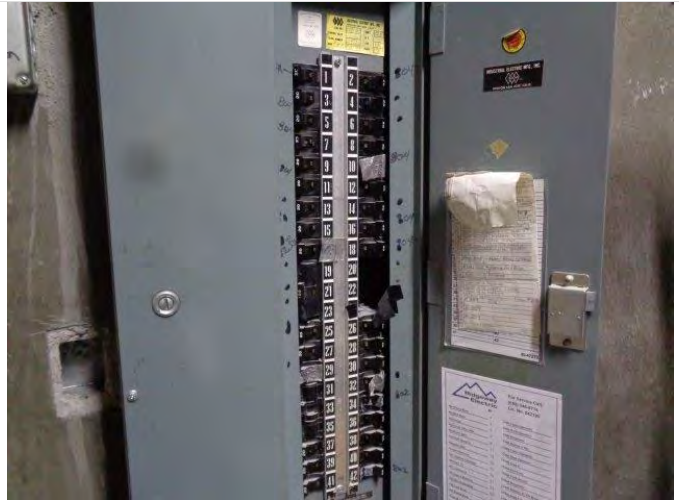
80. Typical distribution panel.

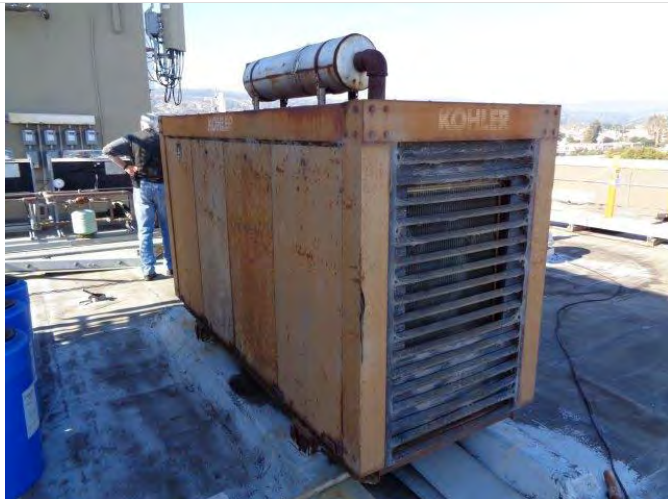
81. Emergency electrical back-up generator atop the roof. Note that this reportedly was not in use.

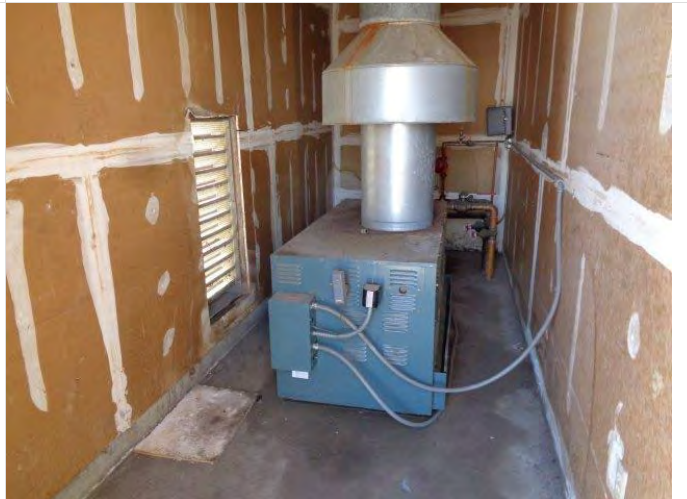
82. Domestic hot water boiler.

| ITEM | EUL | EFF AGE | RUL | QUANTITY | UNIT | UNIT COST | SECTION NO. | CAPITAL REPLACEMENT RESERVES SCHEDULE - COST PER YEAR | | | | | | | | | | | | SUMMARY |
|---|---|---|---|---|---|---|---|---|---|---|---|---|---|---|---|---|---|---|---|---|
| Replace Domestic Hot Water Boiler | 15 | 18 | 0 | 1,336 | kBtuh | \$45 | 7.3 | \$60,120 | - | - | - | - | - | - | - | - | - | - | - | \$60,120 |

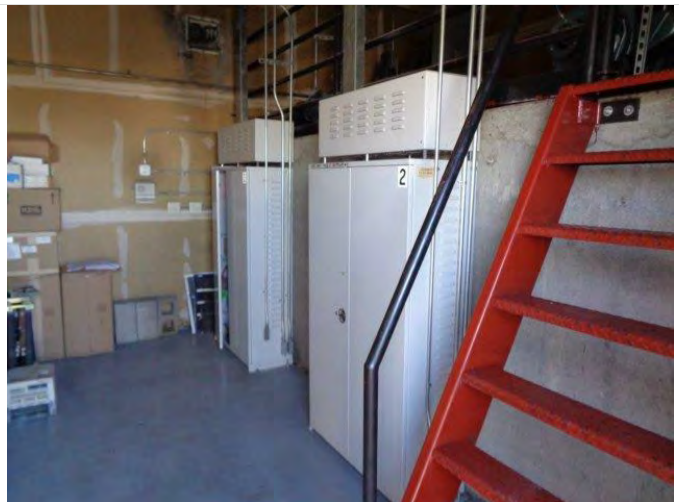
84. Elevator control panels.
