PROPERTY CONDITION ASSESSMENT REPORT

COMMERCIAL BUILDING

123 Main Street

NDDS Project 2311111

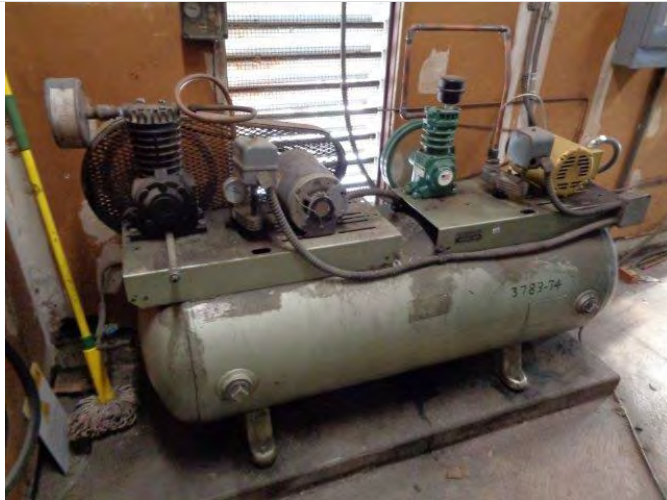
85. Air compressor.

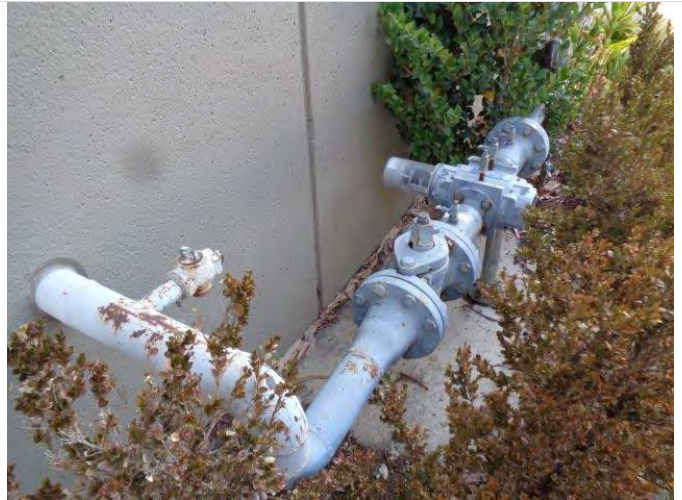
86. Gas meter.

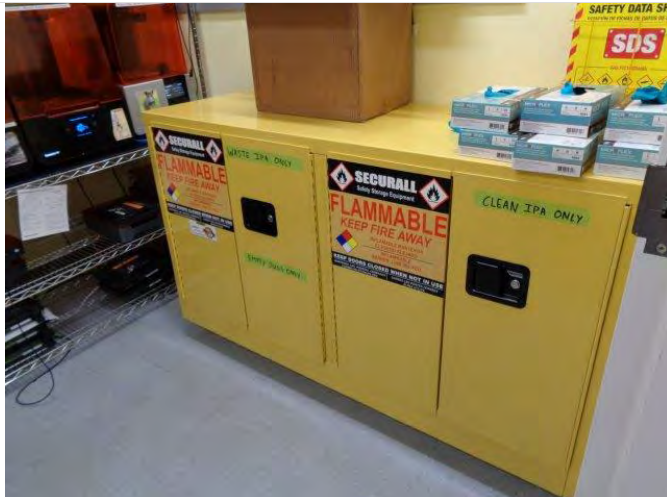
87. Typical chemical storage container within a tenant space.

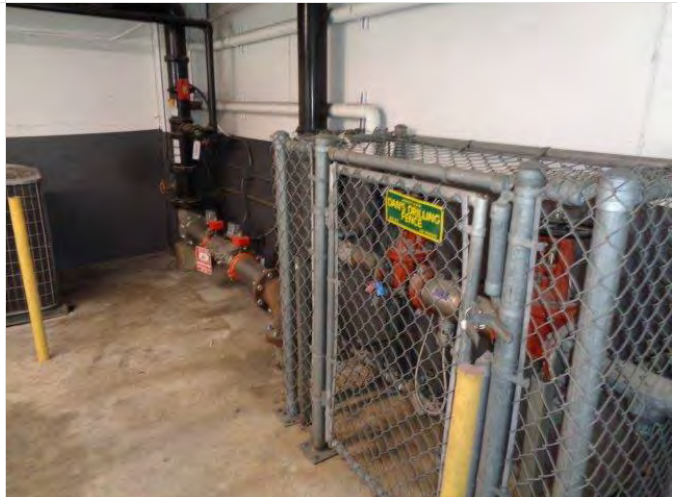
88. Main fire sprinkler riser.

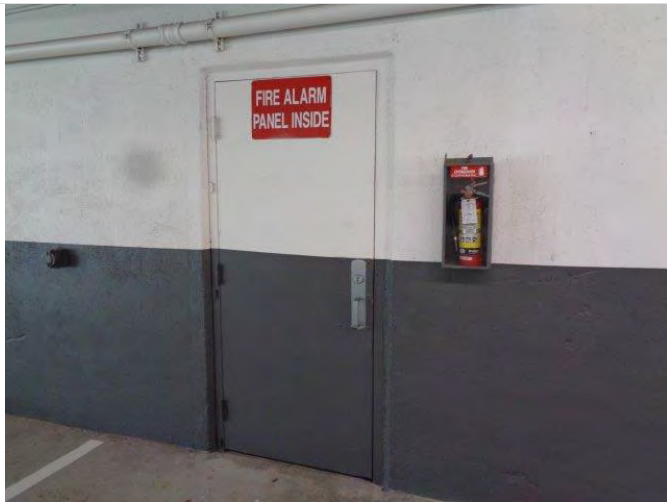
91. Entrance to the F.A.C.P. room and main electric room located within the first level of the underbuilding garage.

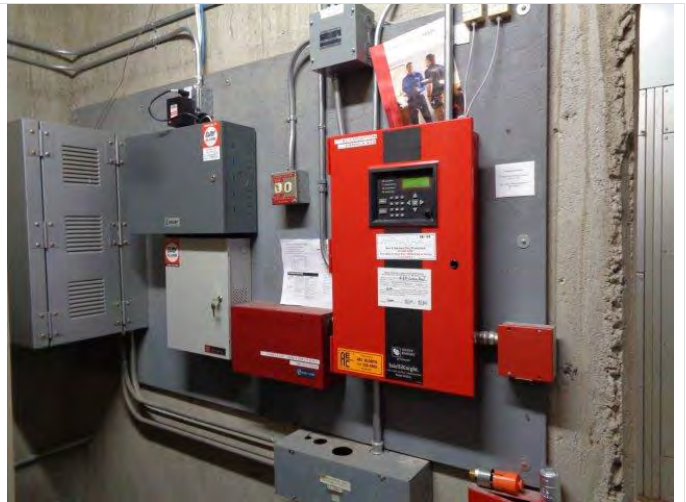
92. Main fire alarm control panel.

| ITEM | EUL | EFF AGE | RUL | QUANTITY | UNIT | UNIT COST | SECTION NO. | CAPITAL REPLACEMENT RESERVES SCHEDULE - COST PER YEAR | | | | | | | | | | | | SUMMARY |
|---|---|---|---|---|---|---|---|---|---|---|---|---|---|---|---|---|---|---|---|---|
| Replace Fire Alarm Control Panel | 20 | 14 | 6 | 65,804 | SF | \$1.25 | 9.2 | - | - | - | - | - | - | - | \$82,255 | - | - | - | - | \$82,255 |

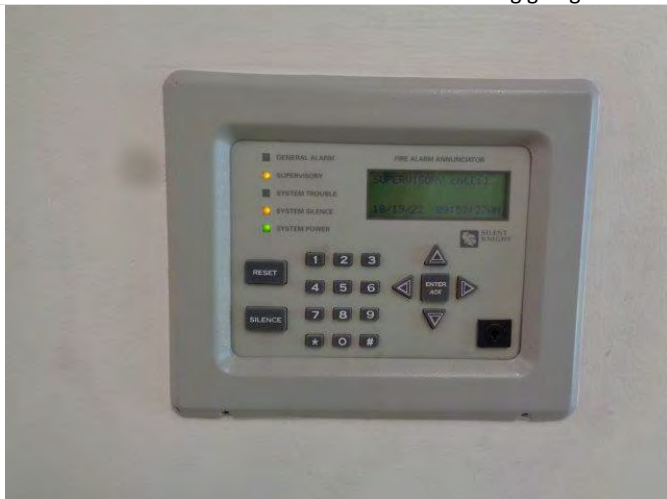
93. Addressable panel in the main lobby.

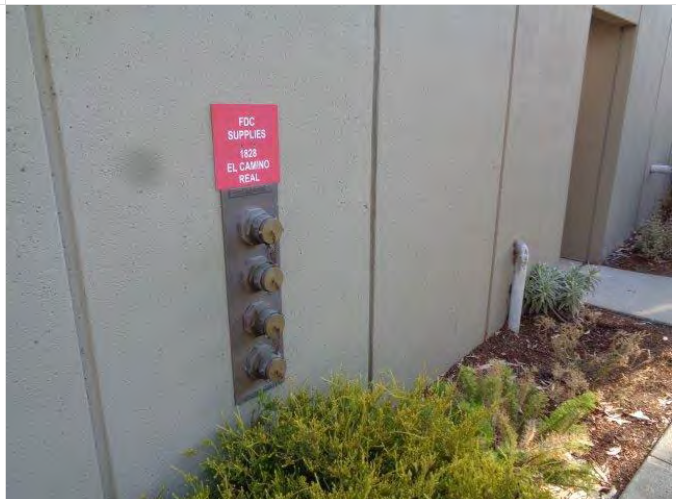
94. Fire department connections along the west (front) elevation.

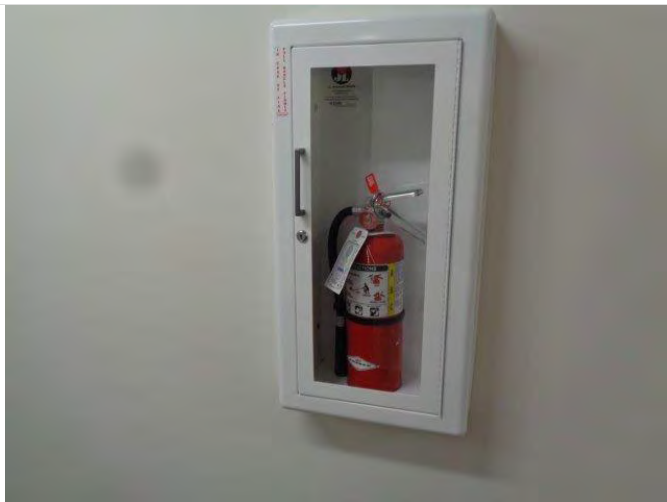
95. Typical cabinet enclosed fire extinguisher.

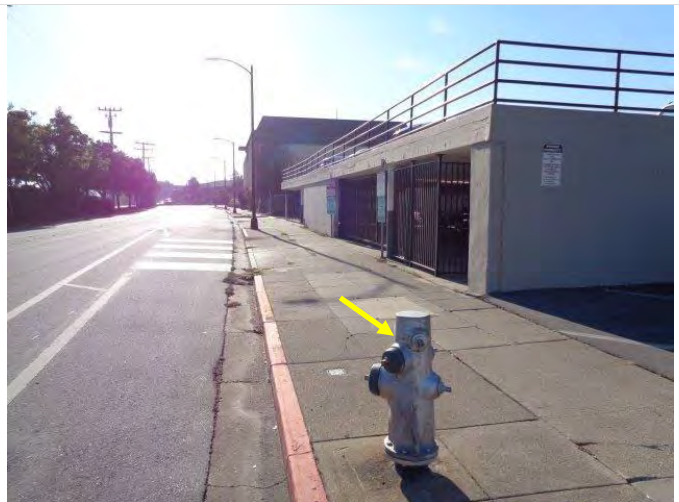
96. Fire hydrant at the northeast corner of the Subject, looking south.

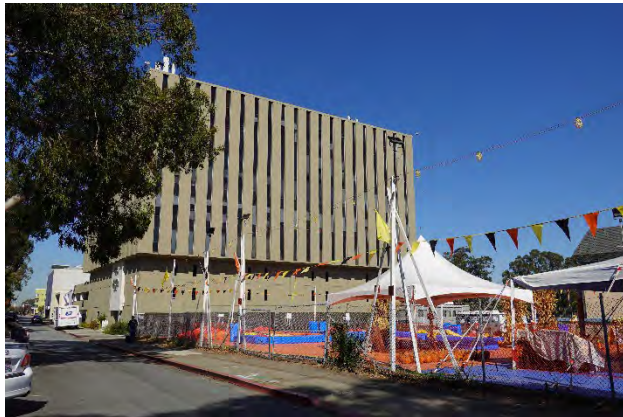
1 Southern elevation

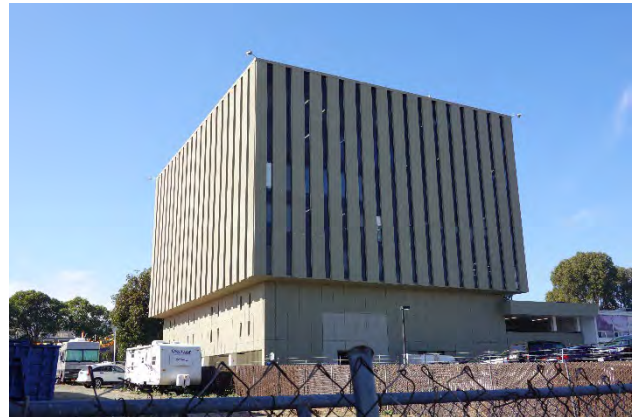
2 Eastern elevation

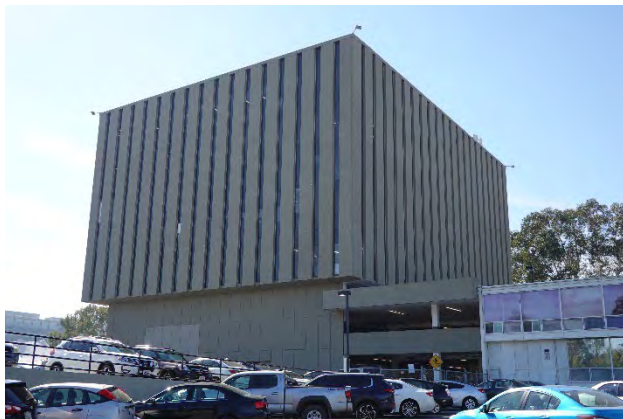
3 North and east elevation

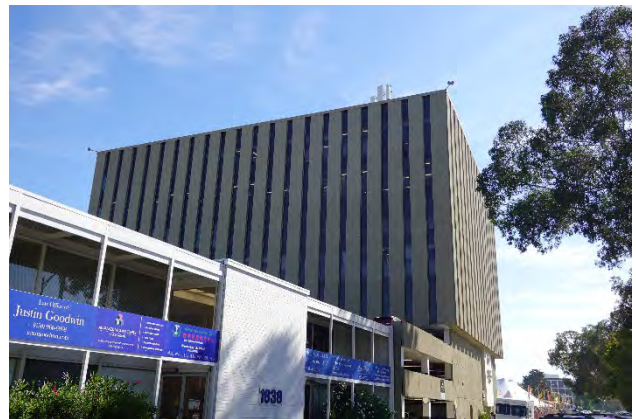
4 North elevation

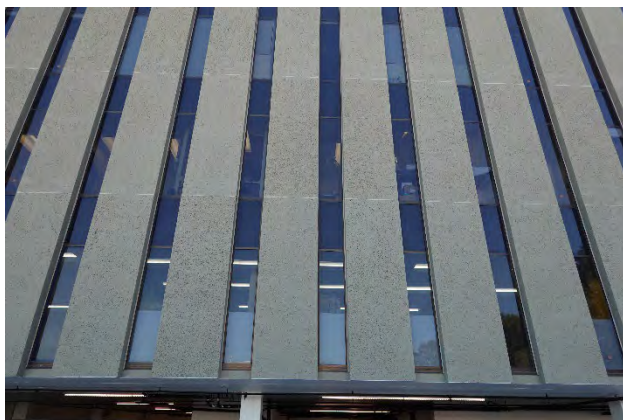
5 Exterior wall cladding is precast with infill sash framing constructed into a curtain wall

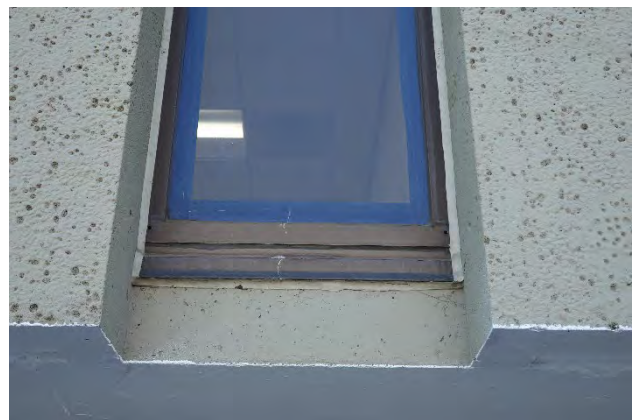
6 Glazing system sill sets onto a finished aluminum flashing. Perimeter seals appear to be urethane.

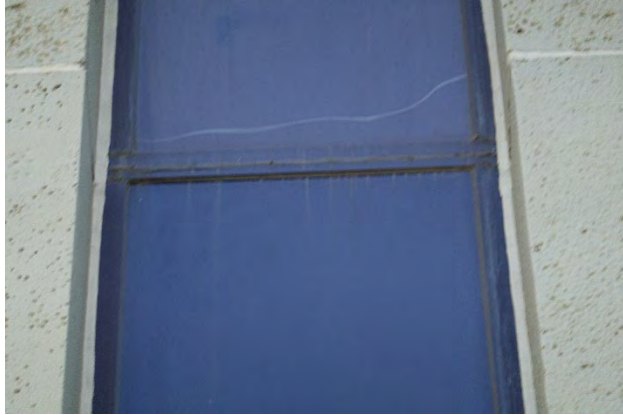
7 "Stack" joint in the glazing system at the floor line of the building

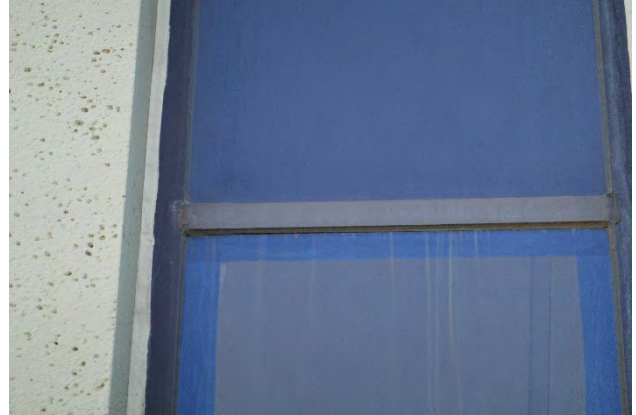
8 Intermediate horizontal member with spandrel over vision

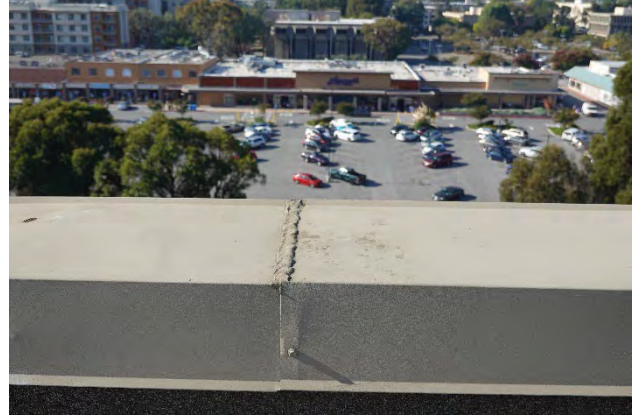
14 Lap and seal in the sheet metal coping

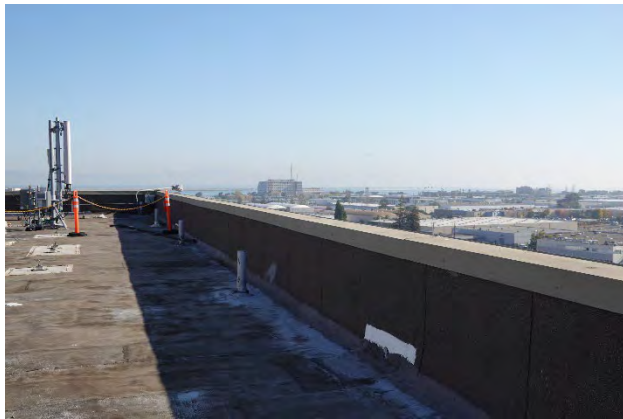
15 Parapet wall with davits behind

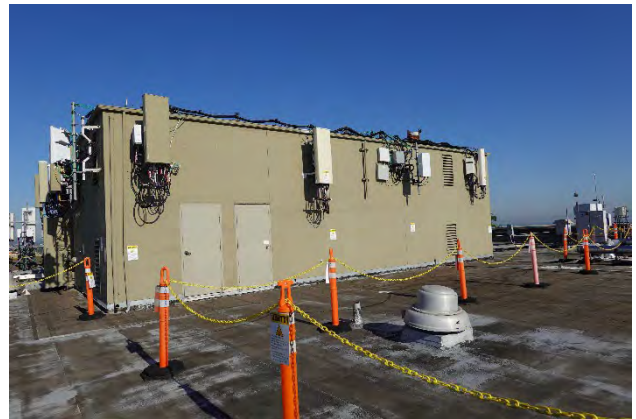
16 Stucco penthouse cladding

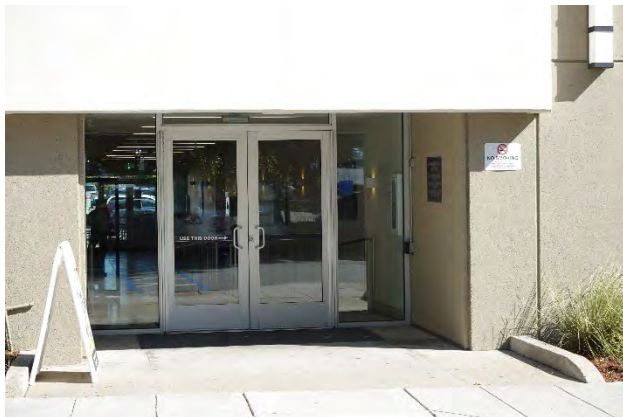
17 Main entrance

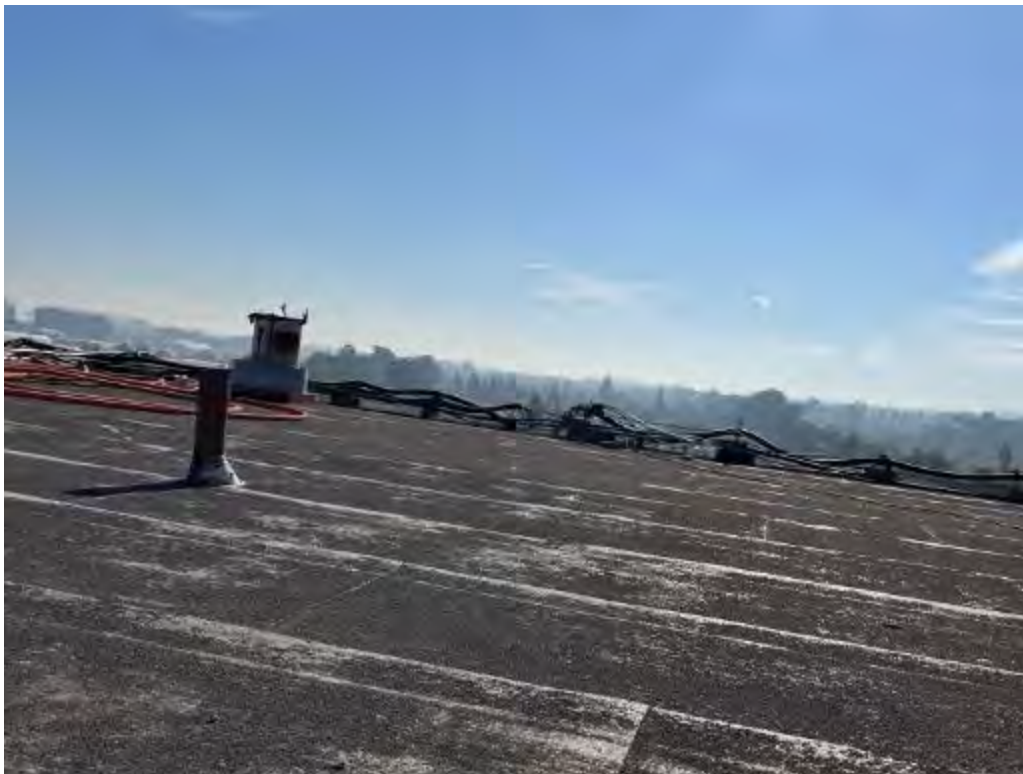
Typical penthouse field membrane sheets/extensive granule loss with exposed scrim

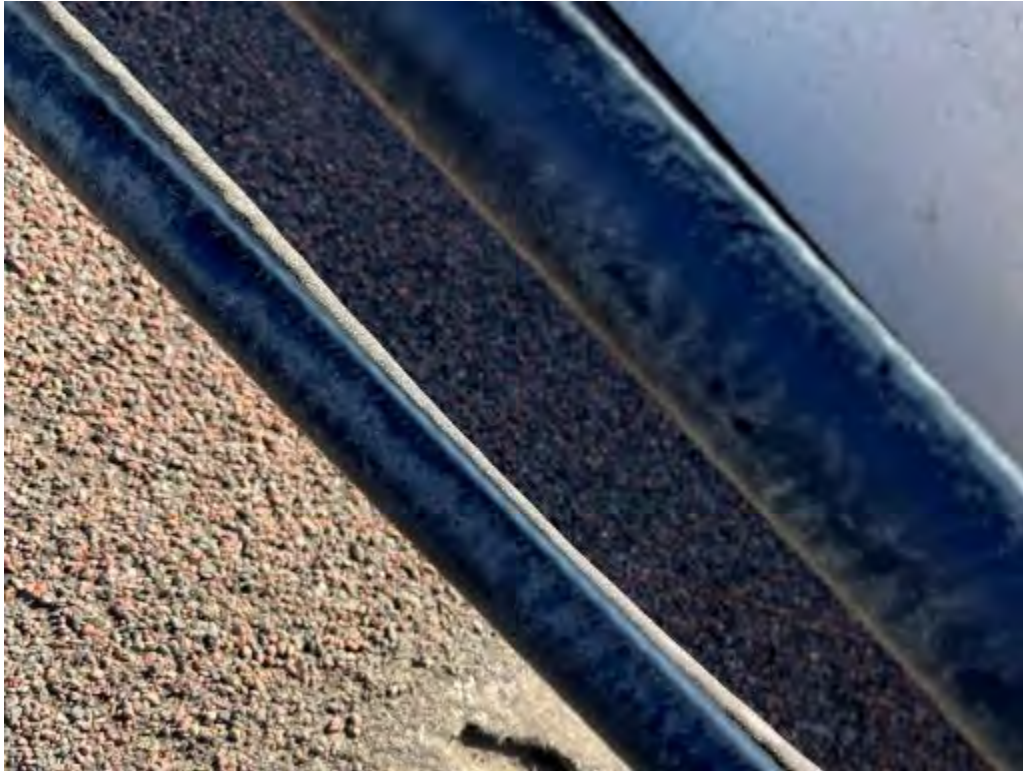
Hole in membrane

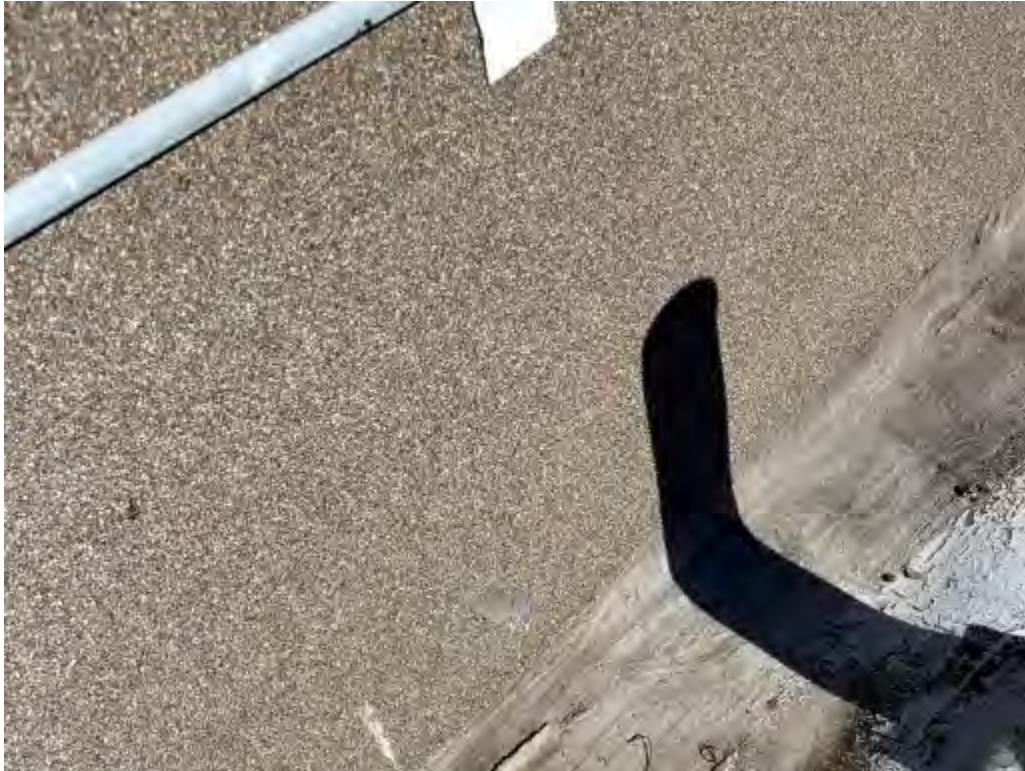
Mastic seal at parapet wall flashing and main roof

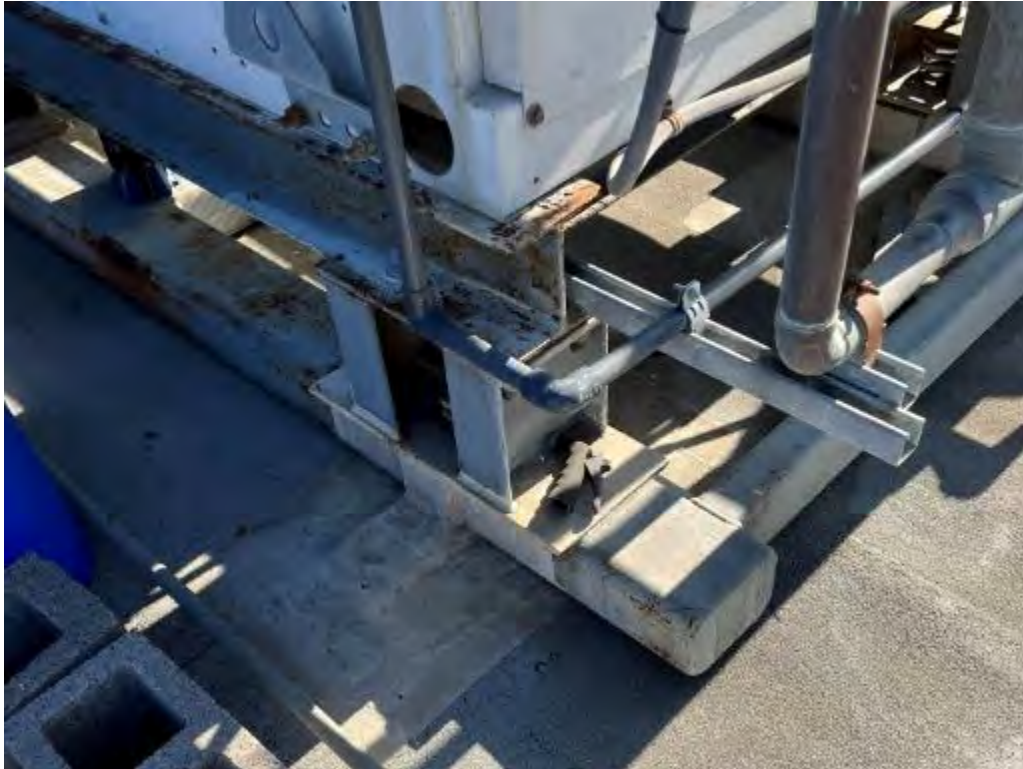
5. Heavy equipment curbs and concrete blocks are missing protective pads and rest directly on the roof membrane.
6. Abandoned, heavy steel antenna stands sit directly on the roof membrane.

Equipment set directly on membrane (no pad)

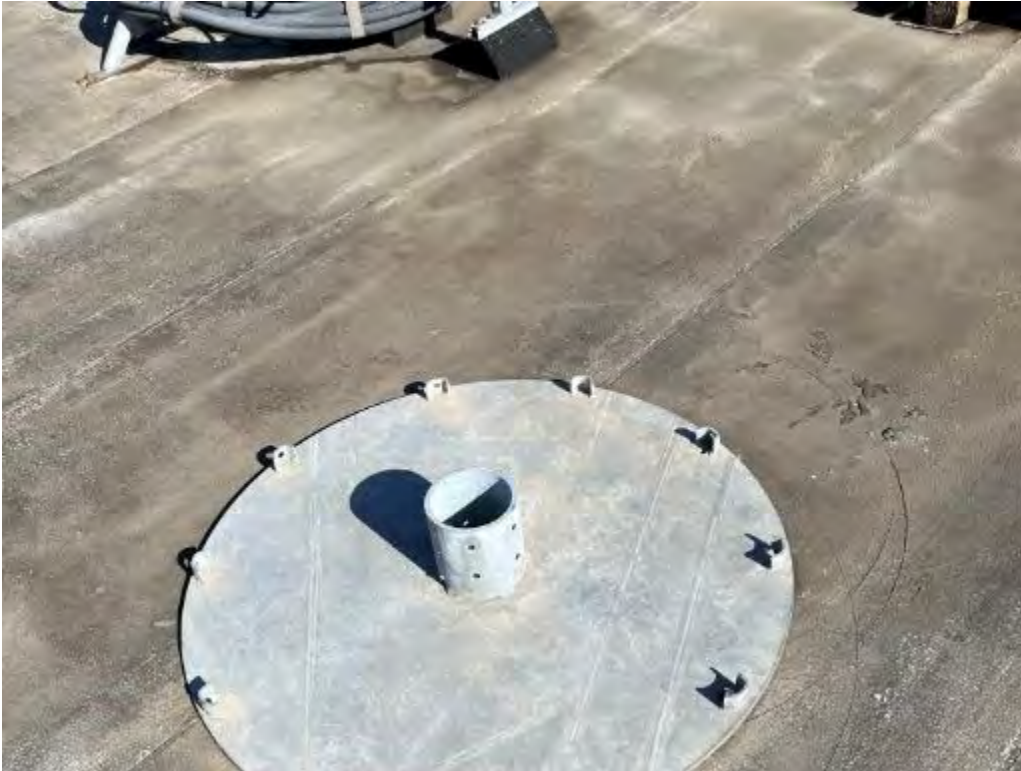
Heavy antenna mount set directly on membrane

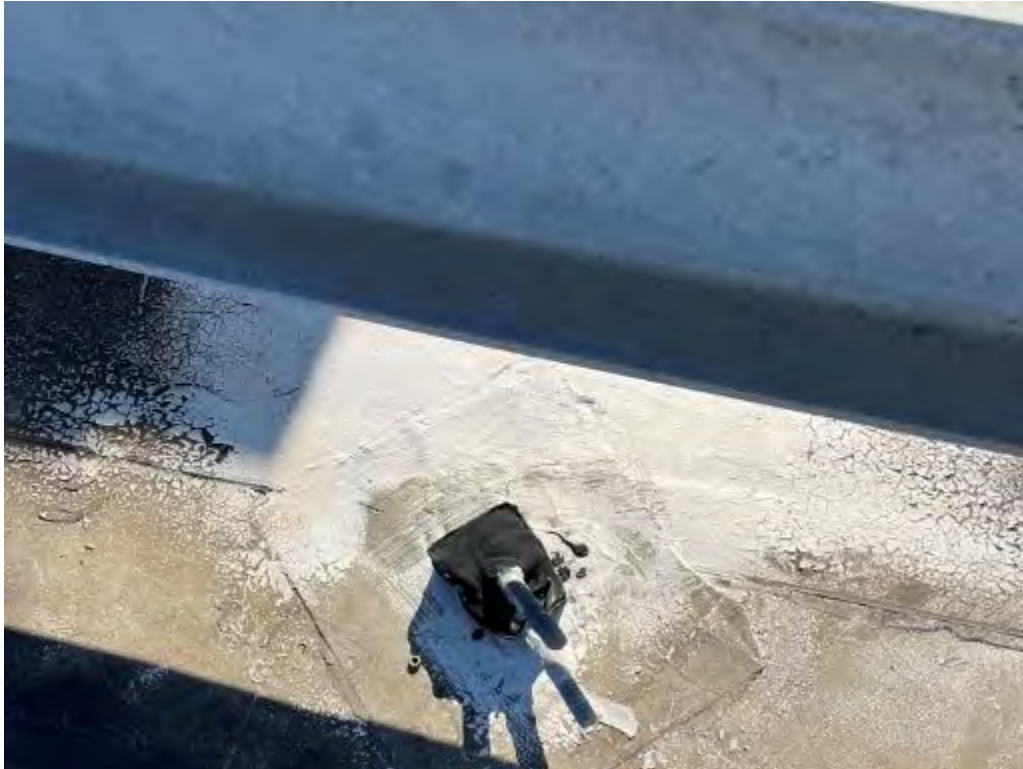
7. Antenna legs bolted to through the roof and into the concrete deck are improperly, insufficiently waterproofed with caulk.
8. Multiple abandoned pitch pans are split/open.

Abandoned pitch pan detail

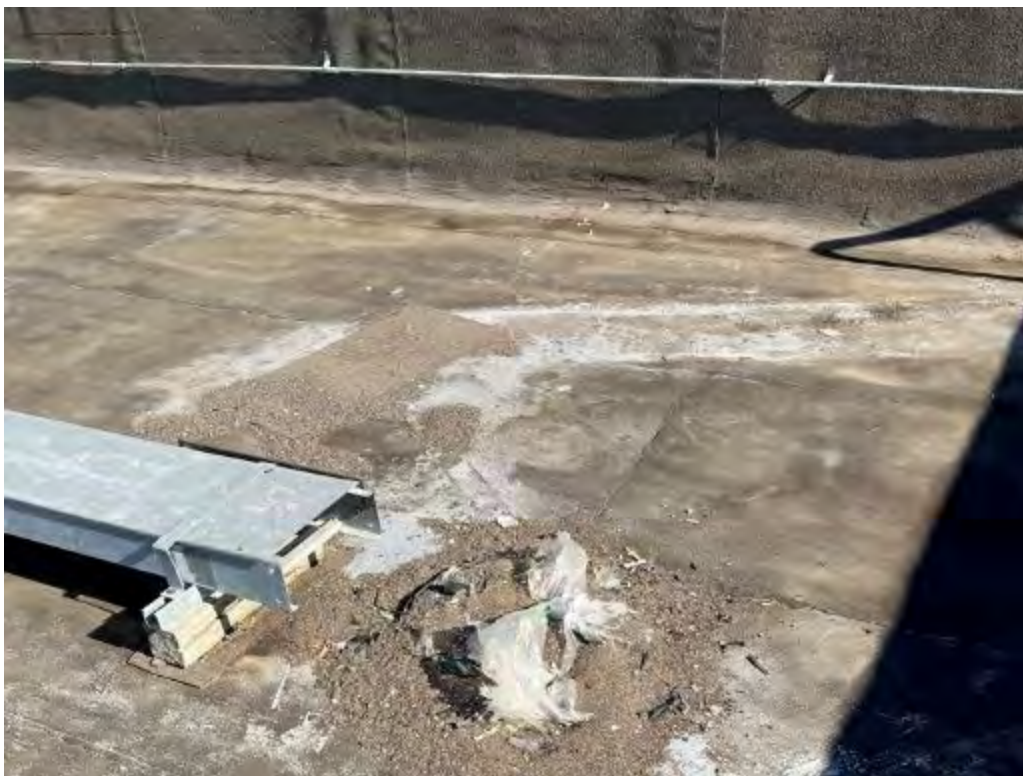
Organic and other debris

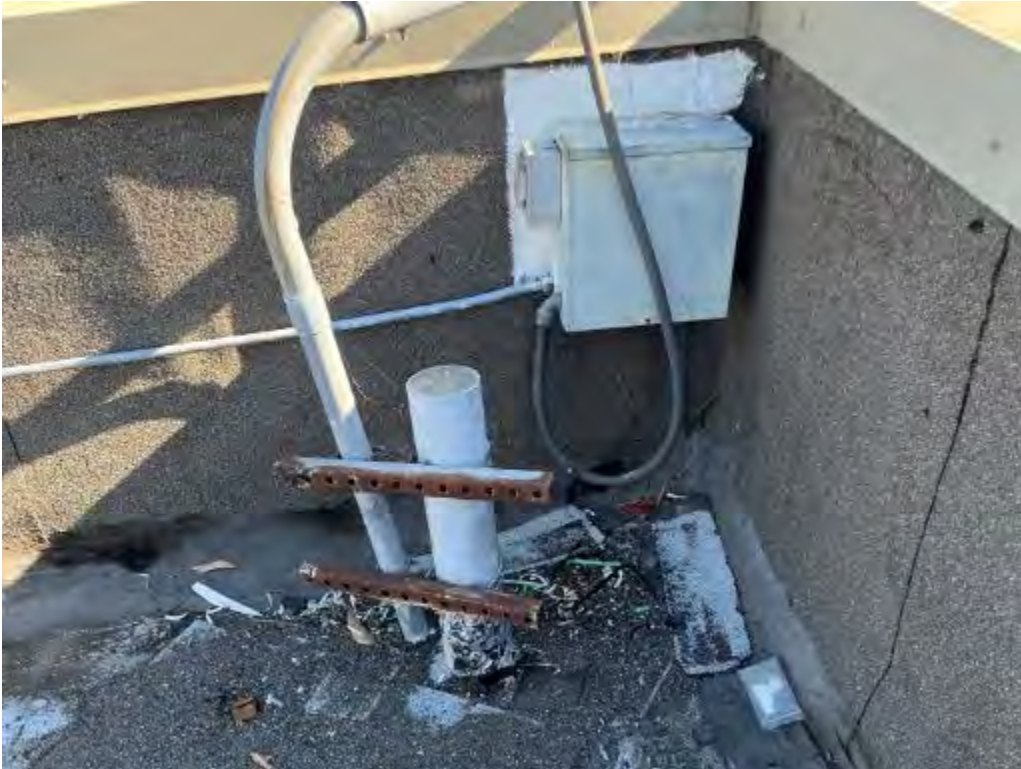
Debris

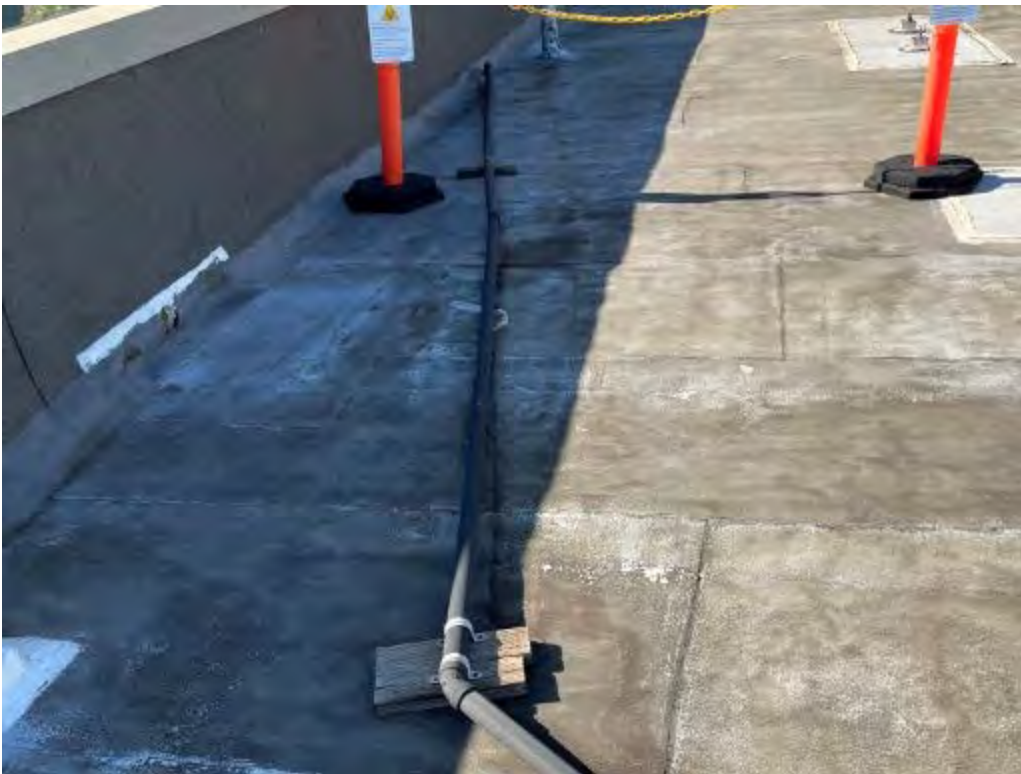
Abandoned PVC drain line

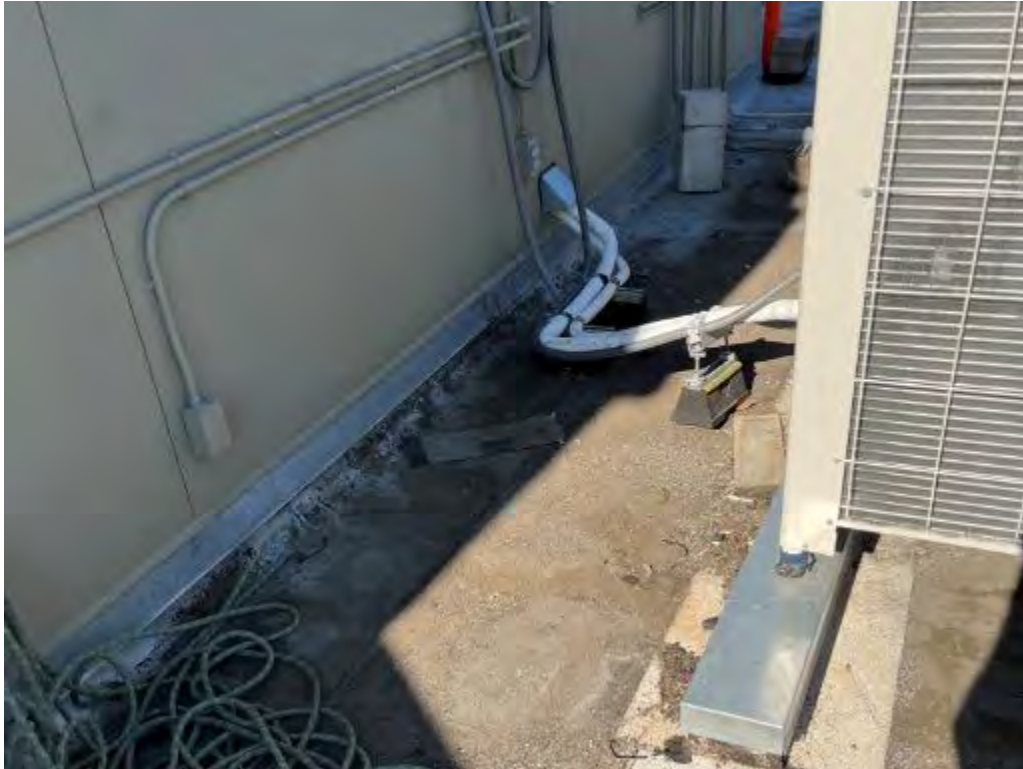
12. Evidence of ponding water was noted in several areas of the roof.
13. The mastic seals around multiple, assorted equipment has split.
14. An exhaust vent on the penthouse roof is severely rusted and is missing its cap.

Evidence of ponding water

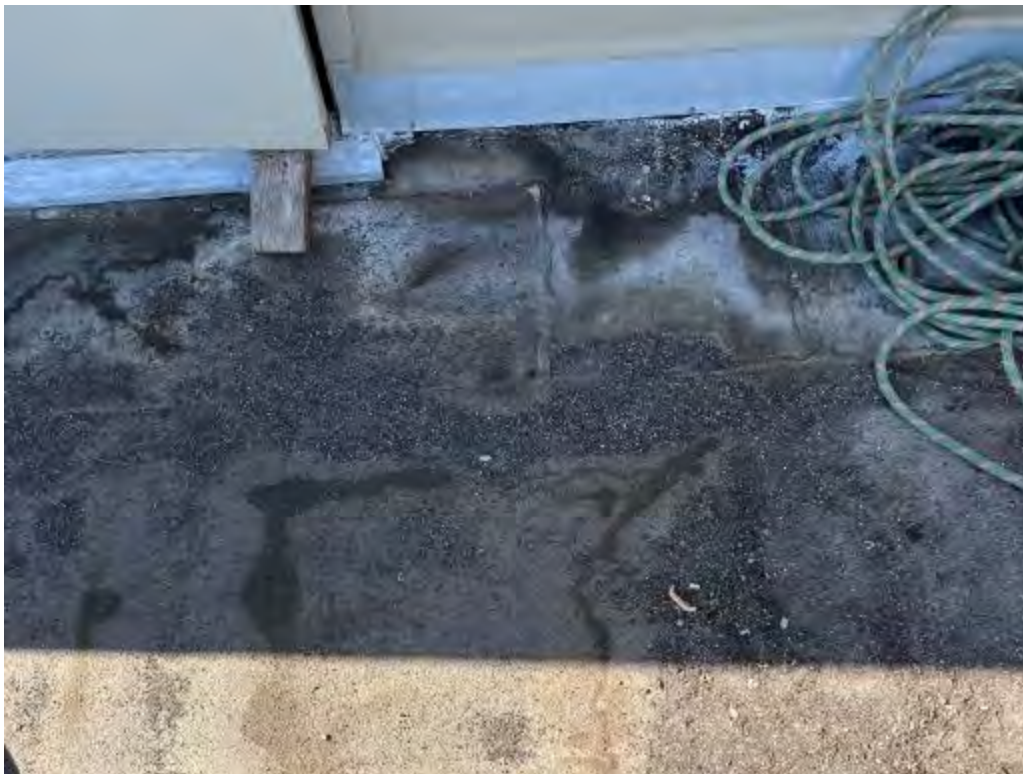
Evidence of ponding water

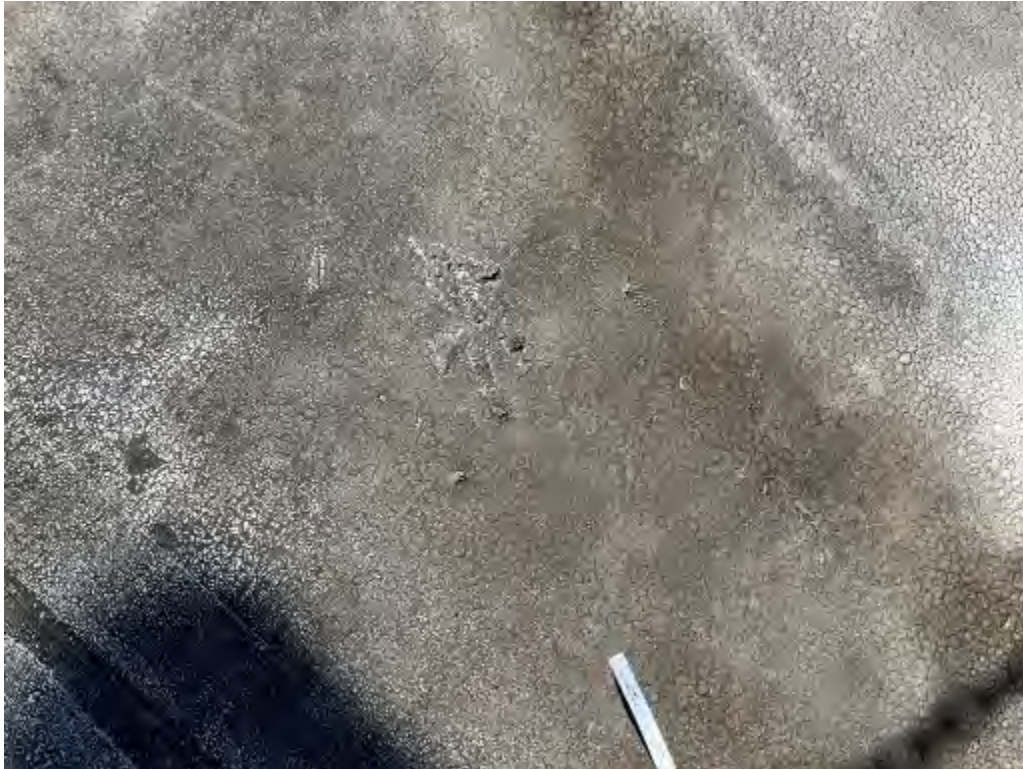
Small punctures in membrane

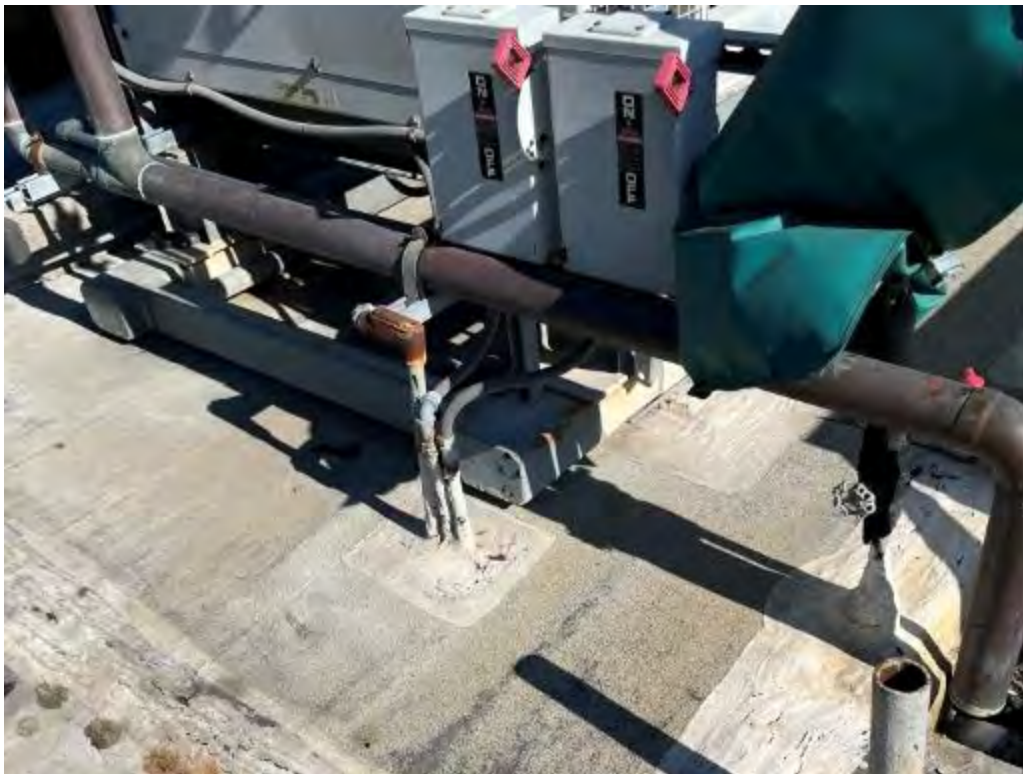
Splits developing at mastic seal around cooling tower

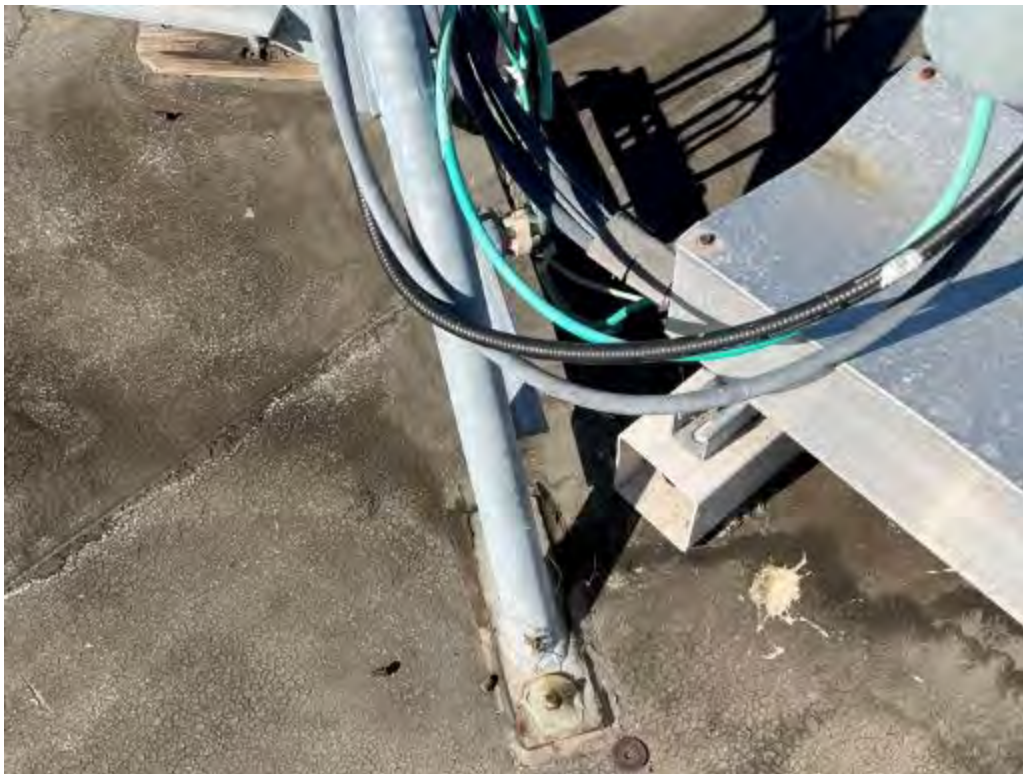
Antenna support leg mounted through roof

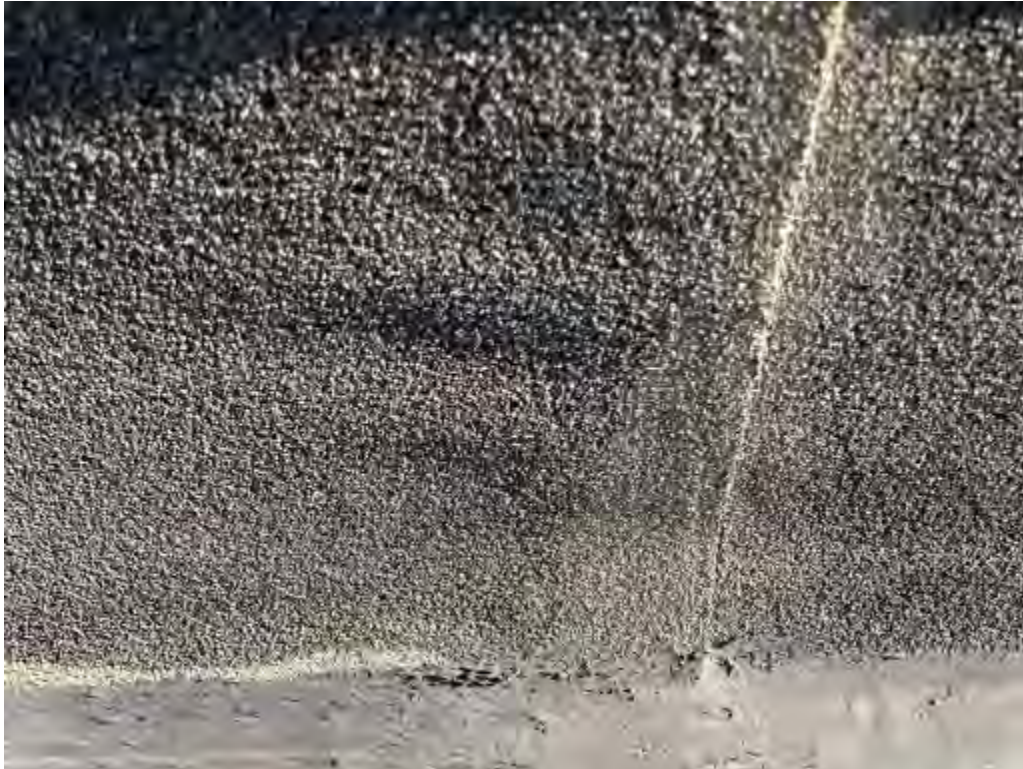
Splits at perimeter mastic roof tie-in

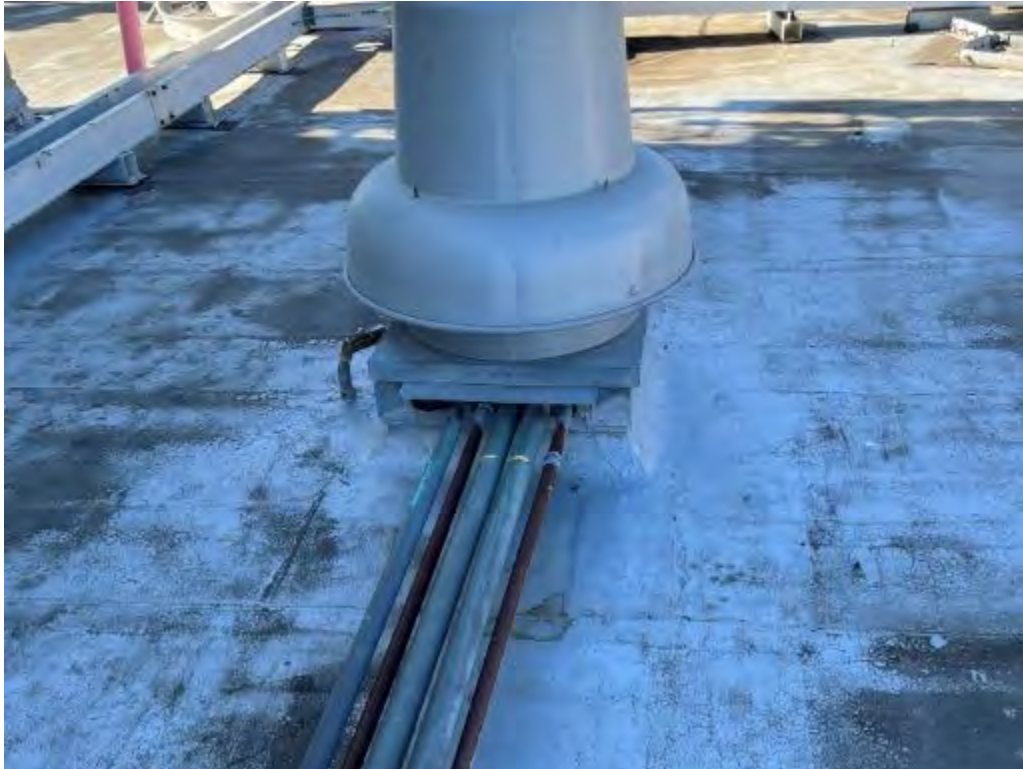
Open pipe penetration

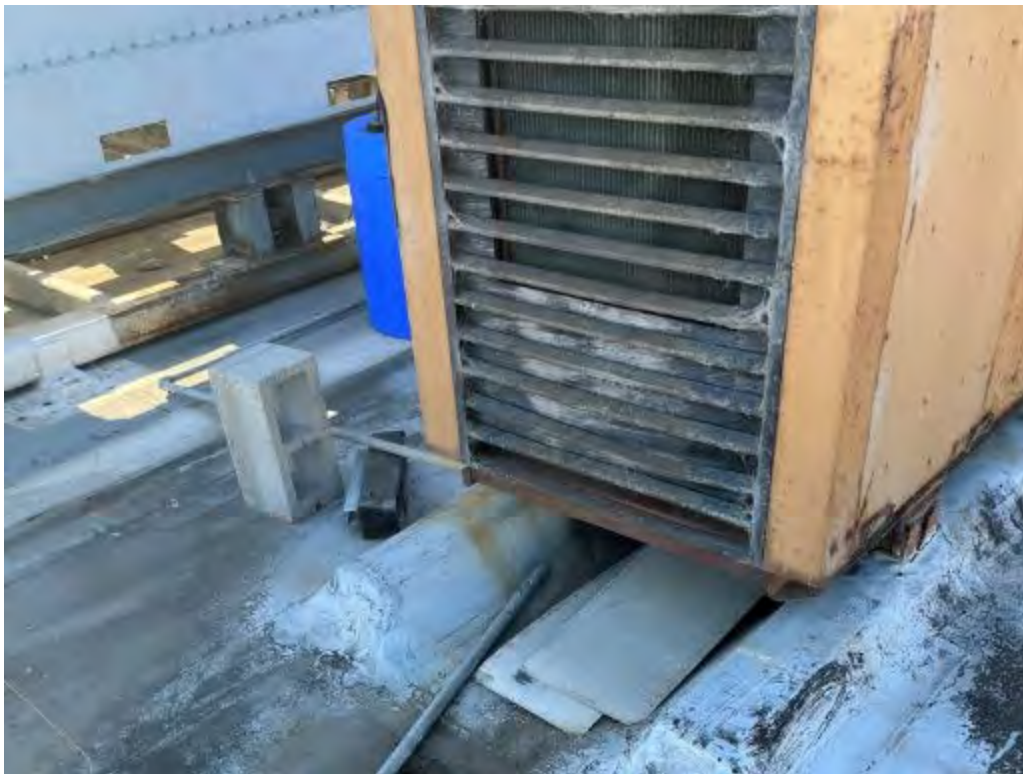
Debris/abandoned concrete block/displaced or abandoned wood support block

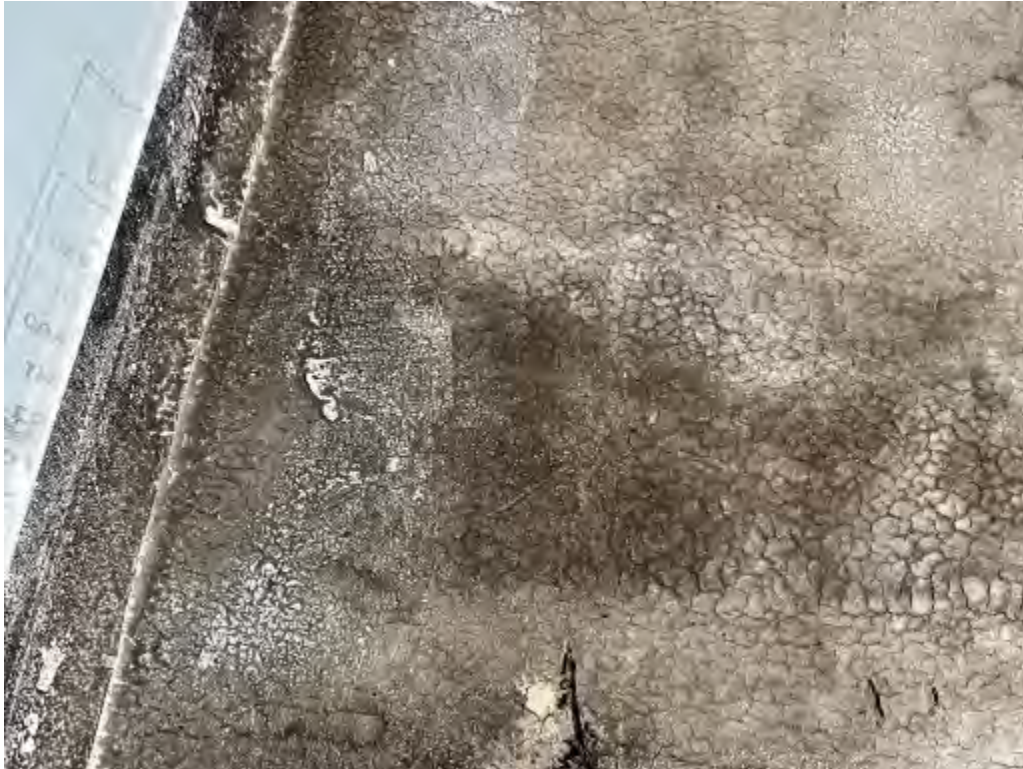
Puncture in membrane

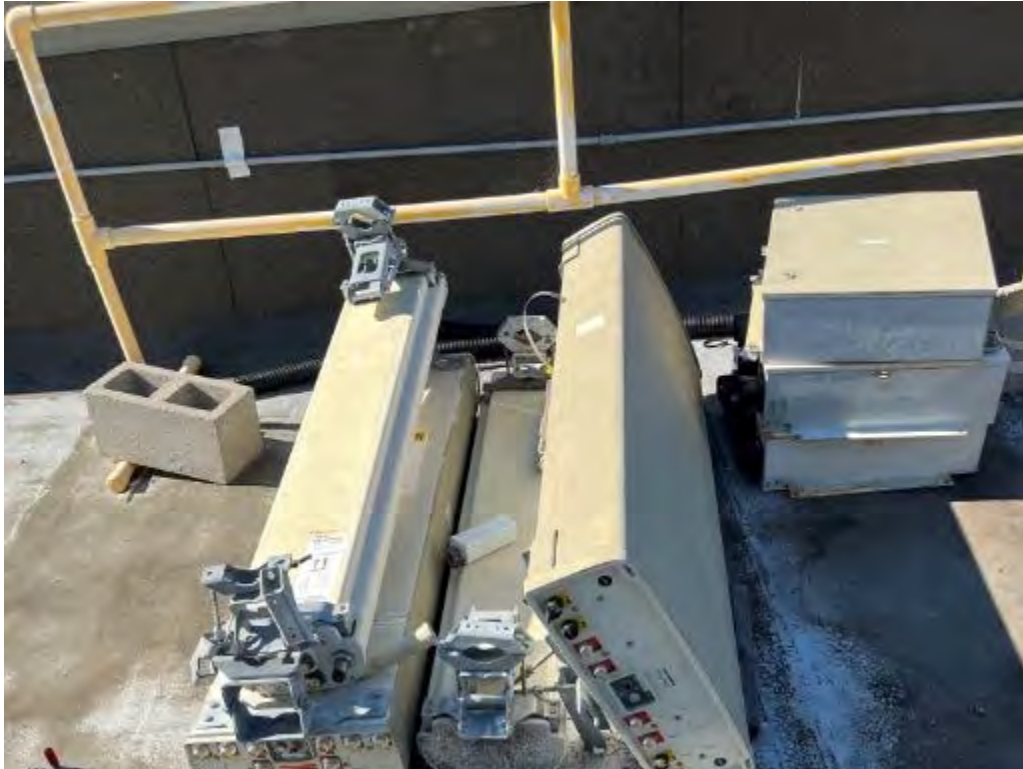
Abandoned antenna components

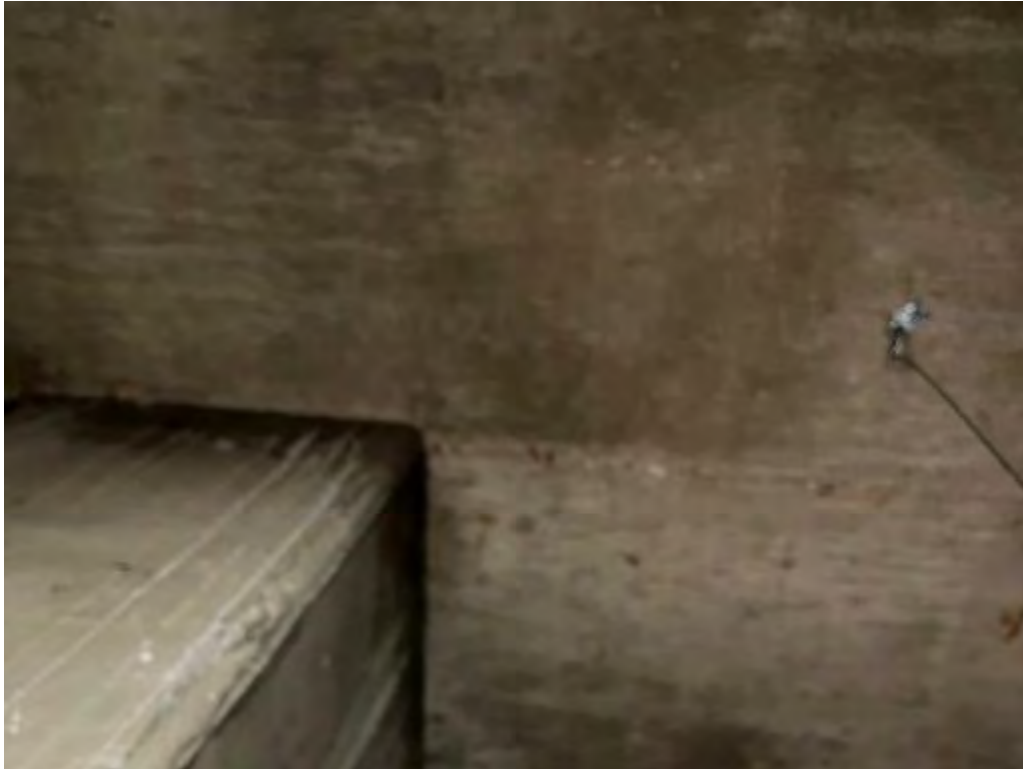
Concrete roof deck detail
