PROPERTY CONDITION ASSESSMENT REPORT

COMMERCIAL BUILDING

123 Main Street

NDDS Project 2311111

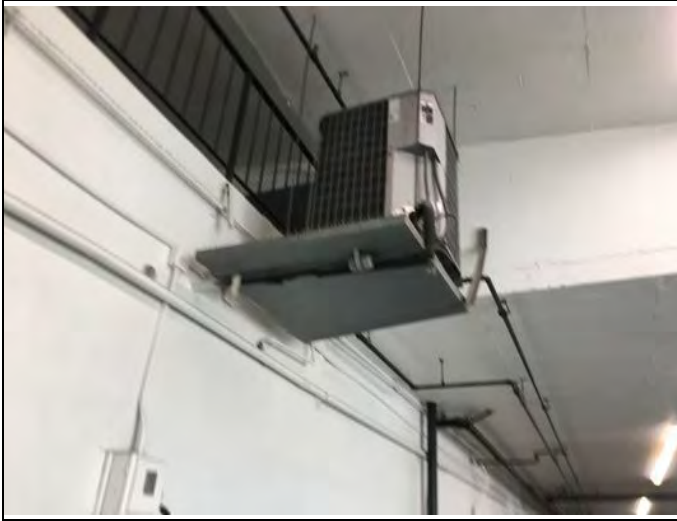
1. 1 of 3 first floor garage level air-cooled split system AC condensing units

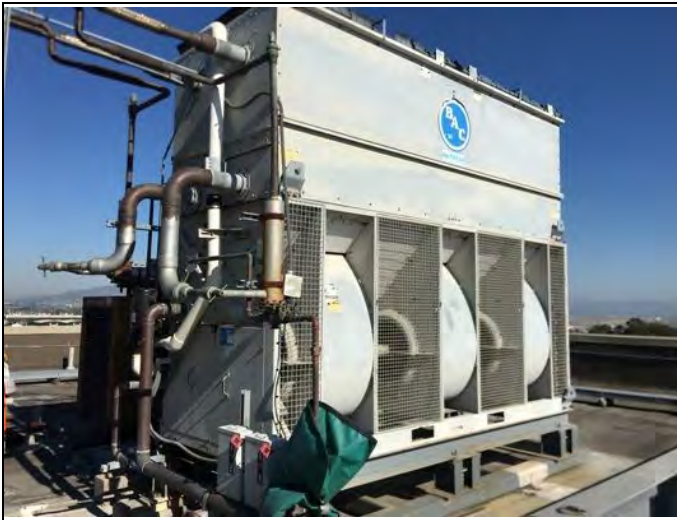
Heat rejection in each tower is accomplished using an older 1995 replacement water-cooled “Baltimore Air Coil (BAC)” forced draft type evaporative condenser with steel case and steel water basin. All surfaces appear to contain “Balti-bond” original factory coating. While not accessible, the evaporative condenser has either a 10 or 15-Hp fan motor with “ABB” VFD

3. Rooftop steel, "Balitbond" coated evaporative condenser unit (2009)

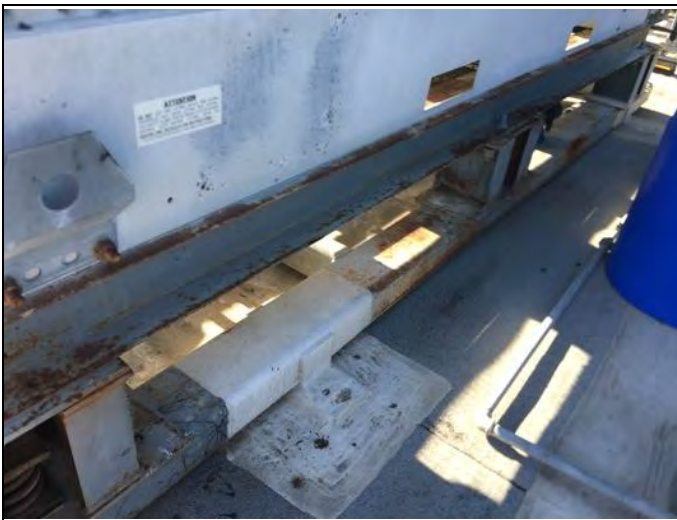
Evaporative condenser is in good shape for its age (27 years) with the following issues observed: Rust on steel drive shaft, shaft bearing at far left (motor side) is making noise and may need replacement, there is little or no corrosion on the water basin, no water leaks noted, unit sits on spring isolators with seismic restraint, and there are rust and corrosion on the steel support beams.

5. Evaporative condenser sits on spring isolator supports, not rusting on steel support frames

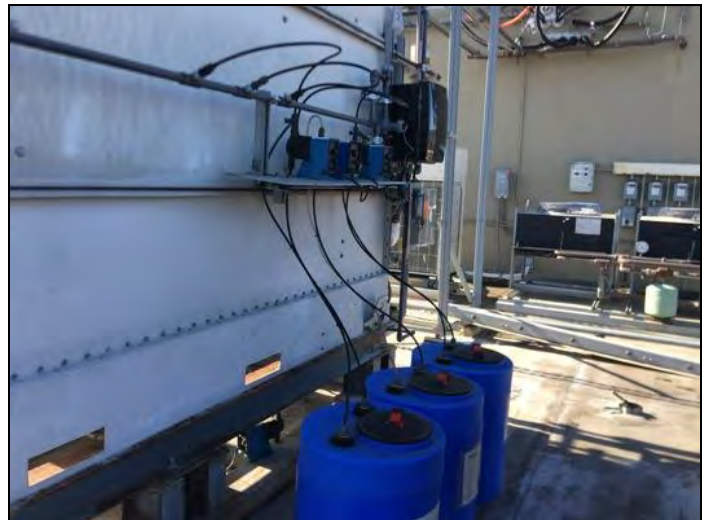
6. Evaporative condenser uses an auto-sensor / auto injection chemical water treatment system

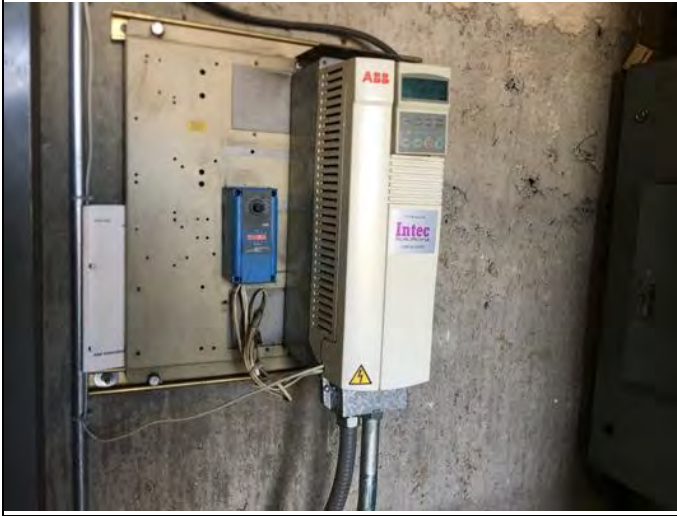
7. VFD variable speed drive for condenser fan with water temperature controller aquastat

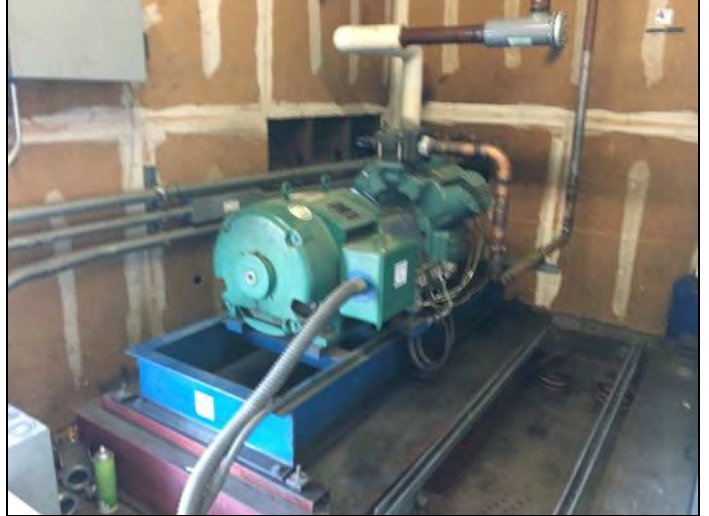
At that time the original refrigerant R22 medium-pressure type compressors were retrofit with R22 replacement refrigerants, possibly including R422, which has equivalent properties. It also appears the DX cooling coils still have original R22 expansion valves.

8. Reciprocating refrigeration compressor #2: 1977 but rebuilt, 75-Hp, Replacement motor

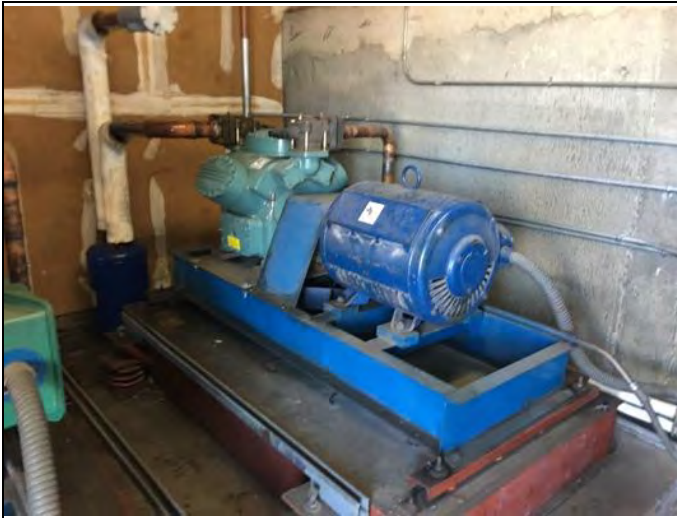
9. Reciprocating refrigeration compressor #1: 1978 but rebuilt, 75-Hp, original motor

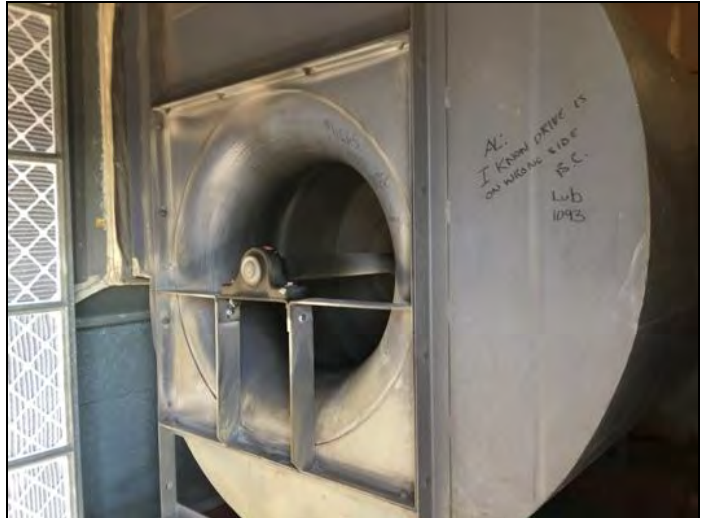
Supply air for both cold deck and hot deck is provided by a common original 1970s “Trane” 40-Hp centrifugal fan. This is a constant air volume system and there is no VFD.

10. Single supply air fan for cold and hot decks, no VFD constant speed. 40-Hp

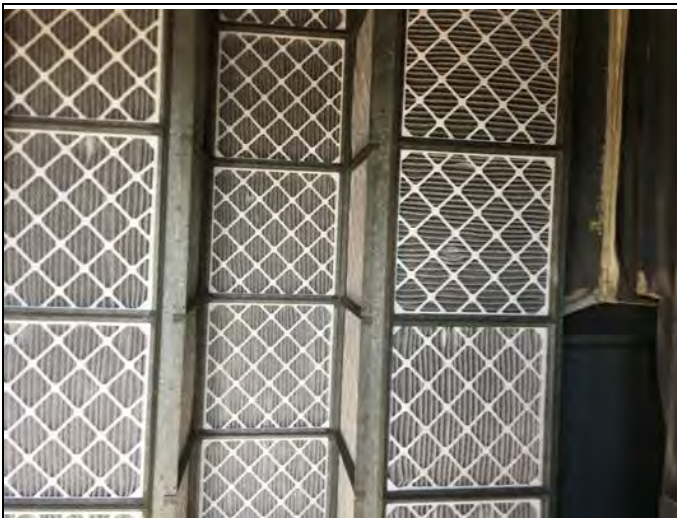
11. Outside air filter bank, 2-in. pleated, standard efficiency

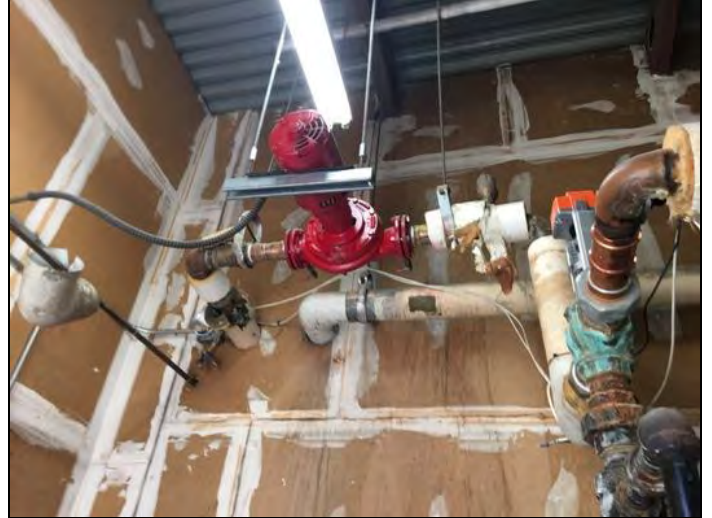
14. Inline type space heating hot water circulation pump to hot deck

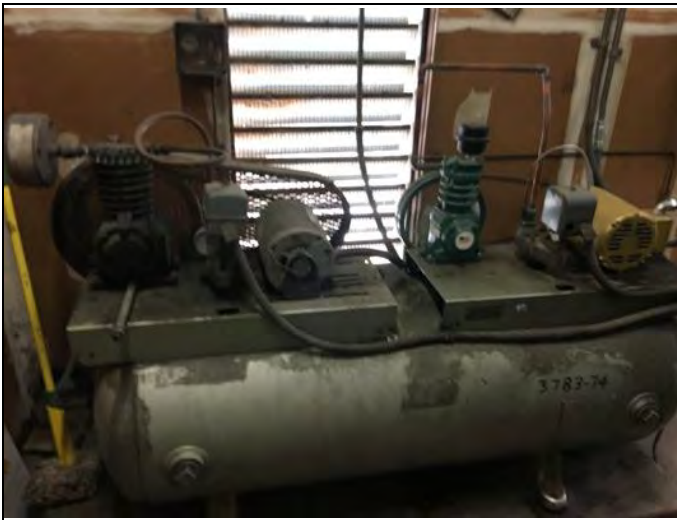
Compressed air for pneumatic controls is provided by a rooftop penthouse dual ¾-Hp reciprocating air compressor, with storage tank and attached refrigerated air dryer unit. It appears the air compressor is a replacement unit installed in approximately 2001.

15. Older dual-reciprocating compressor pneumatic control air compressor

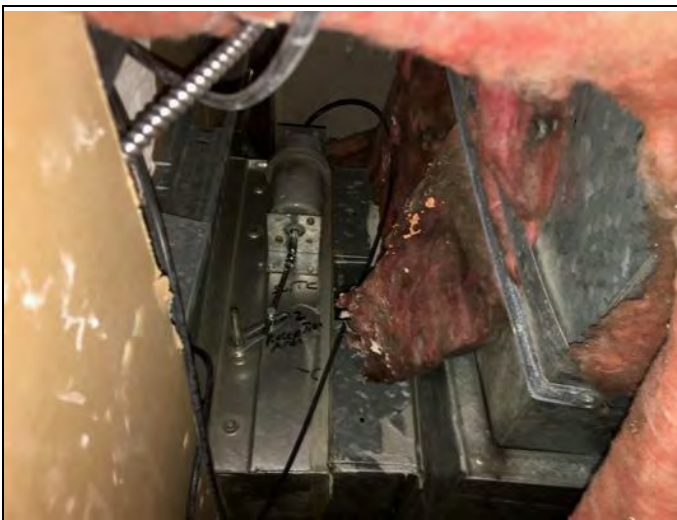
17. Cold deck interior space mixing box damper controller with pneumatic actuator

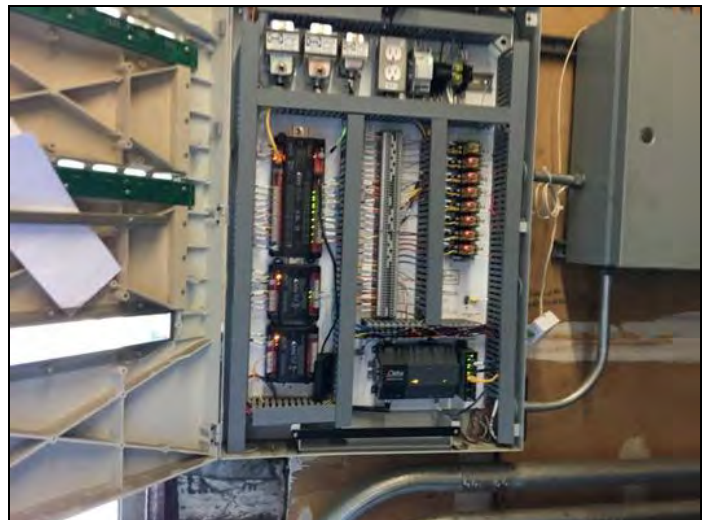
There is a limited function DDC “front end” programmable computer terminal control software installed noted as “Delta” “Envision” which was last updated in about year 2019. The energy management system (EMS) is remotely controlled by the installer, “Emcor Mesa”. There is no Internet router installed, and the owner and facility engineer have no remote access to the system except by plugging in a laptop into an RJ45 terminal with a cable.

18. Retrofit (2019) “Delta” direct digital control (DDC) modules

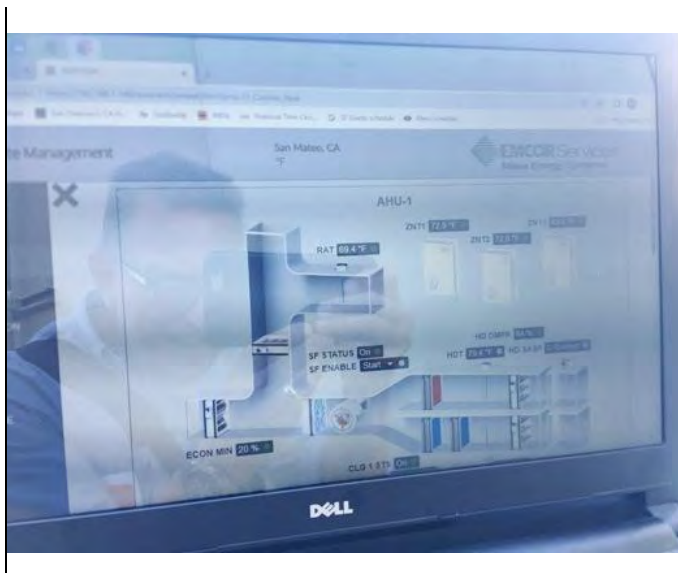
19. Programmable energy management system built-up air handler system control screen

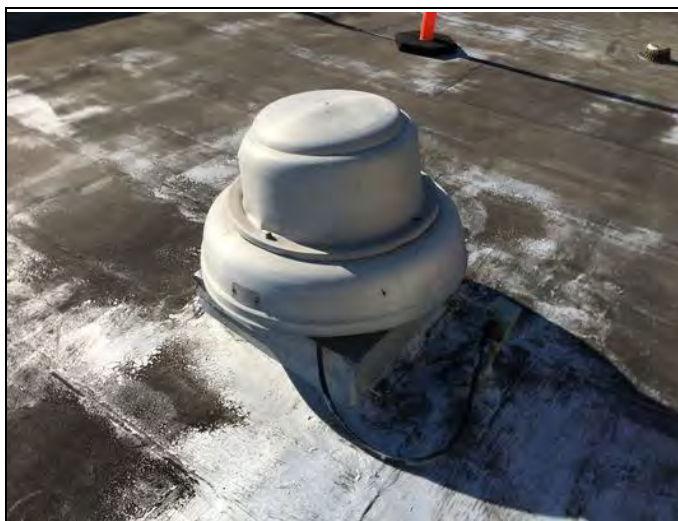
Ventilation/Exhaust: There are two (2) newer appearing rooftop centrifugal type exhaust fans used for 6th floor laboratory space. In addition, base building contains seven (7) original 1979s small rooftop axial type exhaust fans for use in restroom exhaust stacks and machine/elevator/boiler rooms.

21. Typical of axial type rooftop exhaust fans

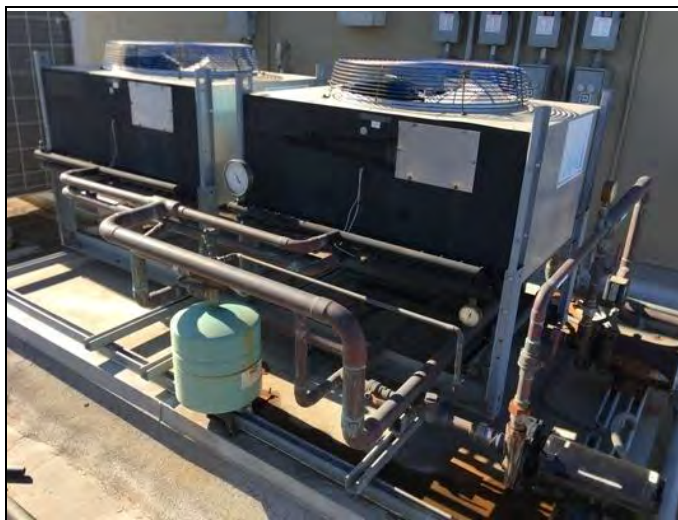
23. Tenant owned air-cooled condenser units for 6th Laboratory space

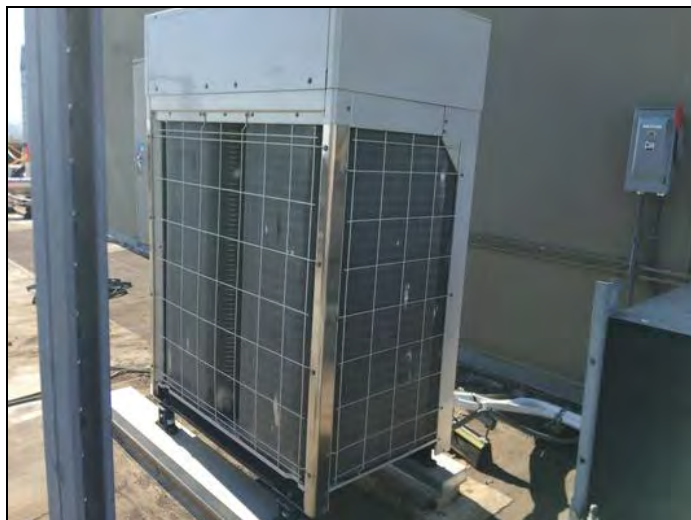
24. “Amazon” owned VRF type condenser unit

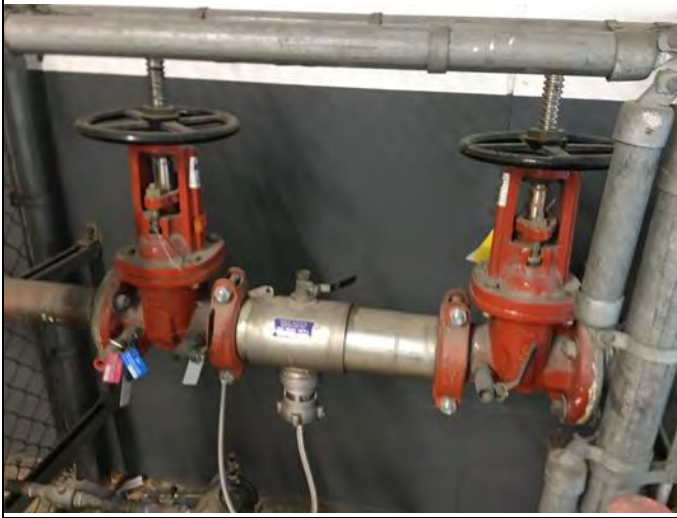
PLUMBING: Public utility provides domestic water into the building through a 3-in. service line with new back-flow prevention device. Water is circulated to the building using incoming utility line pressure, and no booster pumps are used. Water piping inside structure was observed as copper tubing. Hot water for front office restrooms is generated in a rooftop

25. Incoming 3-in. potable water utility service pipeline with new stainless-steel back-flow prevention device

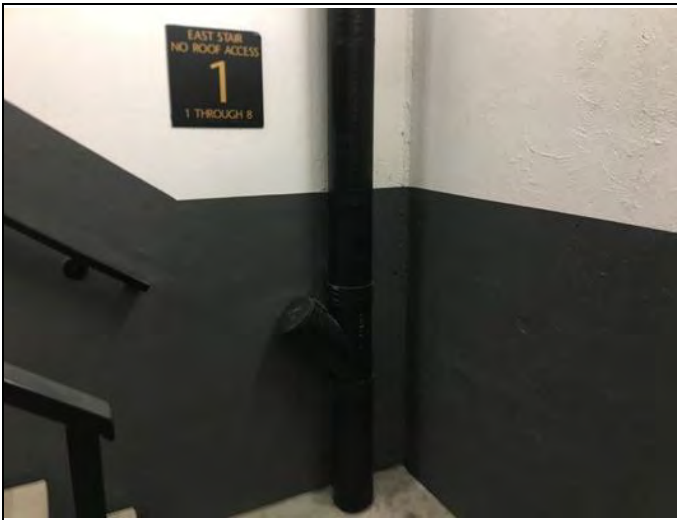
27. Stairwell cast iron roof drain down-comer with clean out connection

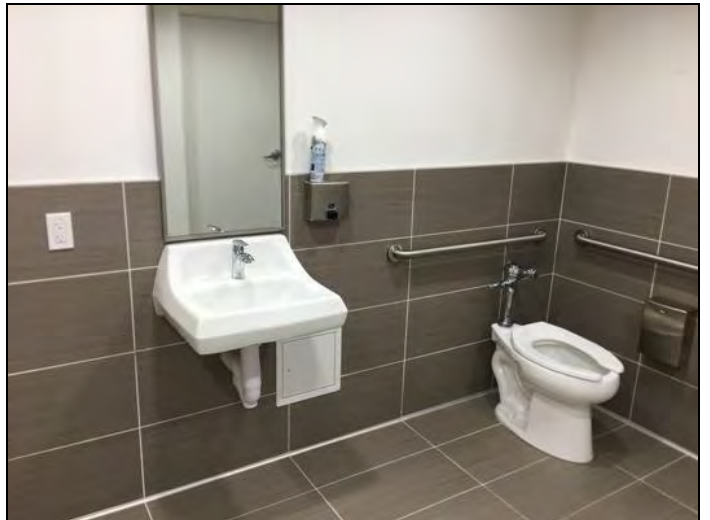
28. Recent updated "unisex" restroom fixtures

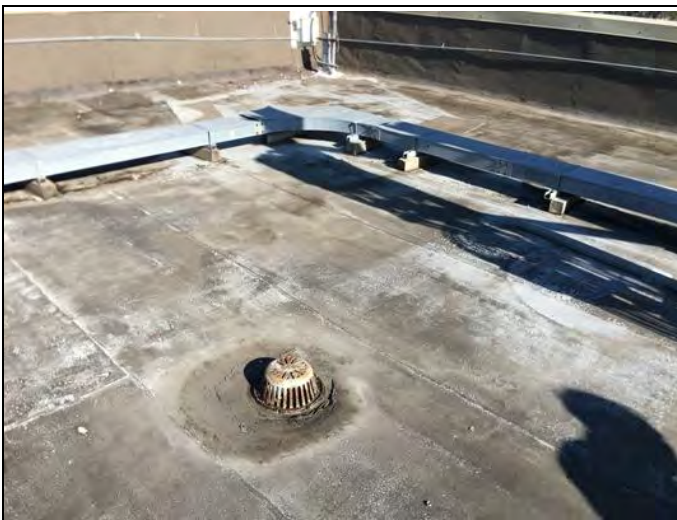
29. Note single rooftop covered drain, no adjacent over-flow drains installed

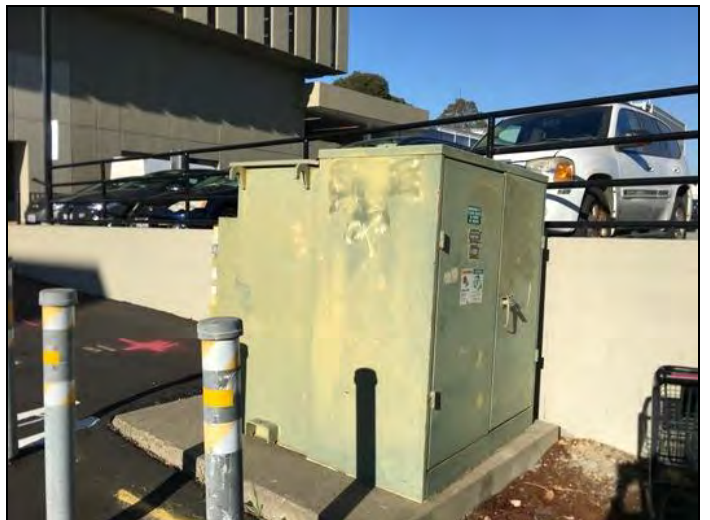
30. Exterior pad-mounted utility high-voltage transformer supplies 277/480V electricity into subject building

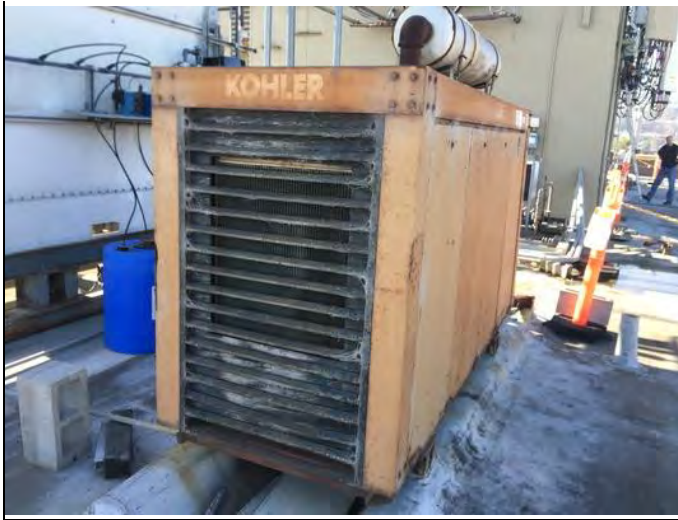
31. Original 1979 diesel engine driven 55-kW E-power generator, Out-of-service

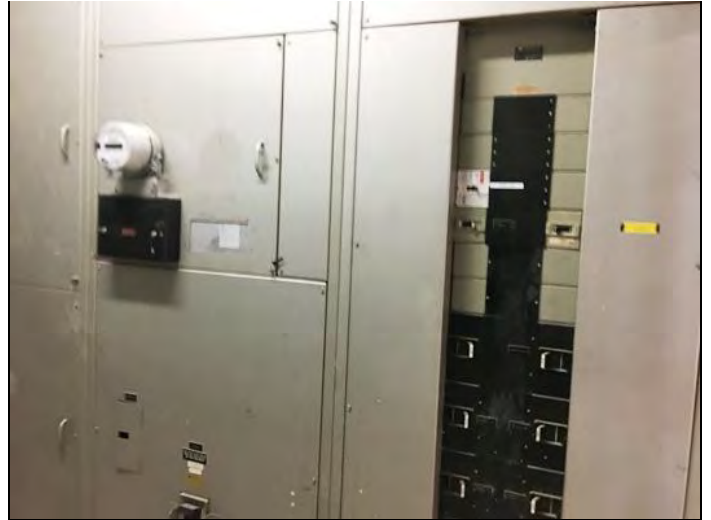
32. Main original 1970s single metered electric power distribution switchboard, 1600A, 277/480V

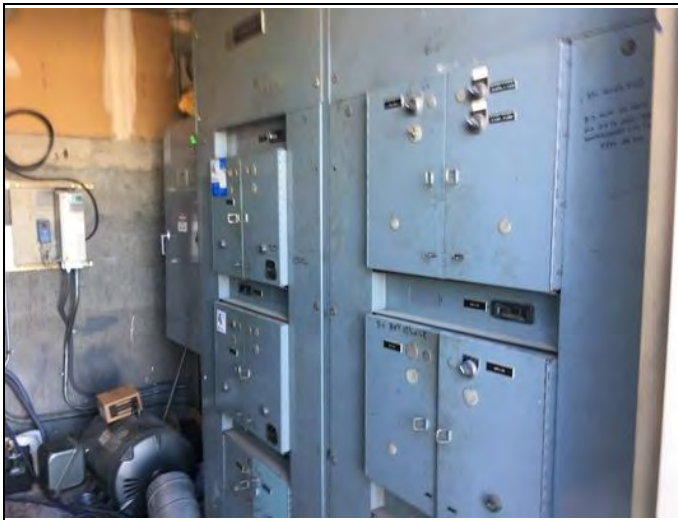
33. Penthouse HVAC equipment motor control center, 400A, 480V

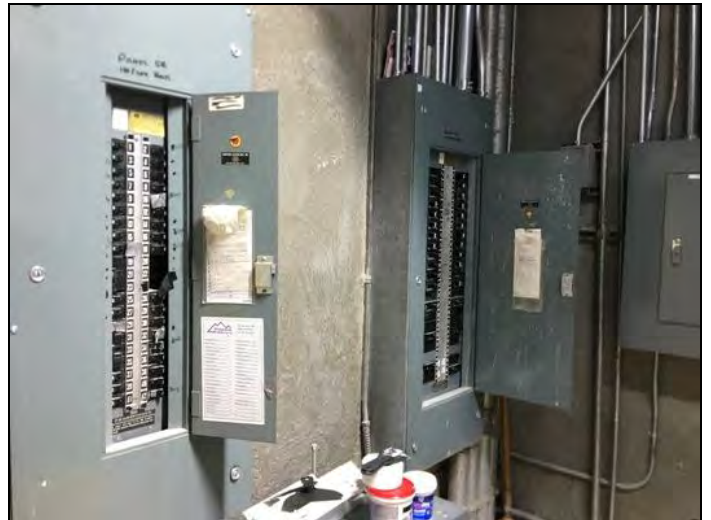
34. Typical floor original 225a, 277/480V panels and 225A, 120/208V sub-panels

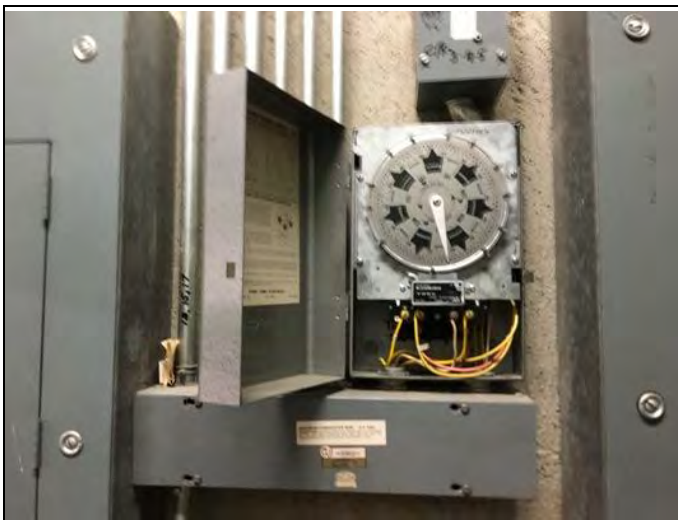
35. 7-day old fashioned mechanical timer for exterior and parking lights

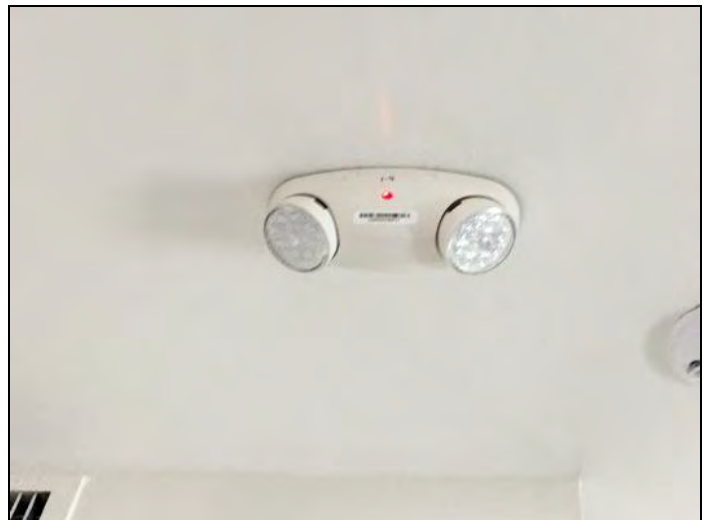
36. Typical of battery pack type emergency egress light fixtures

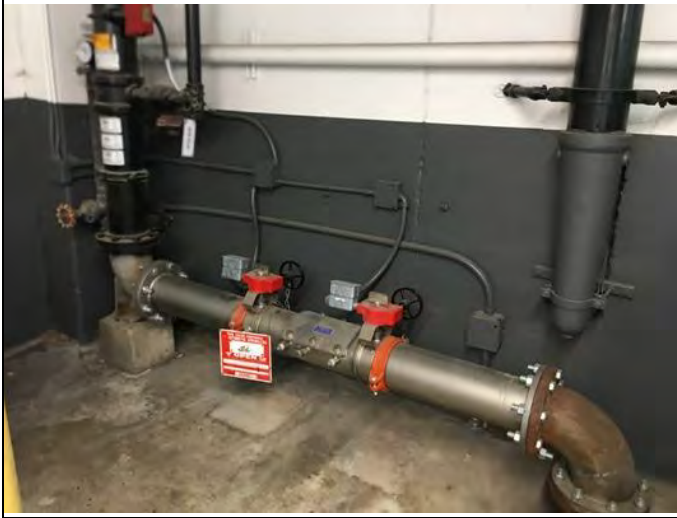
37. Incoming 6-in. firewater utility service pipeline with new stainless-steel back-flow prevention device

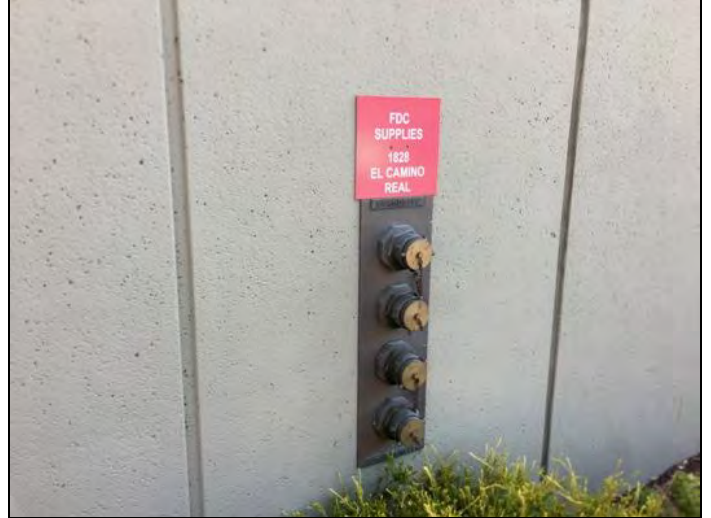
38. Exterior 4-head FDC (fire department hose connections)

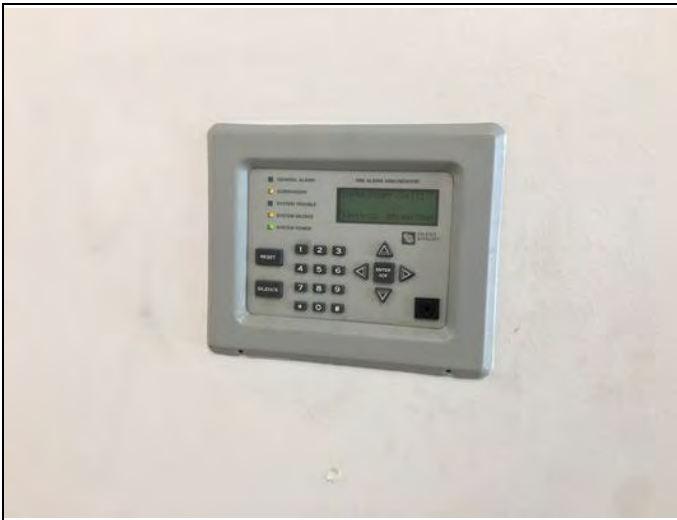
39. Lobby level fire alarm control panel keyboard annunciator

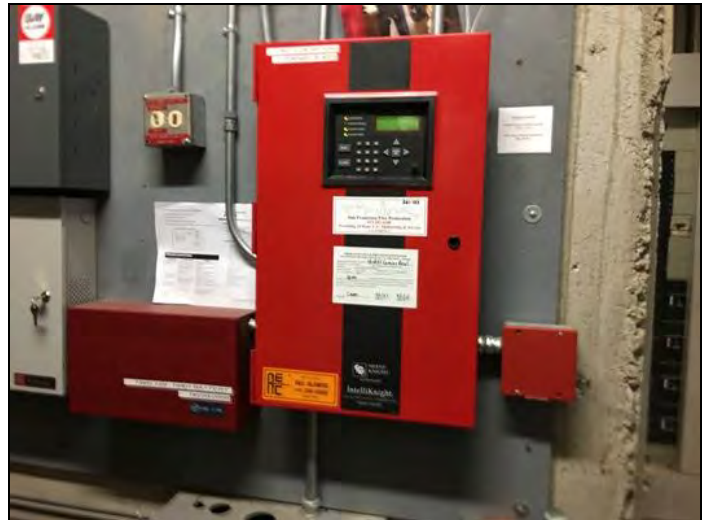
40. 2008 addressable fire alarm control panel (FACP)

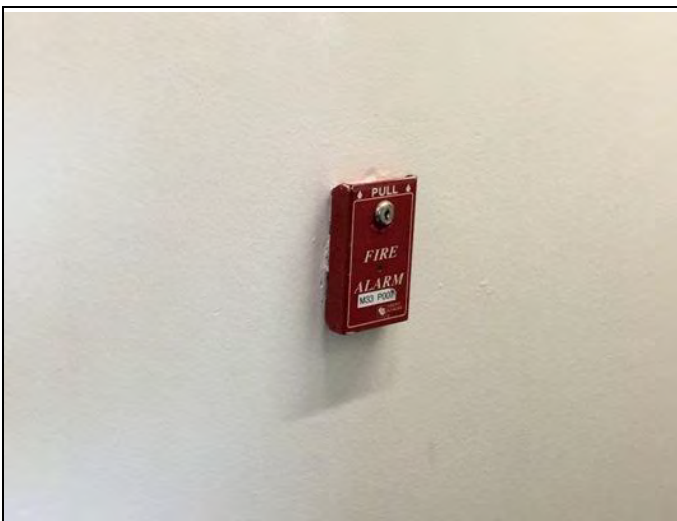
41. Typical wall mounted manual “pull” station alarm device

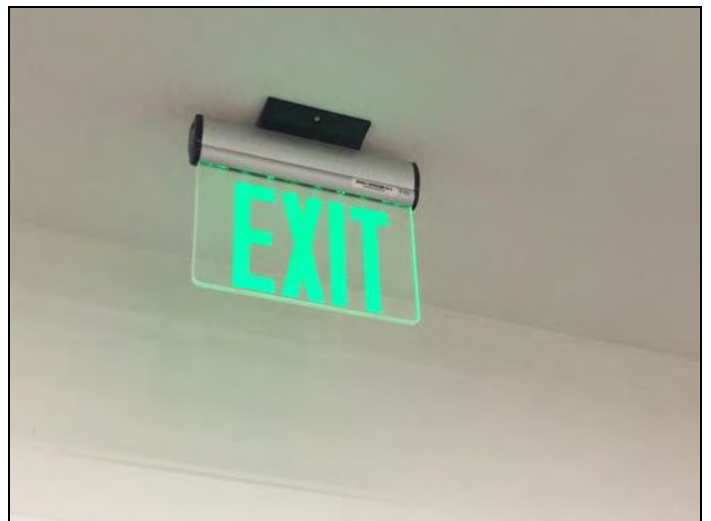
42. Typical upgraded LED Exit sign fixture

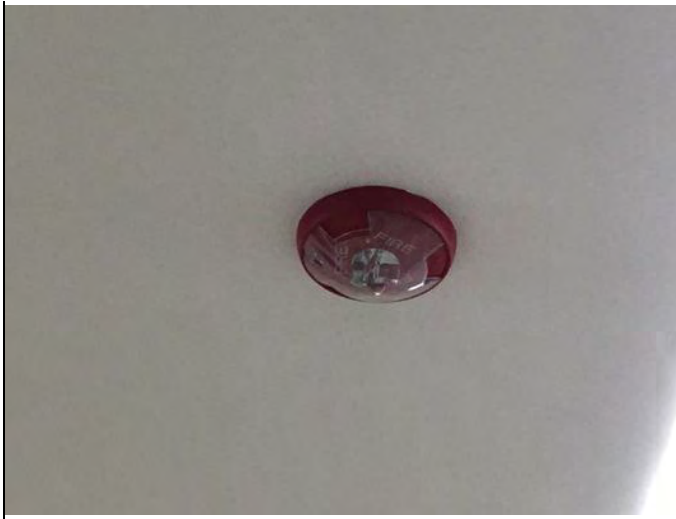
43. Typical ceiling mounted newer vintage audio-visual horn/strobe alarm device

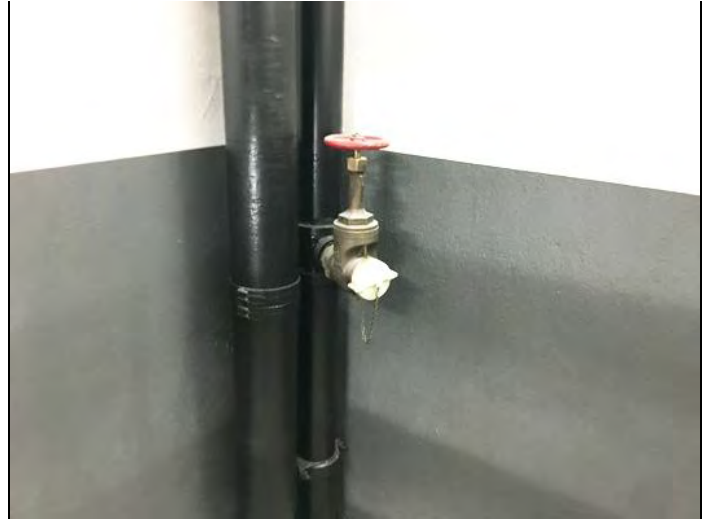
44. Stairwell 6-in. wet standpipe with hose connection at every floor and rooftop

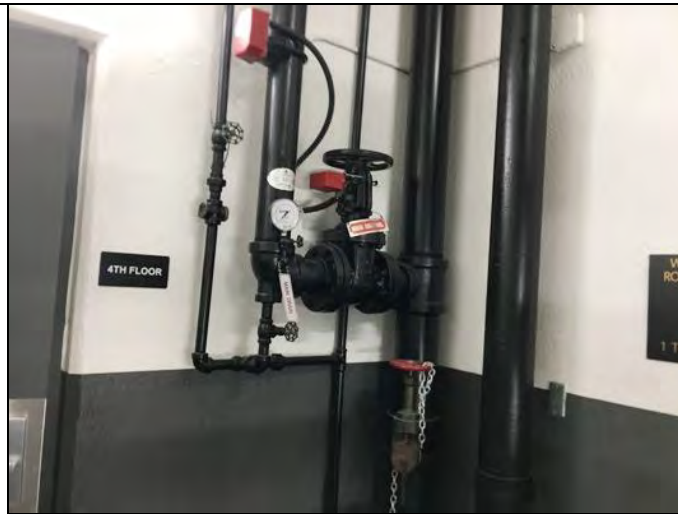
45. Alternate stairwell wet sprinkler firewater riser with flow alarm sensor and floor branch line

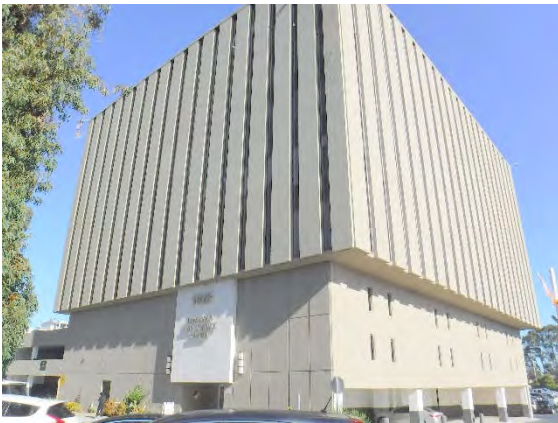
Figure 2. Office Building west and south elevation.

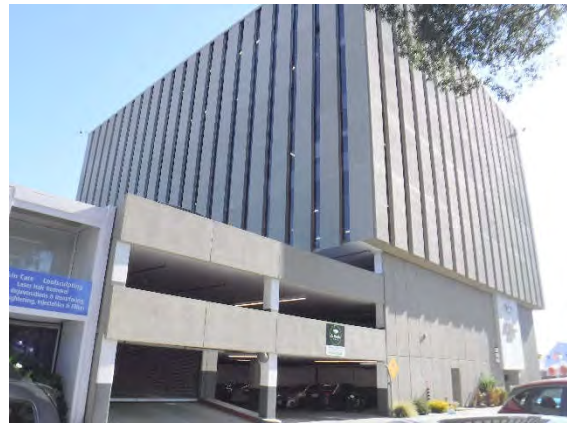
Figure 3. Office Building west elevation and street front.

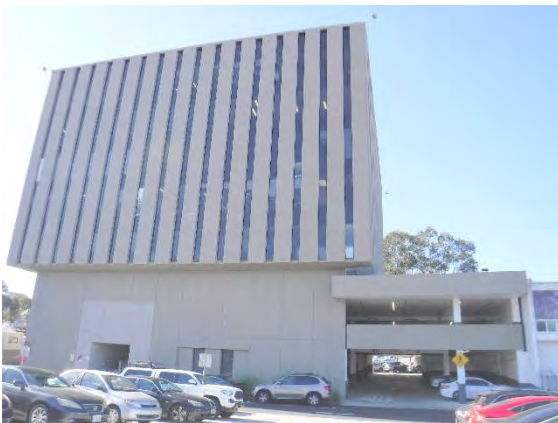
Figure 4. Office Building east elevation.

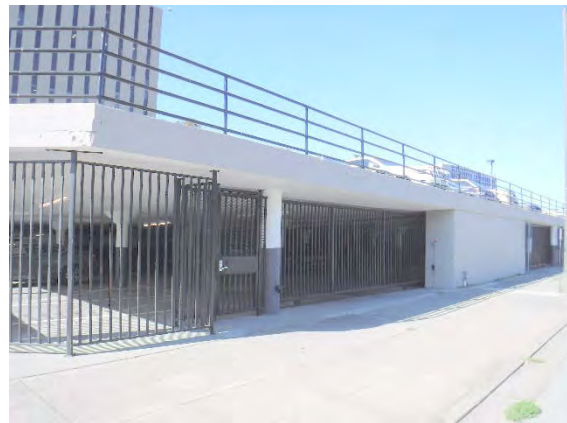
Figure 5. Parking structure east elevation.

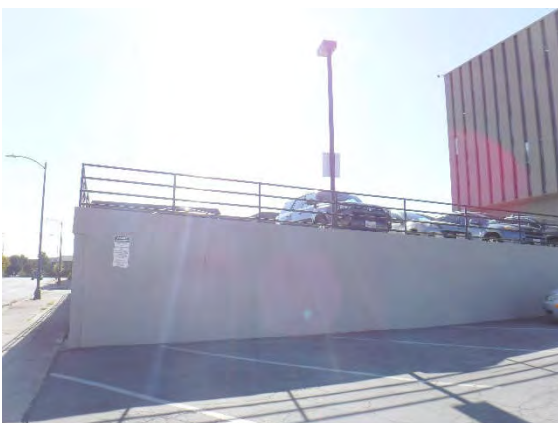
Figure 6. Parking structure north elevation.

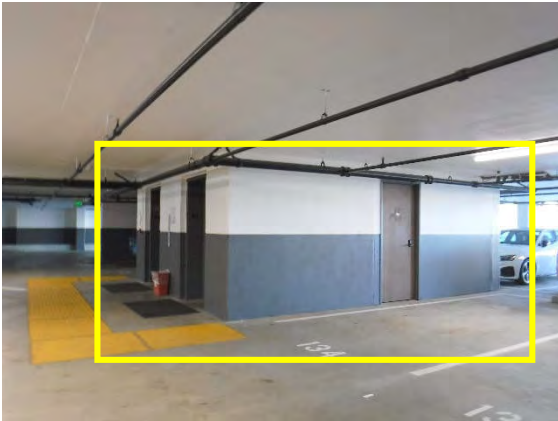
The primary lateral force-resisting system consists of the concrete slabs at the roof and floor levels performing as rigid diaphragms that distribute lateral loads to the concrete shear walls. (Figures 10 and 11). The office floor levels 5 to 8 have slabs that cantilever out from the perimeter concrete column line that create an elevation irregularity (figures 12 and 13)

Figure 10. Concrete shear wall core.

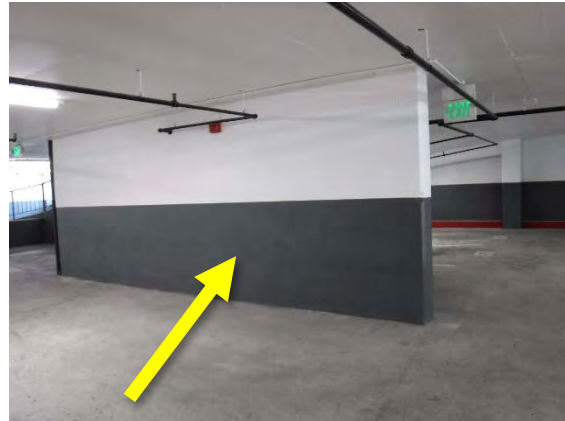
Figure 11. Transverse concrete wall.

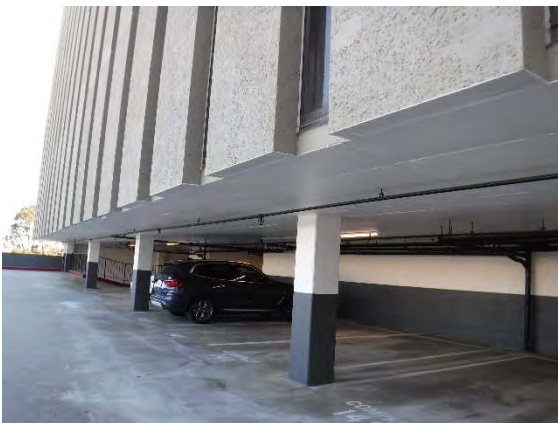
Figure 12. Office building levels 5 to 8 transition from parking levels.

- Both Structures: The date of construction (1974) employs outdated seismic design requirements, which do not include modern seismic design forces and detailing methods. Deficiencies could include but are limited to non-ductile seismic detailing of concrete elements and large spacing between the steel reinforcement of column ties.
- Office Building: The structure has an irregular shape in elevation. The transition between the parking levels to the reduced footprint at the upper levels can focus loads and intensify the damage to the building at these areas.

The damage estimates outlined given can be reduced by the implementation of seismic improvements or retrofits. In general, the expected seismic performance of nonductile concrete construction can be improved by wrapping the frame columns and beams in fiber composites and the addition of concrete shear walls or steel braced frames. These solutions would be applicable for this property. Structural drawings of the building and foundation are generally unavailable; and it is difficult to estimate the costs of such a retrofit. Without this information, it is not practical to estimate required quantities of materials to support a cost estimate.

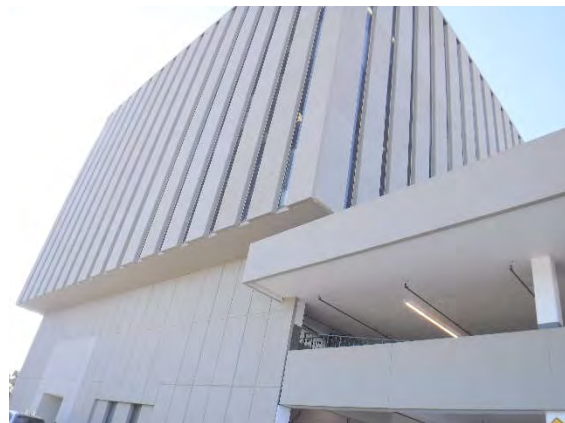
Figure 13. Irregular elevation with office section rising from parking levels.

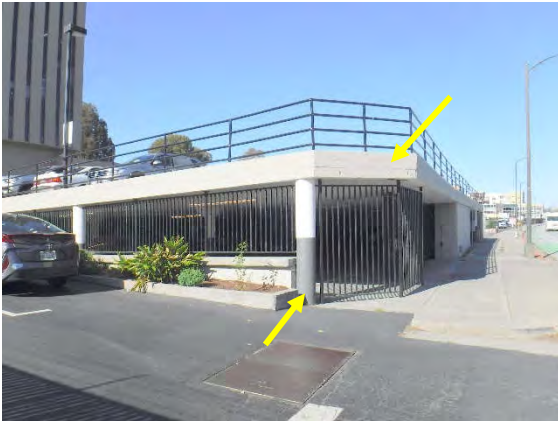
Figure 14. Concrete slab supported by concrete columns.

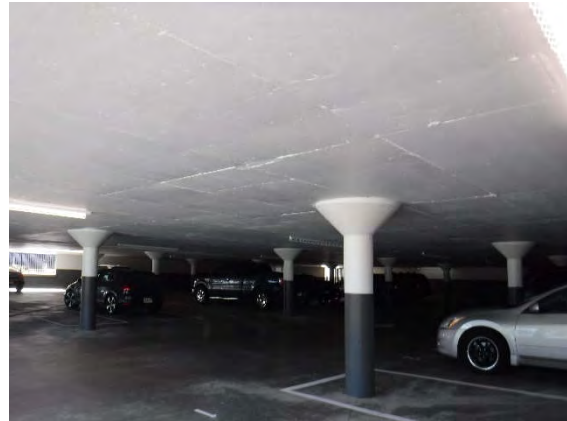
The structure is classified as combination of reinforced concrete shear walls and concrete masonry shear walls with a rigid diaphragm per the ATC 13-1 and the Standard ASCE/SEI 41-17. The primary vertical load carrying system is comprised of a two-way concrete slab supported by perimeter masonry walls lining the south, west and north elevations, a concrete wall at the east elevation, and interior and perimeter concrete columns. (Figure 14). All gravity loads are carried to the foundation systems by the concrete walls, perimeter masonry walls and interior/perimeter concrete columns (Figure 15).

Figure 15. . Concrete slab supported by concrete columns.

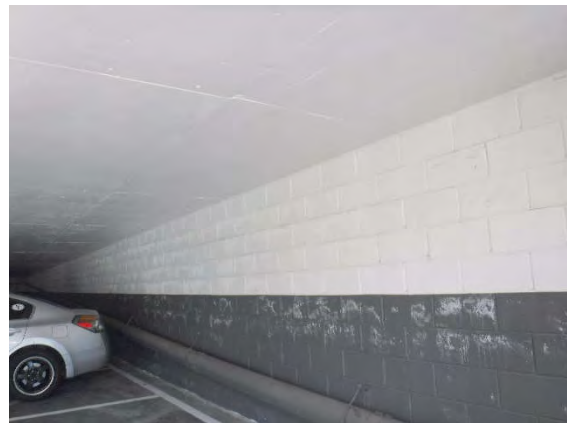
The primary lateral force-resisting system consists of the concrete slab at the roof deck level performing as a rigid diaphragm that distributes lateral loads to the masonry and concrete shear walls (Figures 16 and 17).

Figure 17. Perimeter masonry shear and retaining walls.
